AIRPROX REPORT No 2017179

Date: 29 Jul 2017 Time: 1008Z Position: 5207N 00005E Location: 6nm SW Cambridge Airport

PART A: SUMMARY OF INFORMATION REPORTED TO UKAB

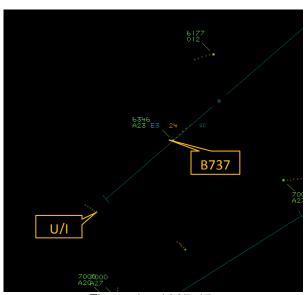
Figure 1 - 1007:45

The B737 was on an IFR departure from Cambridge with a clearance to climb straight ahead on departure from RW23 at Cambridge to an altitude of 2400ft, followed by a left turn towards the BKY VOR/DME, to remain outside of controlled airspace. The aircraft had been cleared for take-off by the Cambridge controller at 1005:30. The controller was providing a combined Aerodrome Control/Approach Procedural service. At 1007:45 the controller instructed the B737 to contact Stansted Radar (Figure 1).

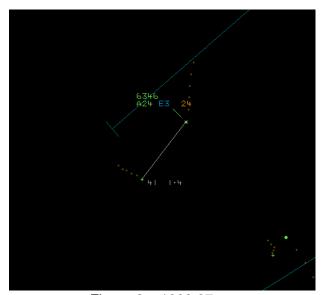
Figure 2 – 1008:27

At 1008:27, the pilot of the B737 contacted Stansted Radar, advising them that they were maintaining 2400ft and routing direct to BKY. The controller instructed the pilot to squawk ident and cleared them to climb further to 5000ft (Figure 2).

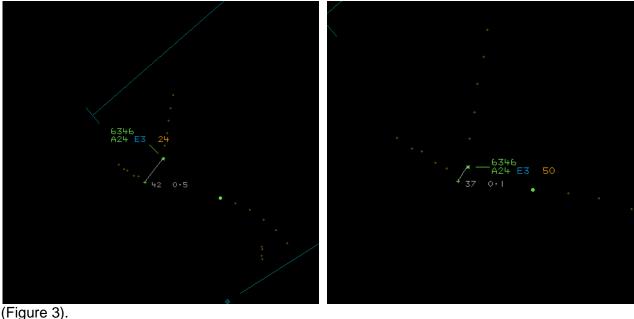
Figure 3 – 1008:42 Figure 4 - 1008:51

At 1008:42, the controller advised the pilot of the B737 of traffic in their 1 o'clock position, confirming that there was no height information available. The pilot of the B737 acknowledged this

and immediately confirmed that they were visual with that traffic and were turning left to avoid it

CPA occurred at 1008:51, with the aircraft separated by less than 0.1nm laterally. The other aircraft was not transponding, and so neither its level nor identity could be determined (Figure 4).

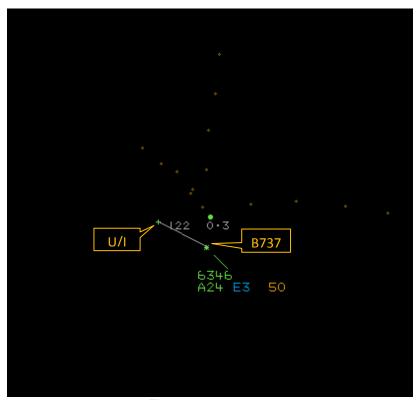
Figure 5 - 1009:10

Although no obvious left turn by the B737 was observed on the radar replay, the other aircraft appeared to make a significant turn away (Figure 5).

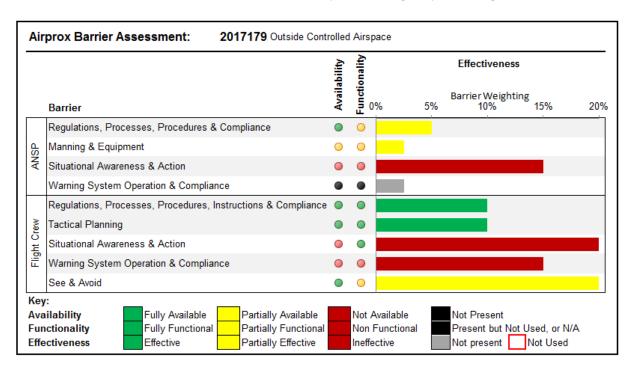
In assessing the effectiveness of the safety barriers associated with this incident, the Board concluded that the key factors had been that:

Regulations, Processes, Procedures & Compliance was assessed as partially effective because Cambridge ATC did not inform the B737, or any other pilots, of the absence of radar services. This might have prompted the pilot to change his departure plan.

Manning & Equipment was assessed as partially effective because Cambridge ATC did not have a radar service available for the departing B737, a medium category aircraft, and this unavailability was not notified to the aircraft crew.

Situational Awareness & Action was assessed as ineffective because Cambridge ATC handed over the B737 to Stansted Radar in conflict. The Stansted radar controller gave the B737 pilot TI but only at the same time as the B737 pilot started to turn to avoid the unknown aircraft.

Situational Awareness & Action was assessed as ineffective because the crew were not aware of the conflicting aircraft until they made initial contact with Stansted Radar.

Warning System Operation and Compliance was assessed as ineffective because, although the B737 was equipped with TCAS II, the unknown aircraft was not transponding and therefore the B737 TCAS could not provide warnings to the B737 crew.

See and Avoid was assessed as partially effective because both pilots likely did not see the other aircraft until the last moment and both had to carry out emergency avoiding action.
