**AIRPROX REPORT No 2017181**

Date: 29 Jul 2017 Time: 1111Z Position: 5049N 00016W Location: 1nm SE Brighton City Airport

**PART A: SUMMARY OF INFORMATION REPORTED TO UKAB**

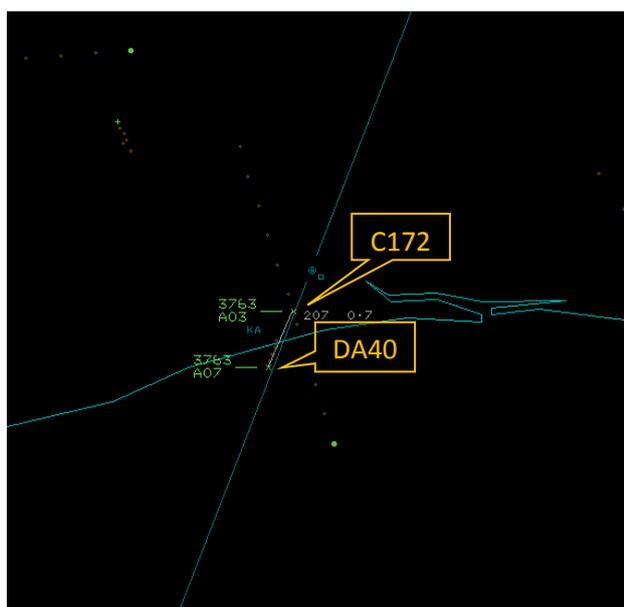
Figure 1 – 1007:45.

The DA40 pilot was conducting left-hand visual circuits to RW20 at Shoreham. The C172 pilot had taxied out and, at 1108:42, reported ready for departure for a local flight to the east of Shoreham. At that time the DA40 was on final approach and cleared for a touch-and-go. At 1111:52, the C172 pilot was cleared to line-up, and at 1109:11 was cleared for take-off. The area radar replay did not show either aircraft until 1110:07, when the DA40 and the C172 appeared 0.7nm apart (Figure 1).

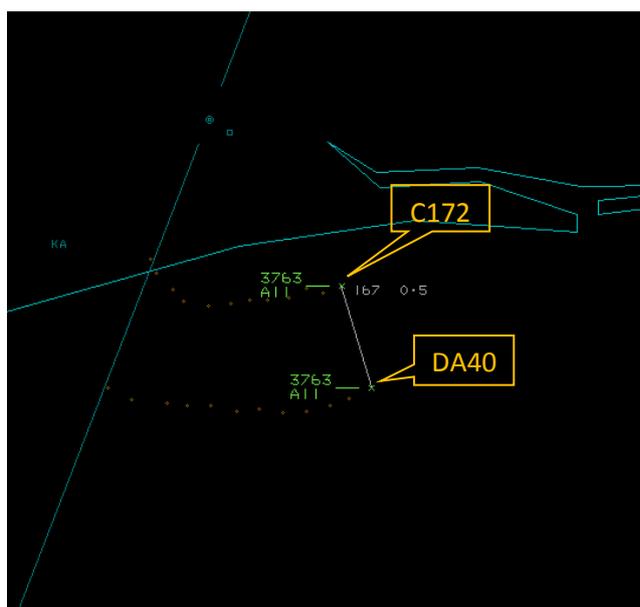
Figure 2 – 1111:06.

At 1111:06 both pilots had turned left at the same time and were running parallel crosswind (Figure 2).

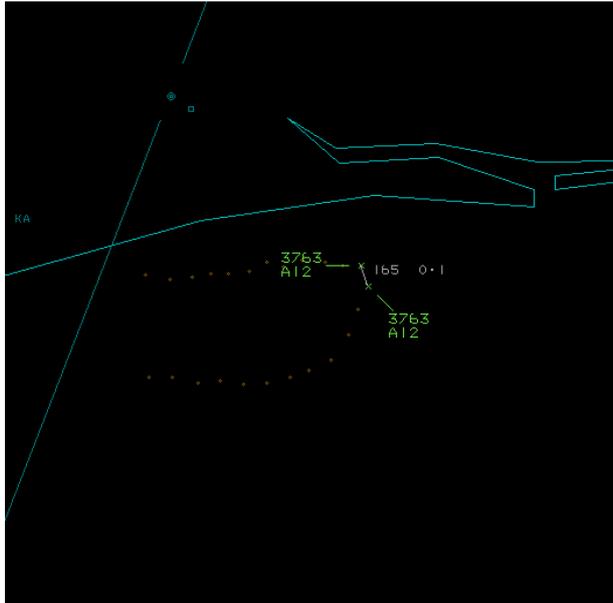
Figure 3 – 1111:18.

At 1111:18, the DA40 pilot had commenced a left-turn into the downwind position (Figure 3).

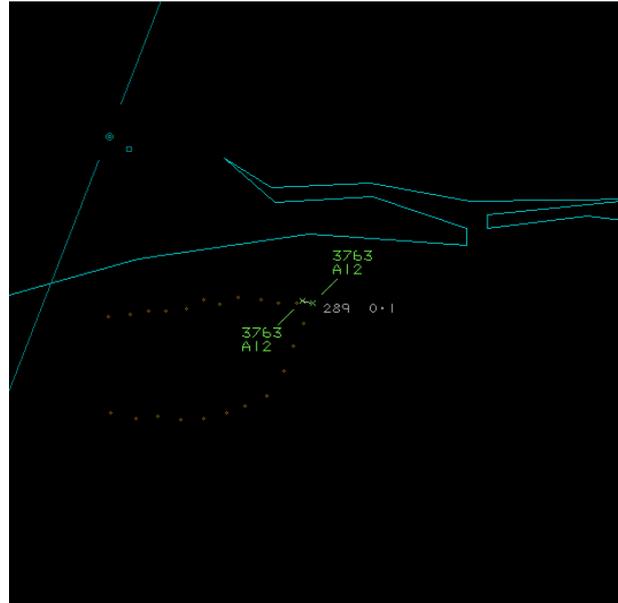
Figure 4 – 1111:20.

CPA occurred at 1111:20 (Figure 4), with the aircraft separated by less than 0.1nm laterally and less than 100ft vertically.

At 1111:22, the DA40 pilot reported downwind, and, in the same transmission, reported the C172 having under-flown them by 100ft which was acknowledged by the controller.

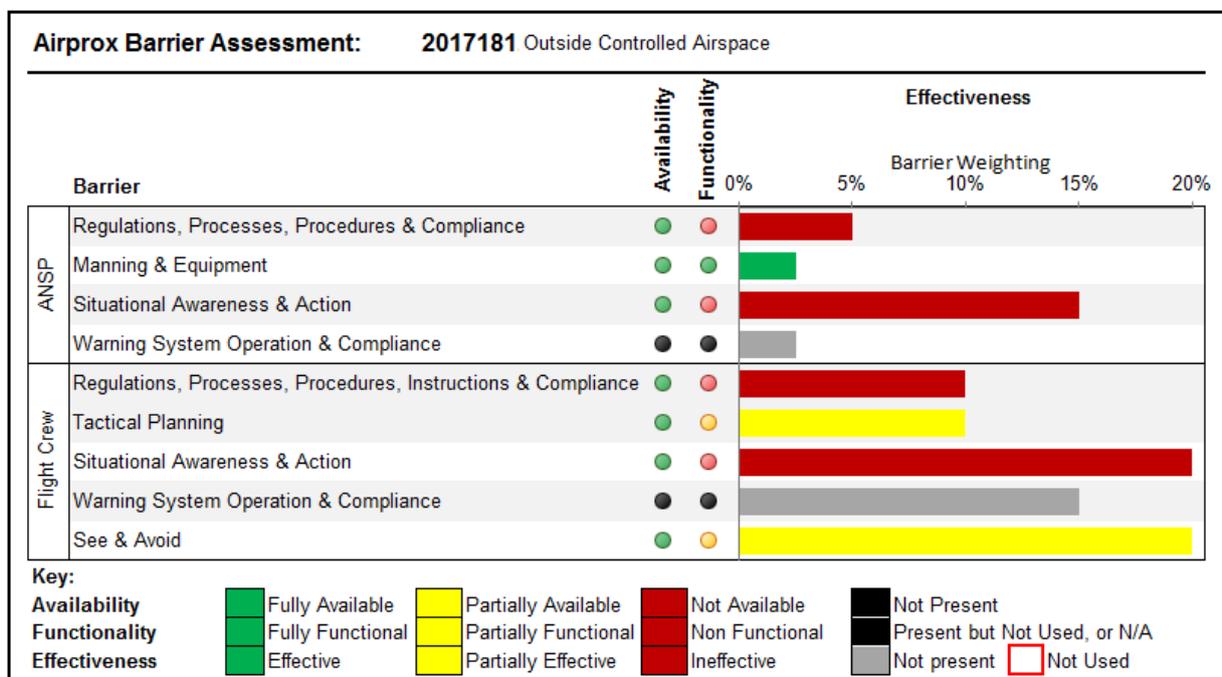
**Regulations, Processes, Procedures and Compliance** were considered as **ineffective** because the Shoreham controller did not pass Traffic Information or inform either pilot of the other's intentions.

**Situational Awareness and Action** were assessed as **ineffective** because the controller was not aware that the aircraft had been likely to conflict until the DA40 pilot reported that the C172 had passed underneath him.

**Regulations, Processes, Procedures and Compliance** were considered **ineffective** because the C172 pilot did not integrate with the DA40's circuit pattern.

**Tactical Planning** was assessed as **partially effective** because the C172 pilot did not ensure that his departure track deconflicted effectively with the circuit pattern.

**Situational Awareness and Action** were considered as **ineffective** because, although the C172 was aware that the DA40 had departed ahead of him, he did not monitor its departure path.

**See and Avoid** was **partially effective** because both pilots obtained only a late sighting of the other aircraft and both pilots had to take emergency avoiding action in the short time available.
