AIRPROX REPORT No 2017235

Date: 28 Sep 2017 Time: 1528Z Position: 5143N 00043W Location: Bovingdon VOR

PART A: SUMMARY OF INFORMATION REPORTED TO UKAB

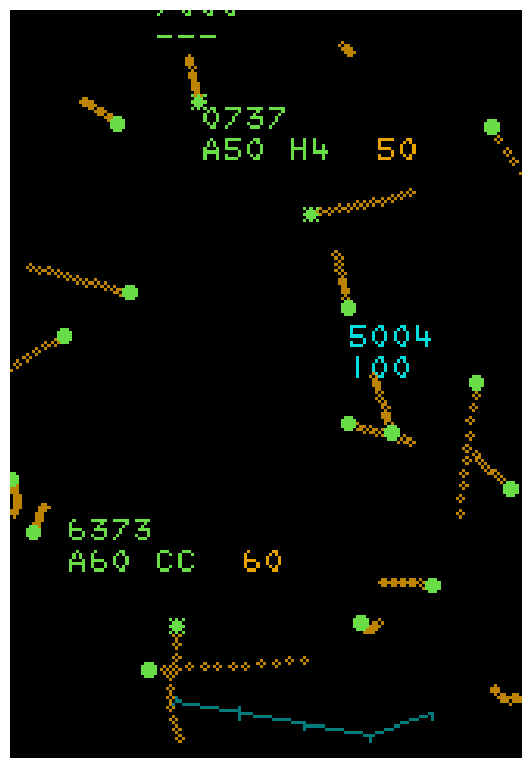
Figure 1 - 1526:40.

At 1526:40, the controller instructed the A320(A) pilot to climb to FL70 and the pilot provided an accurate readback (Figure 1).

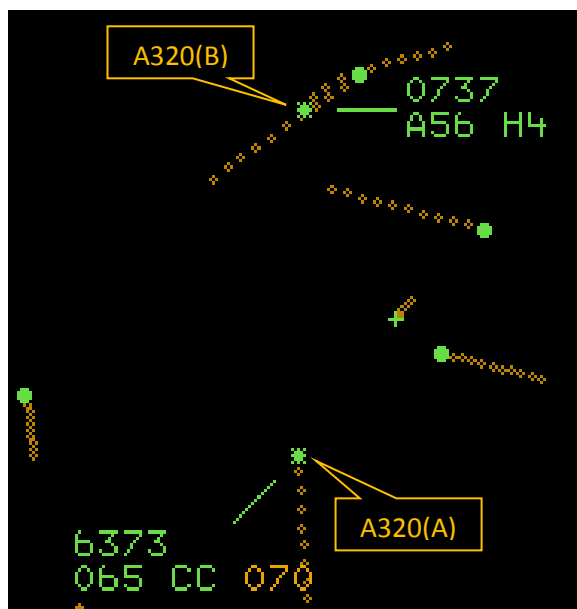
Figure 2 – 1527:45.

At 1527:45, the controller responded with a request for the pilot to say again and then immediately issued an instruction to the pilot: “[C/S] maintain altitude six thousand feet stop your climb at six thousand feet.” The A320(B) pilot responded: “actually we received a clearance to (unintelligible) five zero climbing five thousand feet now we are maintaining five thousand feet”. Simultaneously the controller was heard saying: “stop your (unintelligible)”.

Figure 2 displays A320(B) at altitude 5600ft at the time of these transmissions.

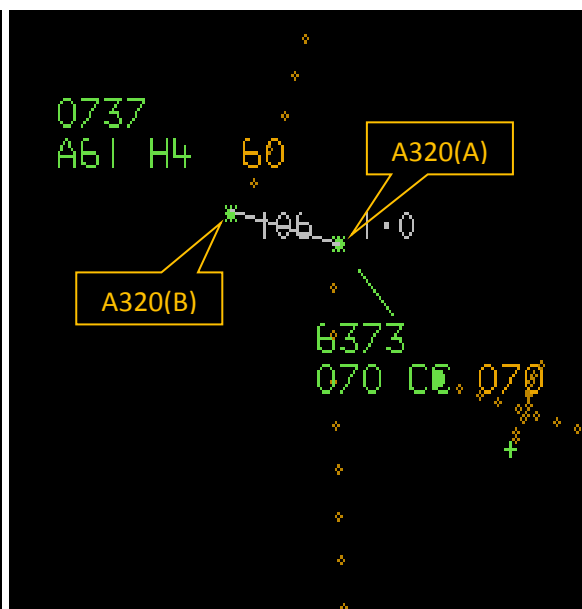
Figure 3 – 1528:25.

At 1528:25 (Figure 3), CPA occurred. The aircraft are displayed as being laterally separated by 1.0nm with vertical separation of 1100ft. The display shows A320(A) at FL70 on the standard pressure setting of 1013hPa and A320(B) at altitude 6100ft on QNH 1019hPa.
