**AIRPROX REPORT No 2017247**

Date: 12 Oct 2017 Time: 0935Z Position: 5026N 00032E Location: ivo XIDIL

**PART A: SUMMARY OF INFORMATION REPORTED TO UKAB**

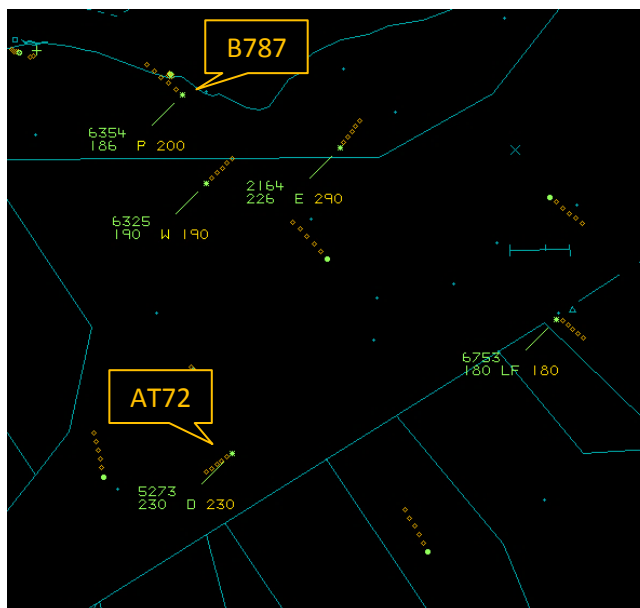
Figure 1 – 0932:00.

At 0932:00, the controller cleared the B787 pilot to climb to FL220 (Figure 1).

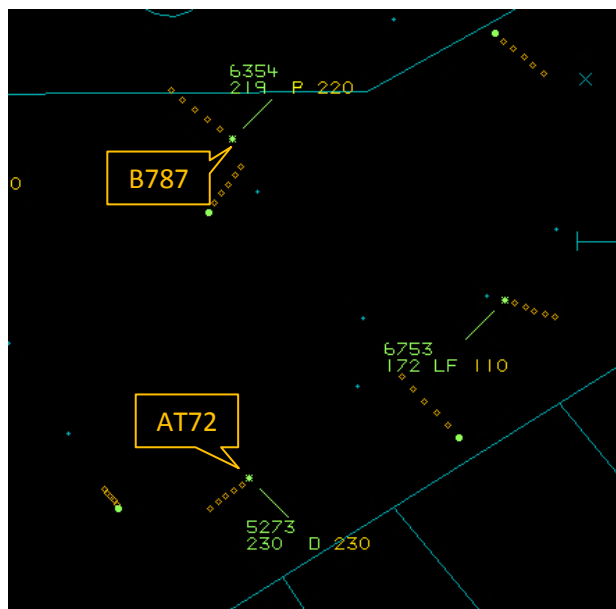
At 0933:40, the new controller cleared the B787 pilot to resume their own navigation to a reporting point on the London/Paris FIR boundary, and to climb to FL250 (Figure 2).

Figure 2 – 0933:40 (ATR72 17nm S of B787).

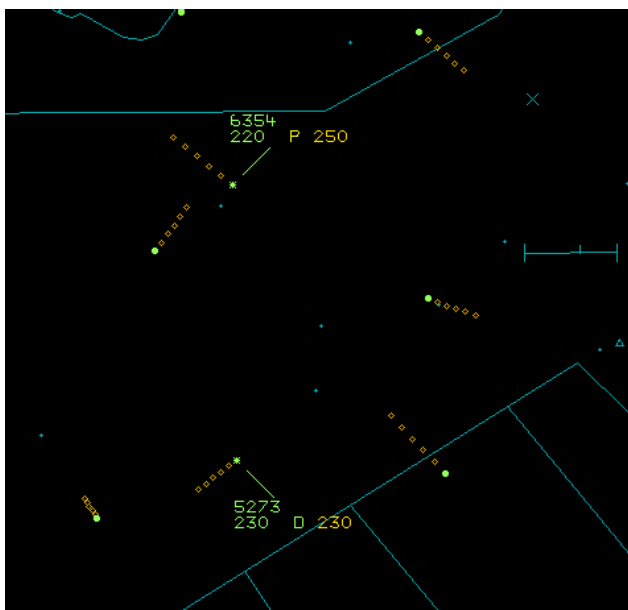
The controller then, at 0934:00, (Figure 3), transmitted: *"In fact [C/S] maintain two two zero my apologies descend to maintain flight level two two zero"*.

Figure 3 – 0934:00 (15nm apart).

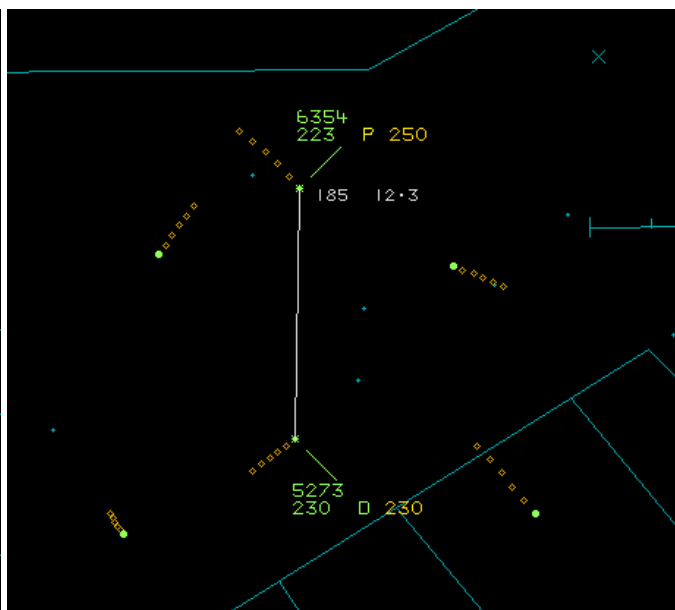
Figure 4 – 0934:30.

At 0934:18, the controller instructed the B787 pilot to turn left heading 125°, and then, at 0934:30, (Figure 4), went on to issue an avoiding action instruction: *"[C/S] avoiding action turn left heading one zero five"*

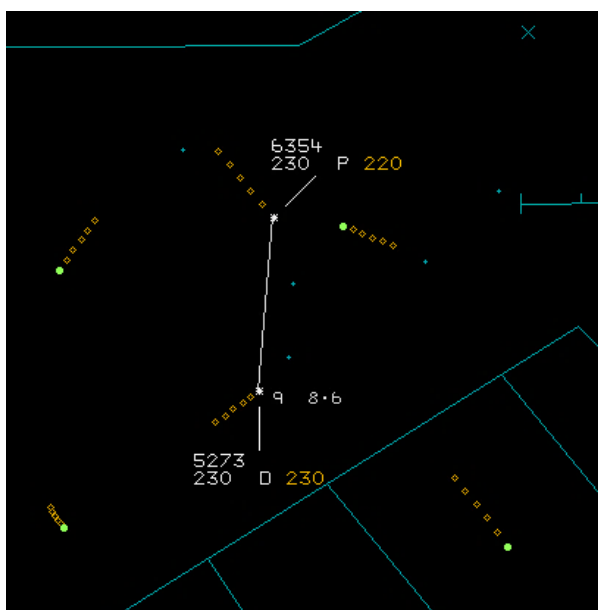
Figure 5 – 0934:42.

The pilot of the B787 read back the instruction, and at 0934:42, (Figure 5), the controller issued an avoiding action instruction to the ATR72 pilot: *"[wrong C/S prefix – stops] [C/S suffix] avoiding action, turn right heading one six zero degrees"*.

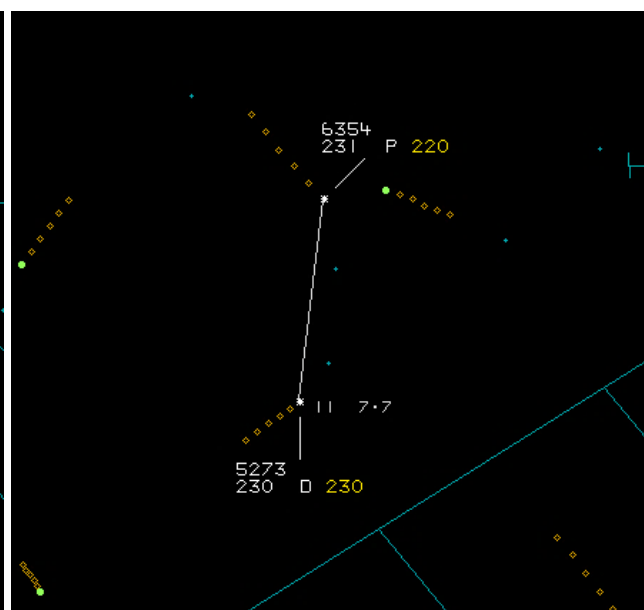
Figure 6 – 0934:48.

At 0934:48 the controller again repeated the instruction to the B787 pilot to descend to FL220 which was read back by the pilot (Figure 6).

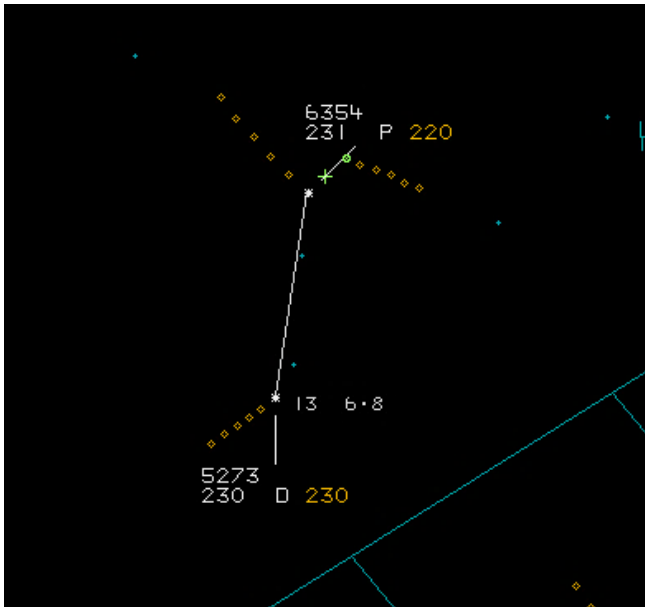
Figure 7 – 0934:55.

At 0934:55, (Figure 7), the controller issued a further avoiding action turn to the B787 pilot, which was read back by the pilot: “???? [part C/S], avoiding action turn left now heading zero eight zero degrees”.

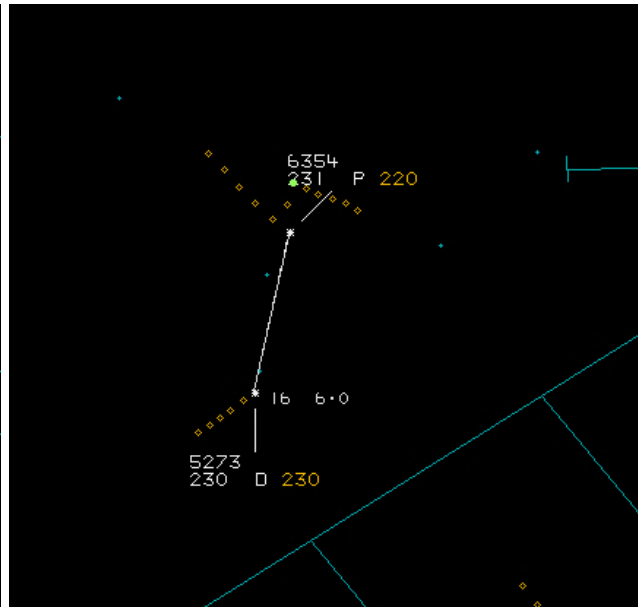
Figure 8 - 0935:00.

At 0935:00 the controller instructed the ATR72 pilot to turn right heading 180° (not issued as an avoiding action turn), (Figure 8).

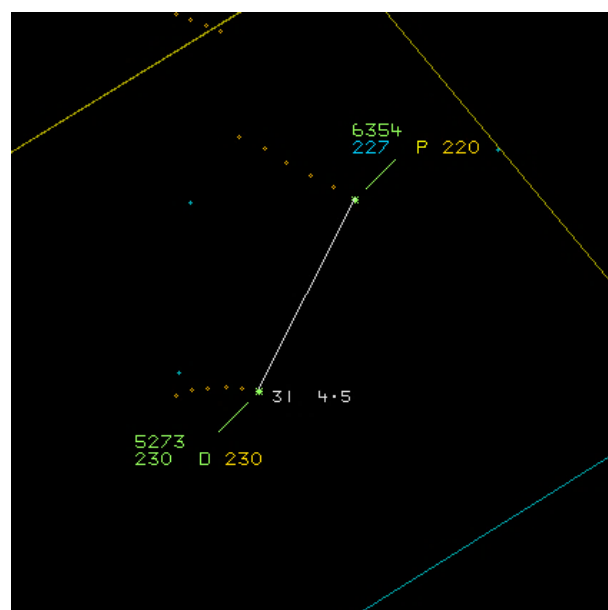
CPA was at 0935:23, with the aircraft separated 4.5nm laterally and 300ft vertically (Figure 9).

Figure 9 – 0935:23.

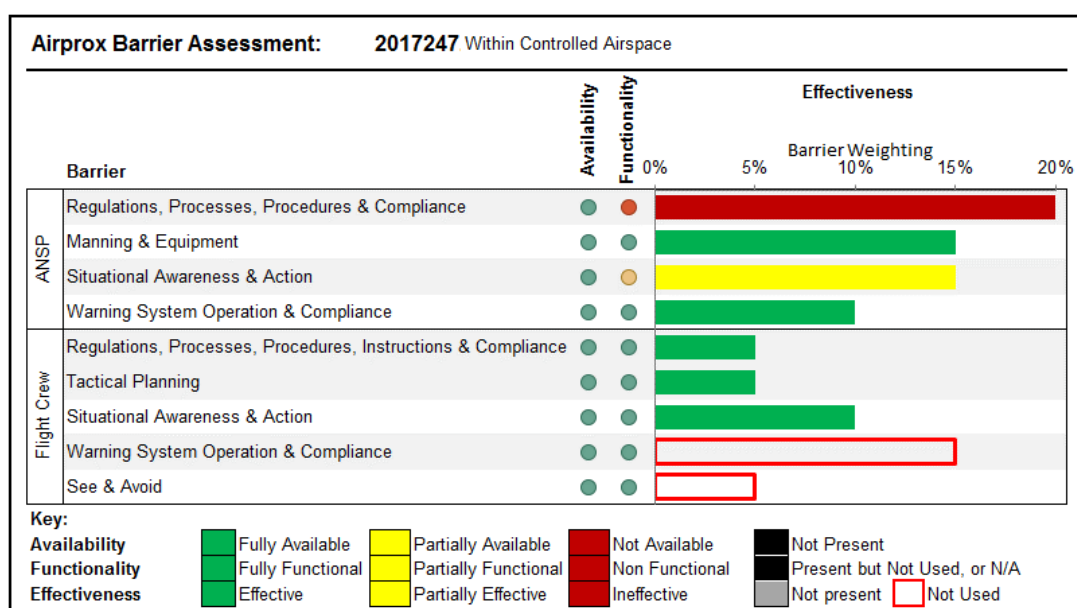
**Regulations, Processes, Procedures and Compliance** were assessed as **ineffective** because the ATC team did not comply with the LACC procedures. The handover of the Worthing Tactical Sector was incomplete and occurred at the same time as the Planner position was handed over; the Worthing Tactical controller did not utilise IFACTS before instructing the B787 pilot to climb; and the OJTI did not remain near the Sector after handover to assist the oncoming controller.

**Situational Awareness and Action** were assessed as **partially effective** because the Worthing Sector Tactical controller instructed the B787 pilot to climb into conflict with the ATR72. However, he quickly realised the confliction and took action to control the situation.

**The Warning System Operation and Compliance and See and Avoid** were **not used** because the two aircraft did not proceed into close proximity.
