## AIRPROX REPORT No 2017276

Date: 16 Dec 2017 Time: 1144Z Position: 5207N 00024E Location: Wrating Common

### PART A: SUMMARY OF INFORMATION REPORTED TO UKAB

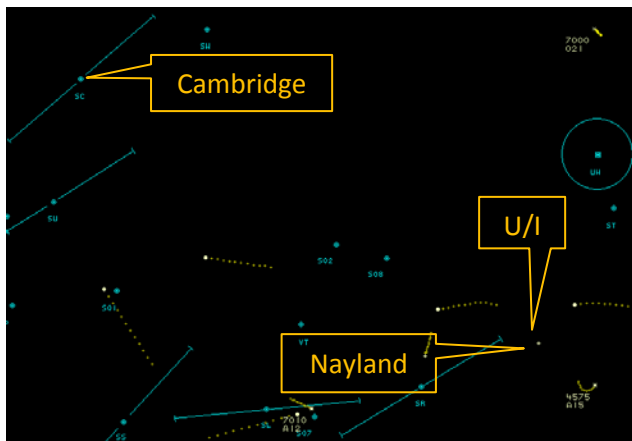
Figure 1 – 1046:15

At 1046:15 the unknown aircraft (U/I) [light-aircraft] is first visible on radar in the approximate vicinity of Nayland airfield. No SSR is visible at this point. (Figure 1).

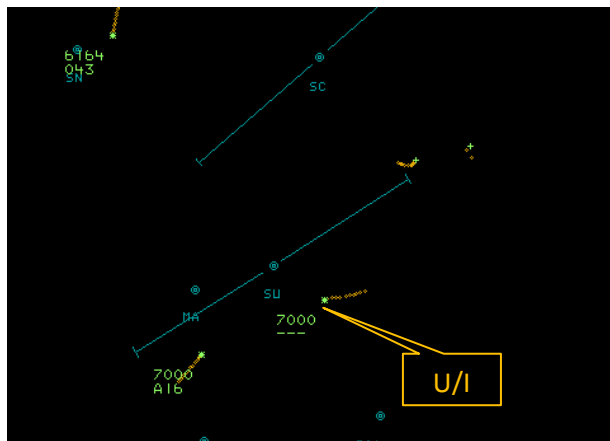
Figure 2 – 1100:08

The unknown aircraft was tracking west at 1100:08 (Figure 2). It then proceeded on its flight to approximately 15nm west of Luton before tracking back to the east.

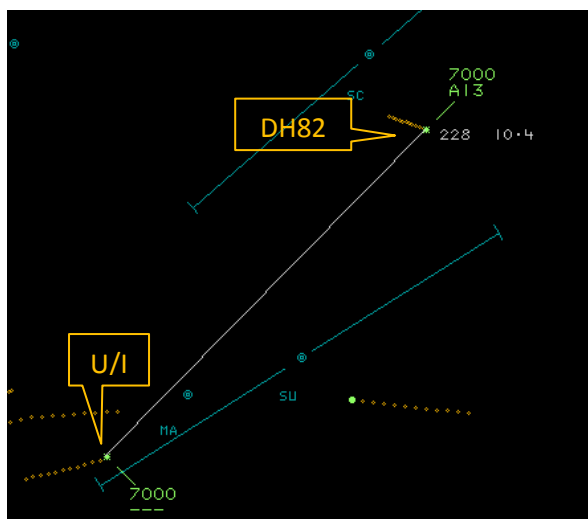
Figure 3 – 1135:31

The formation of two DH82 are first visible on radar at 1135:31. The unknown aircraft was approaching from the west (Figure 3).

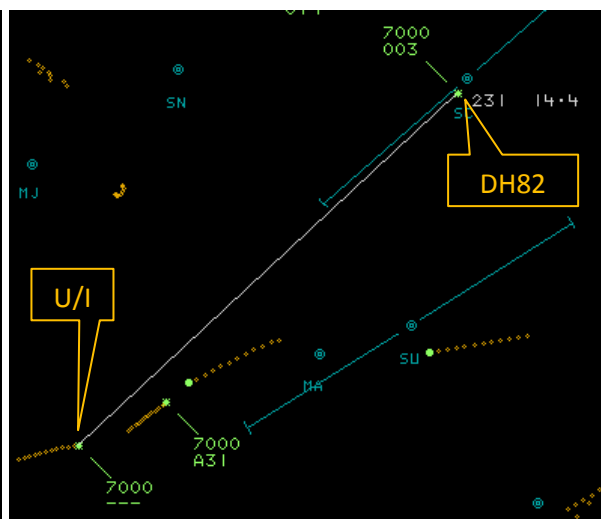
Figure 4 – 1137:31

At 1137:31 (Figure 4) the DH82 formation checked in on frequency with Cambridge Radar and were provided with a Basic Service and issued a squawk of 6161.

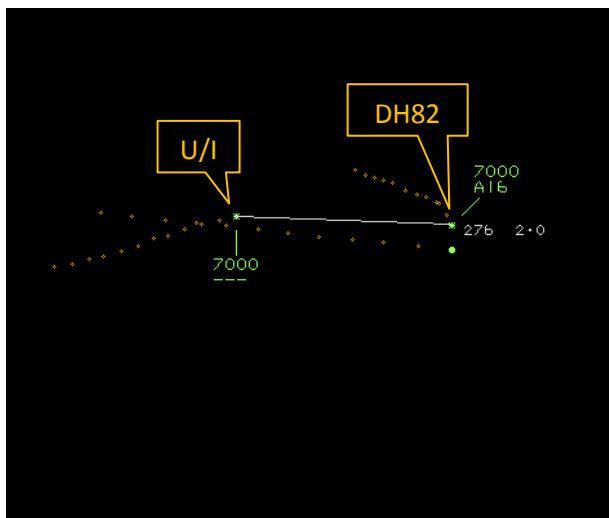
Figure 5 – 1143:27

At 1143:27 (Figure 5), the Cambridge controller passed Traffic Information to the DH82 formation on the unknown aircraft.

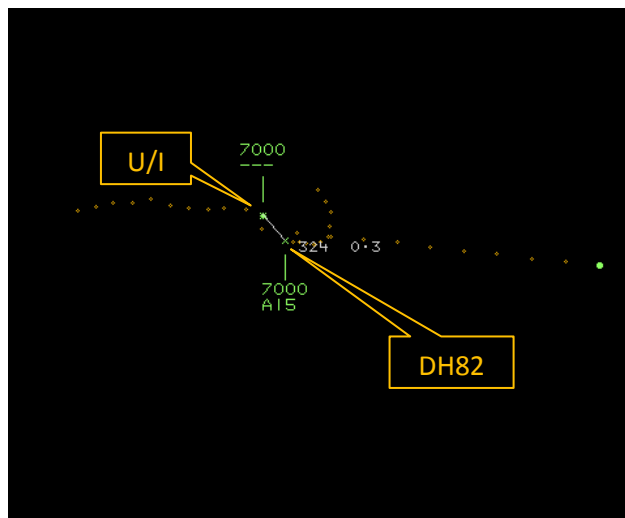
Figure 6 – 1144:00

The controller tried to contact the DH82 formation again at 1143:41 with no reply. At 1144:00 (Figure 6), the DH82 lead aircraft acknowledged the Traffic Information on the unknown aircraft and apologised for not replying. The controller stated to the DH82 formation that they had no level restriction but were to remain outside controlled airspace.

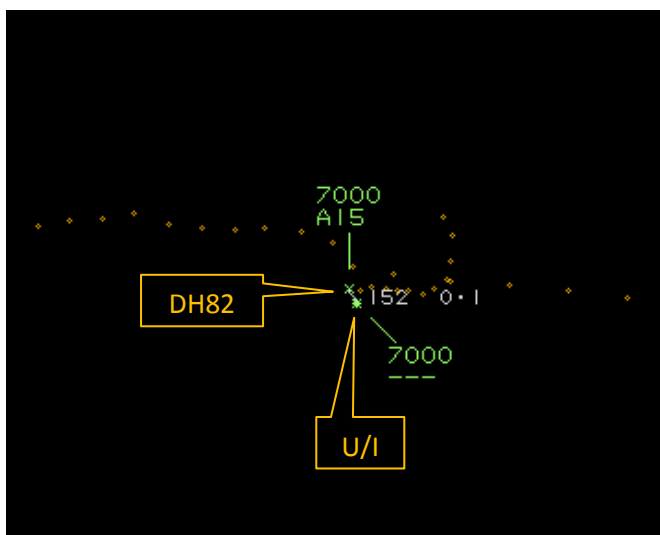
Figure 7 – 1144:07

The first CPA occurred at 1144:07 (Figure 7) with 0.1nm between the unknown aircraft and the DH82 formation.

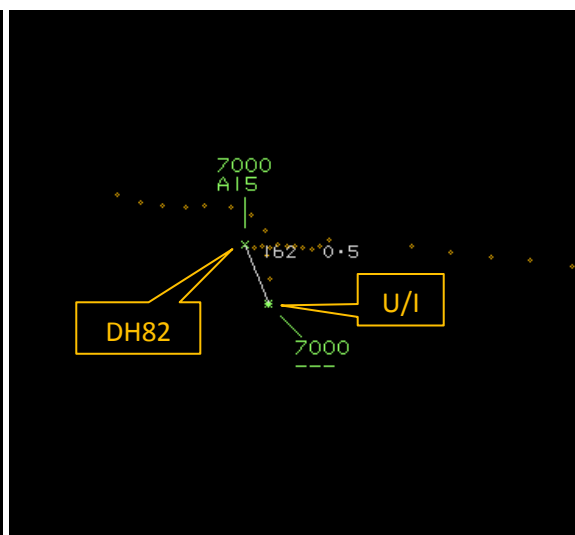
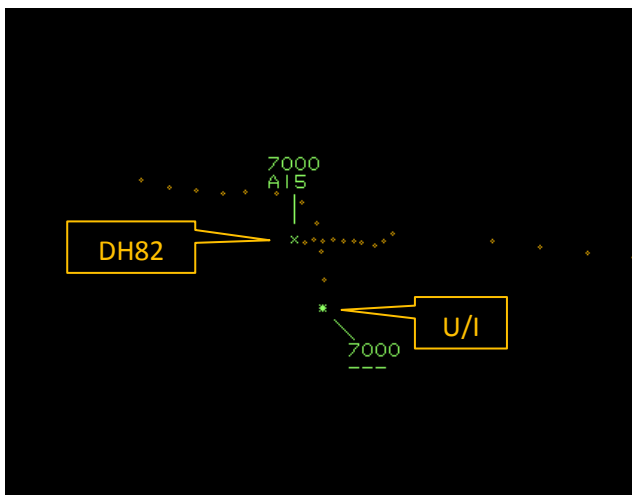
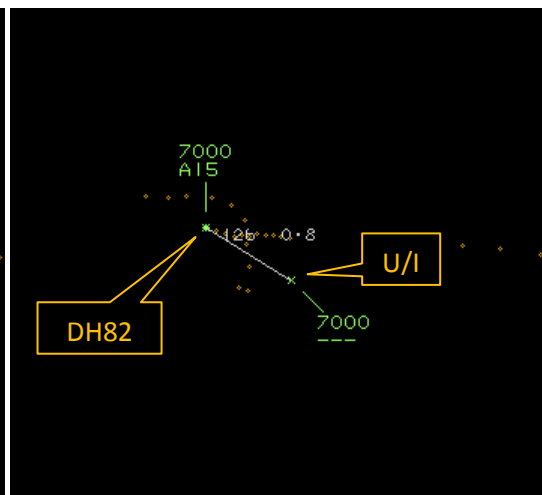
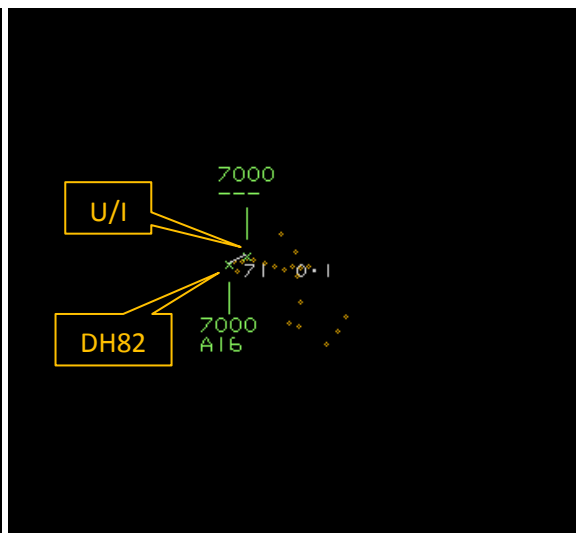
The unknown aircraft then tracked to the south before turning back to close with the DH82 formation again (Figures 8 – 12).

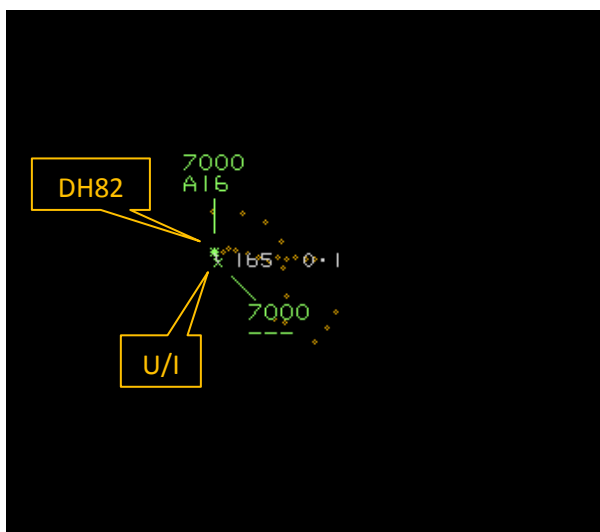
Figure 11 – 1144:35

The second CPA took place at 1144:35 with the unknown aircraft 0.1nm laterally from the DH82 formation (Figure 11). At 1144:37 there was a broken transmission from the DH82 leader containing a reference to remaining outside of controlled airspace but the rest of the transmission was either clipped or unreadable.
