### AIRPROX REPORT No 2016241

Date: 13 Nov 2016 Time: 1258Z Position: 5116N 00253W Location: ivo Cheddar Reservoir VRP

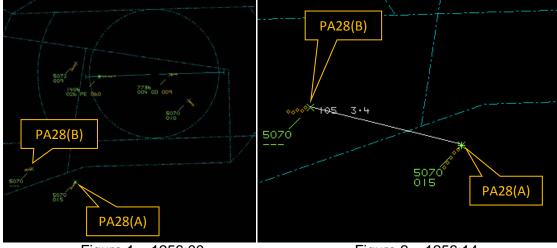
Figure 1 – 1256:00

The PA28(A) had been on a VFR flight to the south-west of Bristol and, at 1249:55, reported to Bristol Radar that they were approaching Bridgewater, routing to the Cheddar VRP for rejoin. The Bristol radar controller instructed the pilot to remain outside controlled airspace and to report with 3nm to run to the VRP, which was acknowledged by the pilot. At 1256:00, the PA28(A) pilot reported 3nm to run to Cheddar, was passed Traffic Information on gliding activity, and instructed to contact Bristol Tower (Figure 1).

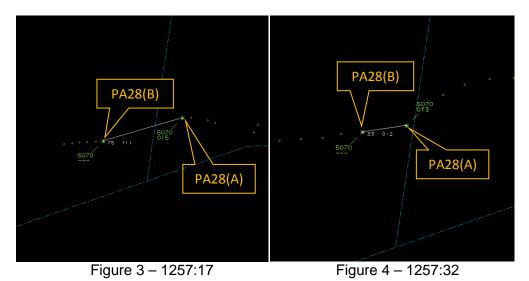
Figure 2 – 1256:14

The PA28(A) pilot reported on the Bristol Tower frequency at 1256:14 with 2 miles to run to the VRP and was instructed to hold at the Cheddar VRP (Figure 2). The PA28(B), which had, up until this point, been manoeuvring on the coastline over 5nm to the west of the PA28(A), was observed to be maintaining an easterly track towards the area of the Cheddar VRP. At 1257:17 the PA28(A) was observed to be established in a left-hand orbit in the vicinity of the VRP, with PA28(B) still maintaining an easterly track (Figure 3). CPA took place at 1257:32 with the aircraft separated by 0.2nm laterally (Figure 4). It was not possible to determine vertical separation from the radar replay, and it was not reported by the pilot of the PA28(A)

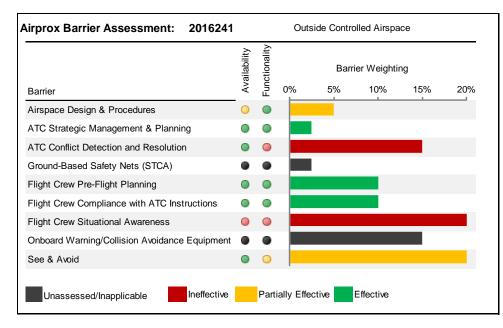
The Board decided that the following key safety barriers were contributory in this Airprox:

Airspace Design and Procedures was considered to be only partially effective because aircraft joining the visual circuit at Bristol do not remain with Radar until they have entered controlled airspace, and there is no requirement for Tower to inform Radar when aircraft are held outside controlled airspace.

**ATC Conflict Detection and Resolution** was considered to be **ineffective** because although the Radar ATCO was generically aware of both PA28s he did not utilise that information sufficiently to pass generic Traffic Information to either PA28 pilot.

**Flight Crew Situational Awareness** was also considered to be **ineffective** because although both the PA28s were probably generically aware of traffic in the area, they had not had specific Traffic Information on each other, and were on different frequencies which removed both pilots' ability to assimilate the other aircraft's position reports.

**See and Avoid** was considered to be only **partially effective** because the PA28(A) pilot saw the PA28(B) late and the PA28(B) pilot did not see the PA28(A).
