AIRPROX REPORT No 2016273

Date: 29 Nov 2016 Time: 1453Z Position: 5057N 00216W Location: 4.2nm WSW Compton Abbas

PART A: SUMMARY OF INFORMATION REPORTED TO UKAB

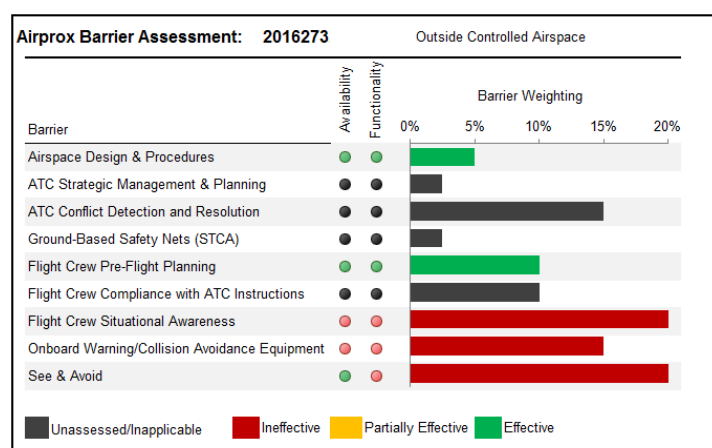
The Board decided that the following key safety barriers were contributory in this Airprox:

Flight Crew Situational Awareness was assessed as **ineffective** because there were no systems present to provide SA and neither of the flight crews involved were aware of the presence of the other aircraft.

Onboard Warning/Collision Avoidance System was assessed as **ineffective** because the Merlin's TCAS was unserviceable and the Cabri was not fitted with a TAS.

See and Avoid was assessed as **ineffective** because the Merlin crew did not see the Cabri in time to increase separation, and the Cabri pilots did not see the Merlin at all.
