AIRPROX REPORT No 2016010

Date: 05 Jan 2016 Time: 1054Z Position: 5254N 00026W Location: 8nm SE Cranwell

PART A: SUMMARY OF INFORMATION REPORTED TO UKAB

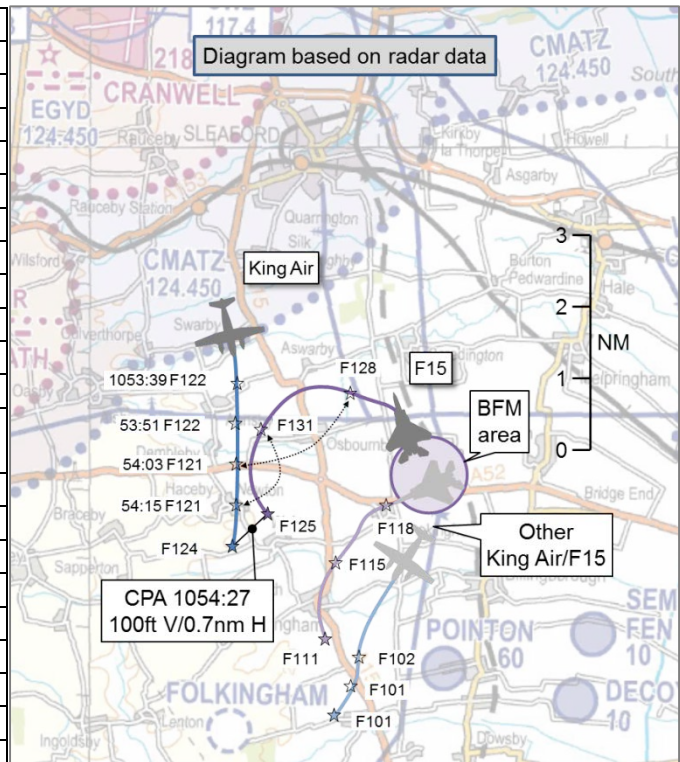
Recorded	Aircraft 1	Aircraft 2
Aircraft	King Air	F15
Operator	HQ Air (Trg)	Foreign Mil
Airspace	Lincs AIAA	Lincs AIAA
Class	G	G
Rules	VFR	VFR
Service	None	Traffic
Provider	N/A	Swanwick Mil
Altitude/FL	FL124	FL124
Transponder	A, C, S	A, C, S
Reported		
Colours	Blue/white/grey	Dark grey
Lighting	Beacon, strobe, nav, recognition	Anti-col, position
Conditions	VMC	VMC
Visibility	NK	>8km
Altitude/FL	FL120	FL140
Altimeter	SPS	SPS
Heading	160°	Turning
Speed	170kt	400kt
ACAS/TAS	TCAS II	Not fitted
Alert	RA	N/A
Separation		
Reported	NK	Not seen
Recorded	100ft V/0.7nm H

The Swanwick controller passed Traffic Information to the F15s with 2nm lateral separation and over 5000ft in height separation when 1 minute and 15 seconds prior to CPA. The controller had been involved in calling traffic to other callsigns immediately prior to updating the F15s. The F15 crews then entered a period of high energy manoeuvres prior to splitting. The F15 crews commented on their report that they were not visual with the two called tracks. Had the King Air pilot called Swanwick earlier for a Service, he could have received information on the F15s.

<u>Cause:</u>	A conflict in Class G.
<u>Contributory Factor(s):</u>	The King Air pilot did not obtain an Air Traffic Service.
<u>Degree of Risk:</u>	B.
<u>Recommendation(s):</u>	HQ Air Command review the provision of an appropriate Air Traffic Service within the Cranwell training areas.
