AIRPROX REPORT No 2016082

Date: 22 May 2016 Time: 1115Z Position: 5114N 00006W Location: Redhill

PART A: SUMMARY OF INFORMATION REPORTED TO UKAB

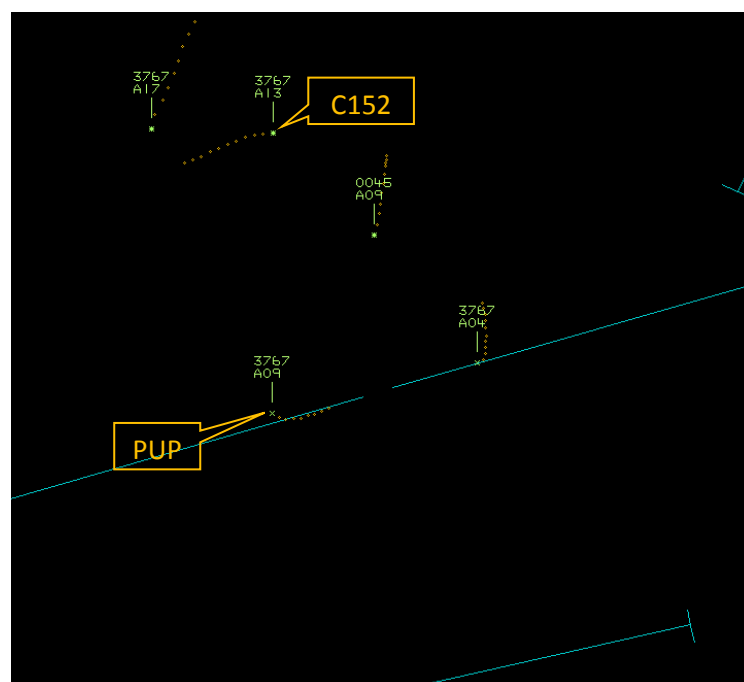
Figure 1 – Swanwick MRT - 1112:11

At 1112:11 the contact most-likely attributable to the Beagle Pup was observed on the radar replay commencing a right-turn from the Runway 26L climb-out at Redhill (Figure 1).

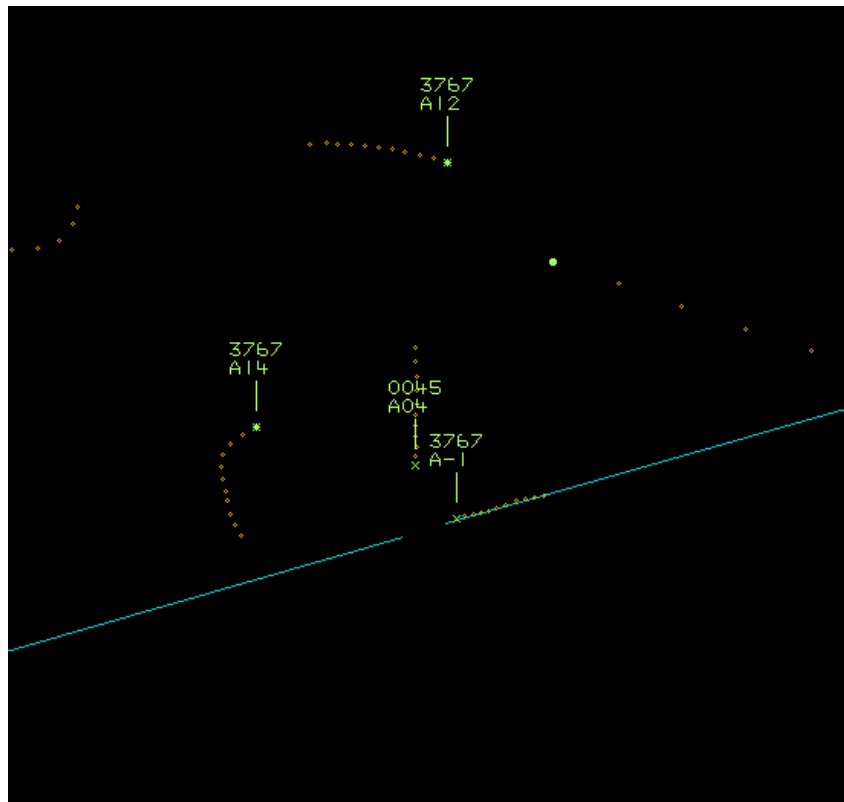
Figure 2 – Swanwick MRT – 1113:05

The C152 pilot reported at the Junction VRP at 1113:05 advising that they were joining right-base for Runway 26L. This was acknowledged by the controller who instructed them to report right-base. The Beagle Pup was observed in a further right-turn to track east at this time (Figure 2).

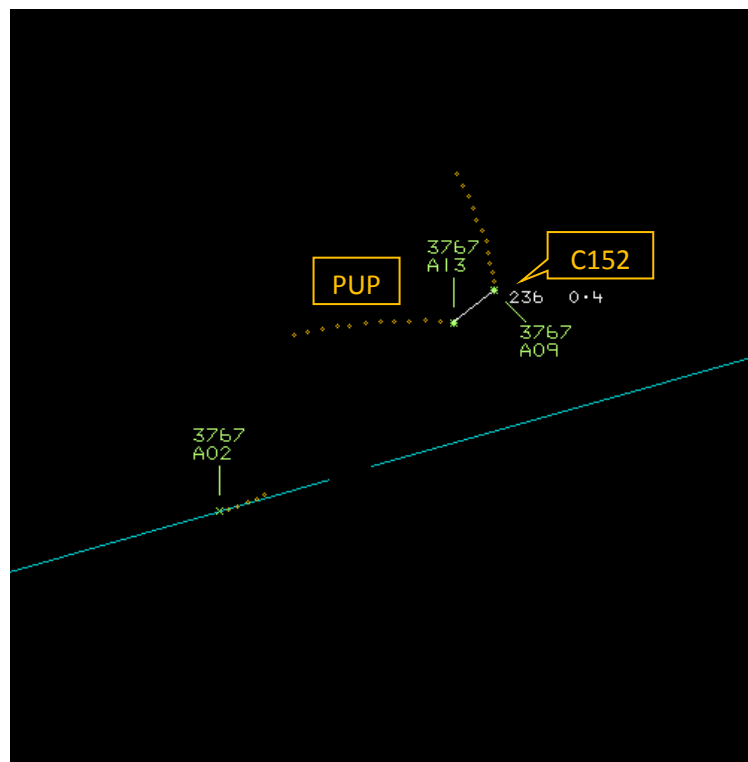
Figure 3 – Swanwick MRT – 1114:18

At 1114:18 the C152 pilot reported on right-base and was instructed to report final by the controller (Figure 3).

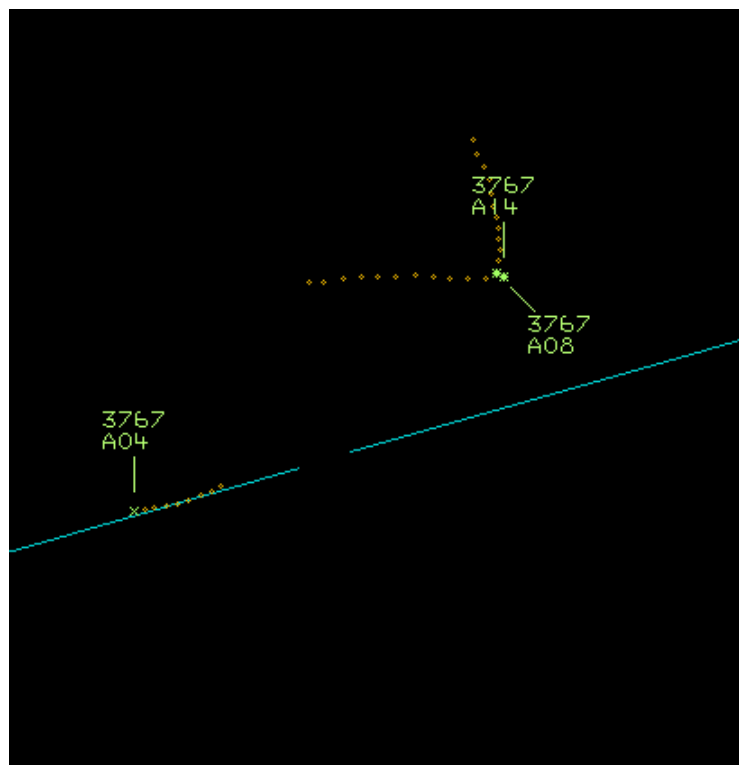
Figure 4 – Swanwick MRT – 1114:30

CPA took place at 1114:30 with the aircraft separated by less than 0.1nm laterally and 600ft vertically (Figure 4).
