AIRPROX REPORT No 2016091

Date: 24 May 2016 Time: 1223Z Position: 5142N 00105W Location: 12nm NNE Benson

An Airprox was reported when a Hawk and a Glider flew into proximity at 1223 on Tuesday 24th May 2016. The Hawk pilot was operating under VFR in VMC and in receipt of a Traffic Service from Benson.

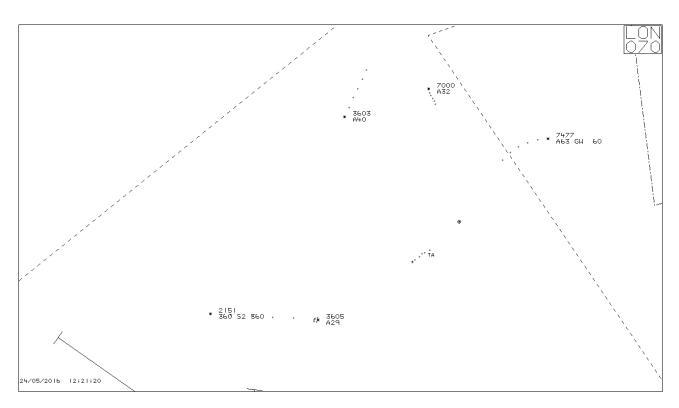
At 1221:20 (Figure 1), The Hawk is travelling in a South Westerly direction at 4000ft under a traffic service (reduced due to high controller workload) with Benson Radar. At this time the Benson primary radar was not operational and Benson Radar was working from the Brize Norton ATC control room in order to use both Primary and Secondary radars. Benson Zone was still operating from Benson with SSR only. The reporting glider was working Benson Zone and (although not required) was passed traffic information about the Hawk to the North.

Figure 1: Geometry at 1221:20 (Hawk squawking 3603; glider squawking 3605, note primary contact to the NE of 3605 squawk).

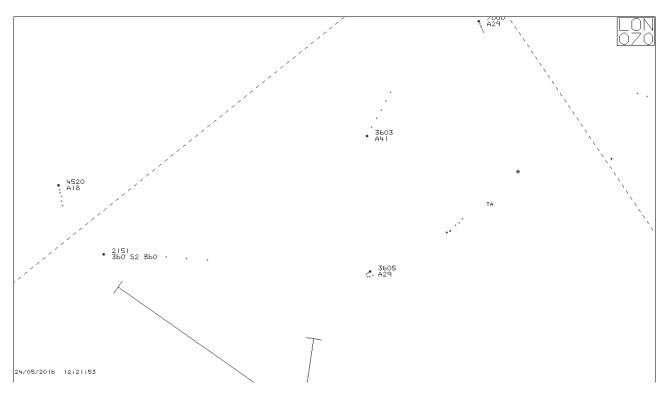
At 1221:53 (Figure 2), The Hawk is passed traffic information about the glider to the South. '[Hawk c/s] traffic left 10 o'clock, 3 miles, crossing right left indicating one thousand one hundred feet below'.

Figure 2: Geometry at 1221:53 (Hawk squawking 3603; glider squawking 3605, note primary contact to the NE of 3605 squawk).

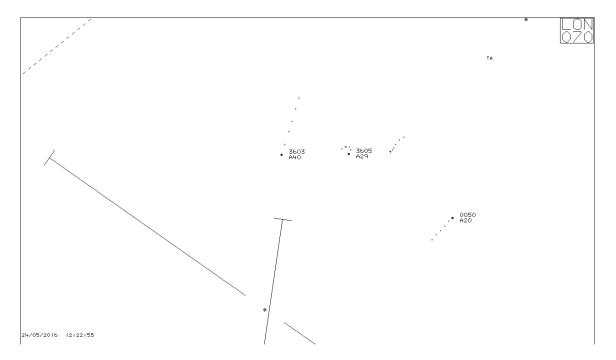
At 1222:55 (Figure 3), The Hawk informs the controller '[Hawk c/s] that's copied there's at least two gliders there'. The radar replay indicates the squawking glider and another primary contact to the east, and this concurs with the pilot's report that they were looking to the left and spotted two gliders in their 8 o'clock position, slightly lower, at 2-3 miles.

Figure 3: Geometry at 1222:55 (Hawk squawking 3603; glider squawking 3605, note primary contact to the E of 3605 squawk).

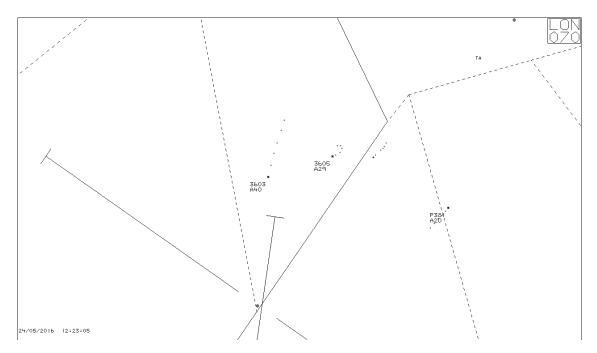
At 1223:05 (Figure 4), The Hawk informs the controller 'Standby just coming up to a glider.' This correlates with the pilot's report of seeing a glider on the nose at quarter of a mile and approximately 50ft below. The radar replay shows no primary contact at this time in the immediate vicinity of the Hawk. From the information available this is when the Airprox most likely occurred.

Figure 4: Geometry at 1223:05 (Hawk squawking 3603; glider squawking 3605, note primary contact to the E of 3605 squawk).

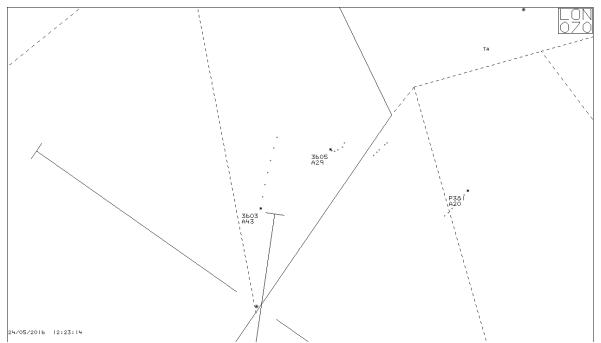
At 1223:14 (Figure 5), the mode C on the Hawk indicates a climb of 300ft (from A40 to A43), and shows the avoiding action climb from the pilot.

Figure 5: Geometry at 1223:14 (Hawk squawking 3603; glider squawking 3605, note primary contact to the E of 3605 squawk).
