### **AIRPROX REPORT No 2016159**

Date: 03 Aug 2016 Time: 0945Z Position: 5430N 00222W Location: NW Kirkby Stephen

# PART A: SUMMARY OF INFORMATION REPORTED TO UKAB

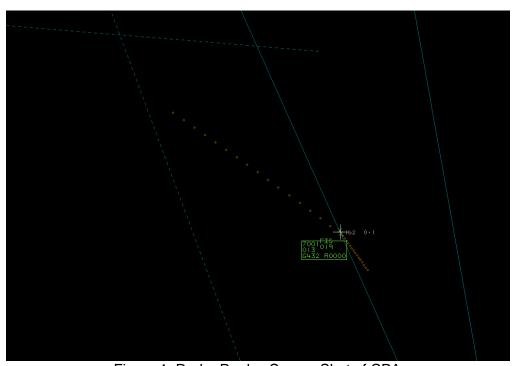
Figure 1: Radar Replay Screen Shot of CPA

The Typhoon and EC120 pilots shared an equal responsibility for collision avoidance and not to operate in such proximity to other aircraft as to create a collision hazard<sup>1</sup>. If the incident geometry is considered as head-on or nearly so then both pilots were required to turn to the right<sup>2</sup>.

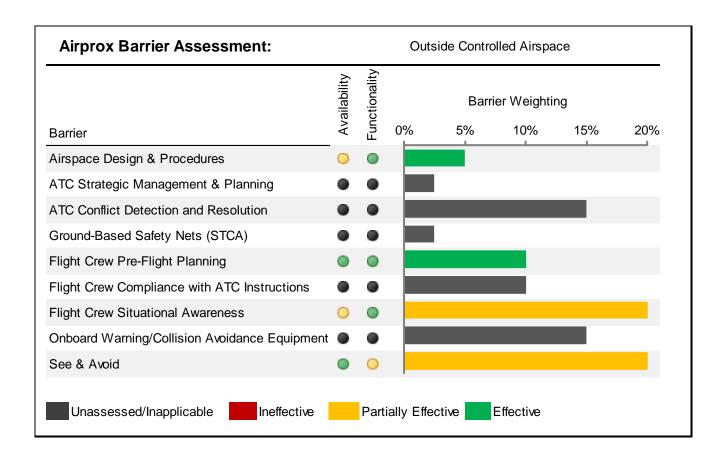
- Airspace Design & Procedures was considered effective overall, but was marked down as only being partially available because of the lack of a VHF LL Common frequency.

- Flight Crew Situational Awareness was considered partially effective because the pilots
  were on different frequencies, whilst this can often be the case, the Board felt that the
  availability and use of a VHF common frequency for low-level flights and transits in areas
  where air traffic services are limited would have increased the information available to both
  pilots regarding the other's presence.

- Onboard Warning/Collision Avoidance Equipment was assessed as being inapplicable
  because neither aircraft was fitted with the equipment. However, the Board agreed that,
  because both aircraft were transponding, if this barrier had been available to at least one of
  the pilots it could have alerted them to the presence of the other aircraft early enough to carry
  out actions to increase separation.

- See and Avoid was partially effective because the Typhoon pilot only saw the EC120 late and when he was in a turn and the EC120 pilot did not see the Typhoon at all. The Typhoon pilot had ascertained that his turn would keep him clear and that no further action was required.
