AIRPROX REPORT No 2016165

Date: 08 Aug 2016 Time: 1515Z Position: 5145N 00118W Location: 10nm East Brize

PART A: SUMMARY OF INFORMATION REPORTED TO UKAB

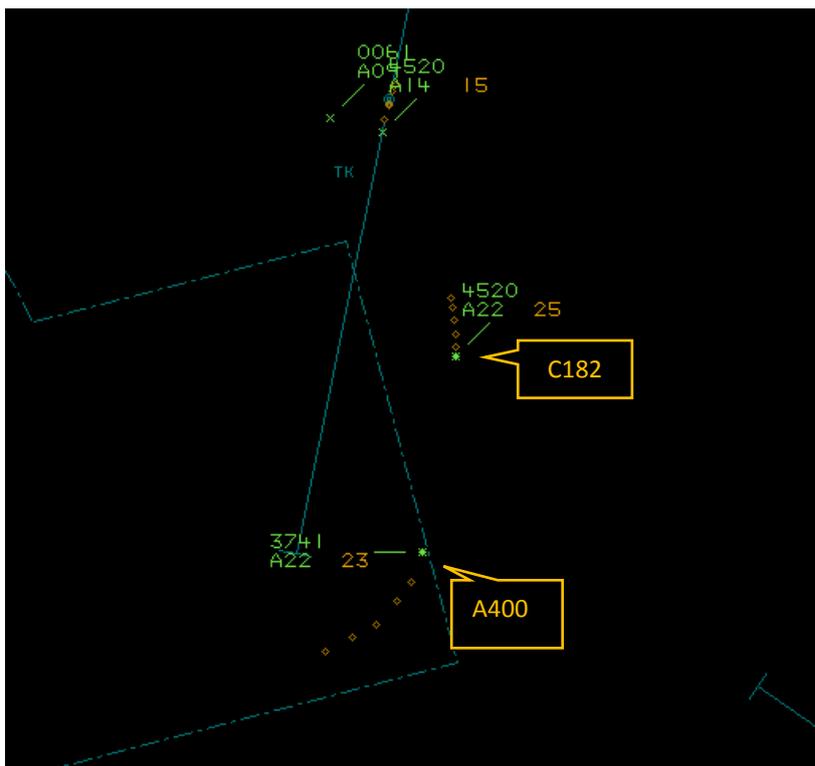
Figure 1 – 1515:23

At 1515:23 the C182 was instructed to climb to altitude 3500ft for the hold (Figure 1).

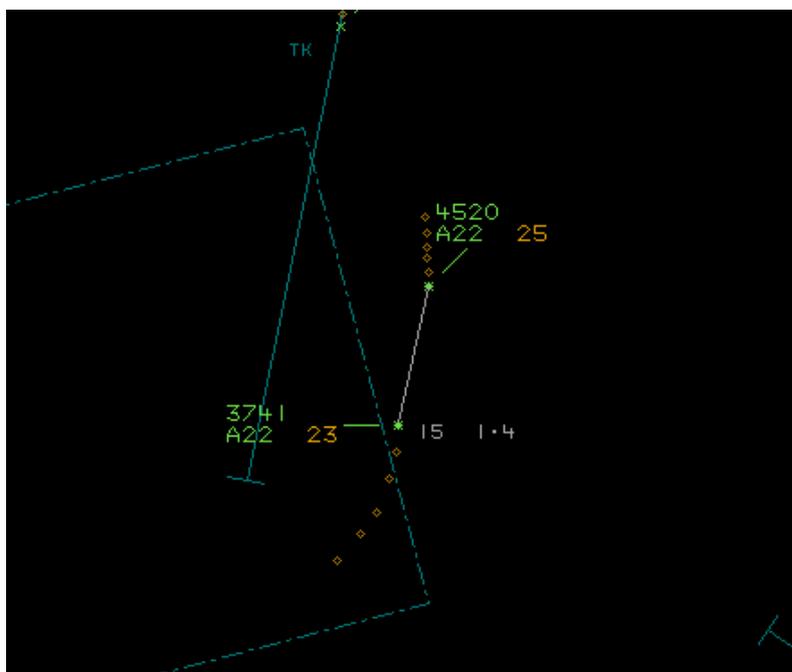
Figure 2 – 1515:33

At 1515:33, the Oxford radar controller instructed the C182 to make an immediate left turn but with no advice on a heading to fly, Traffic Information was then passed, advising the C182 pilot that there was traffic opposite direction to, and at the same level as themselves. The pilot of the C182 immediately reported visual with that traffic (Figure 2).

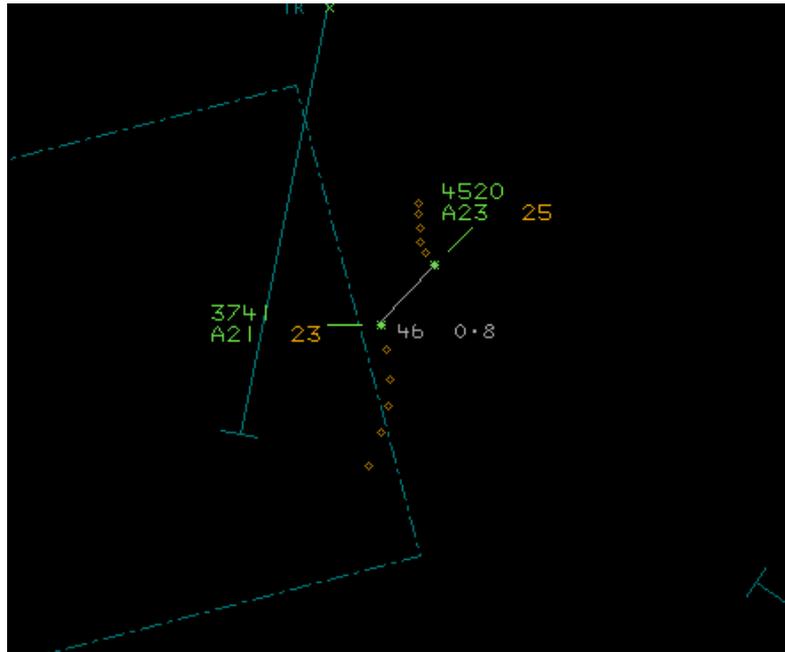
Figure 3 – 1515:42

CPA took place at 1515:42, with the aircraft separated by 0.8nm laterally and 200ft vertically.

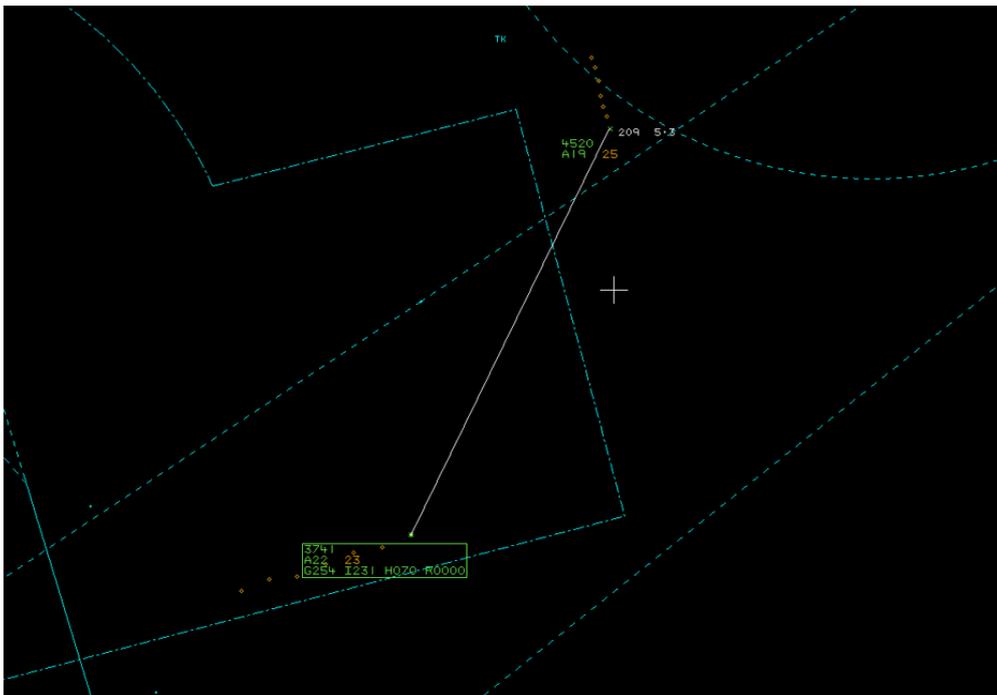
Figure 4: Geometry at 1514:41 (A400 squawking 3741; C182 squawking 4520).

At 1514:41 (Figure 4), the A400 was downwind in the radar training circuit at 2300ft on the Brize QNH and had just been given (1514:29) a base leg turn by the controller onto a heading of 340°. Note that the replay indicates the A400 had not yet initiated the turn. The C182 is tracking south-southeast simulating a missed approach.

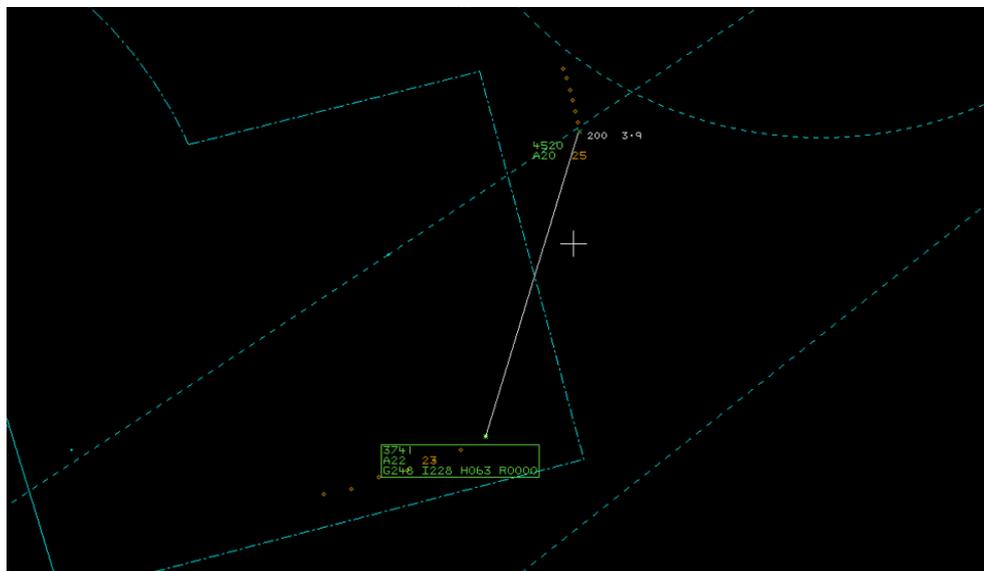
Figure 5: Geometry at 1515:01 (A400 squawking 3741; C182 squawking 4520).

At 1515:01 (Figure 5), the A400 is in the left turn and the controller passes Traffic Information on the C182 *'traffic north three miles tracking south east indicating one hundred feet below'*. The A400 is still within the Brize Norton CTR.

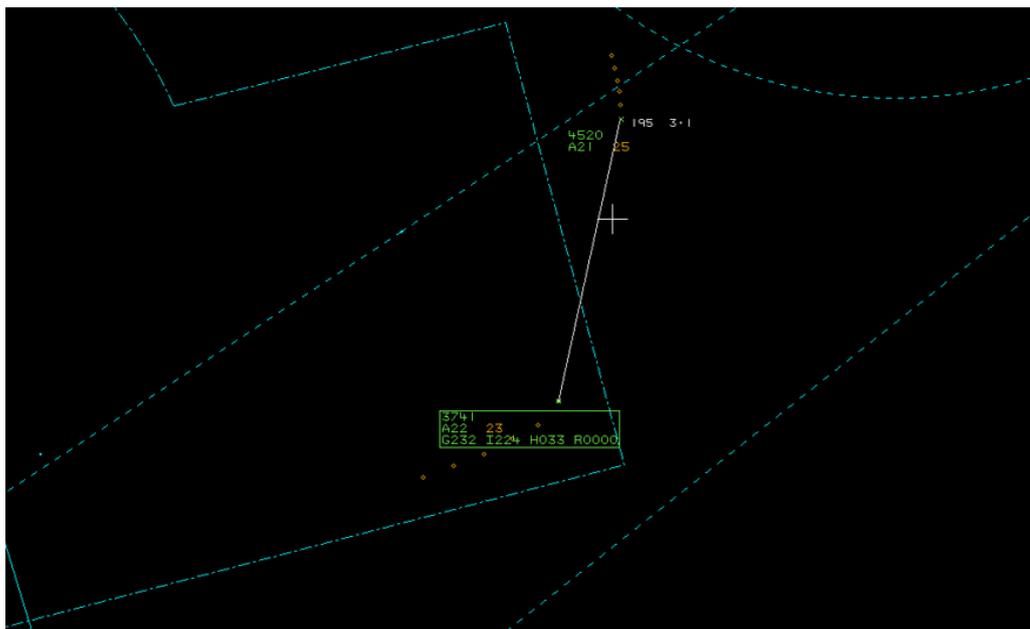
Figure 6: Geometry at 1515:15 (A400 squawking 3741; C182 squawking 4520).

At 1515:15 (Figure 6), the controller gave the A400 a further left turn onto a heading of 280° for positioning for the PAR.

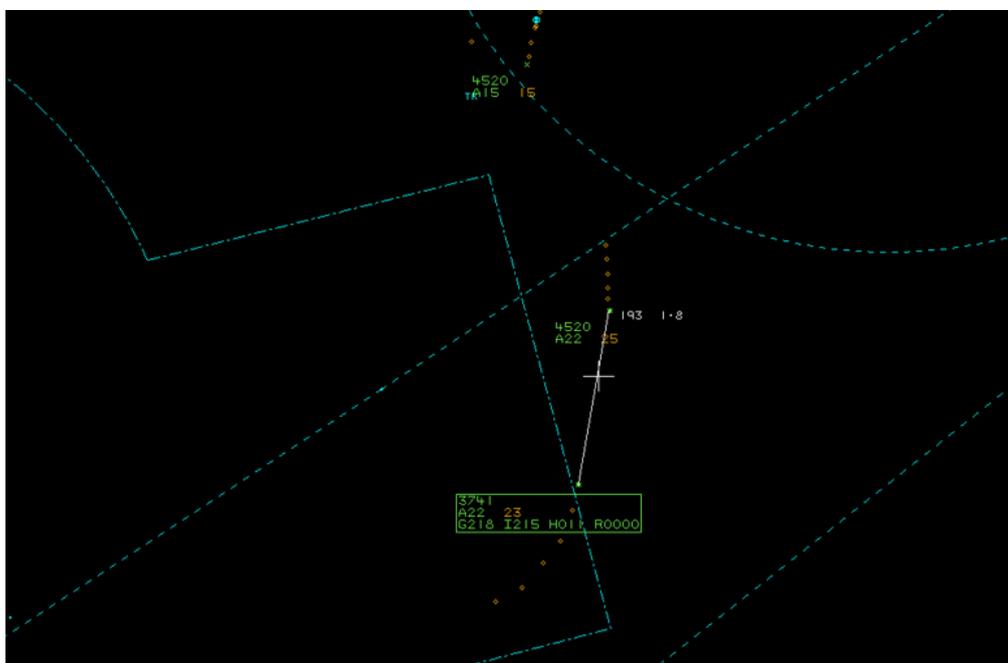
Figure 7: Geometry at 1515:29 (A400 squawking 3741; C182 squawking 4520).

At 1515:29 (Figure 7), A400 pilot calls visual with the C182. The radar replay shows that 1.8nm lateral separation exists with the aircraft at co-altitude. The A400 is still in the left hand turn and is outside the Brize Norton CTR.

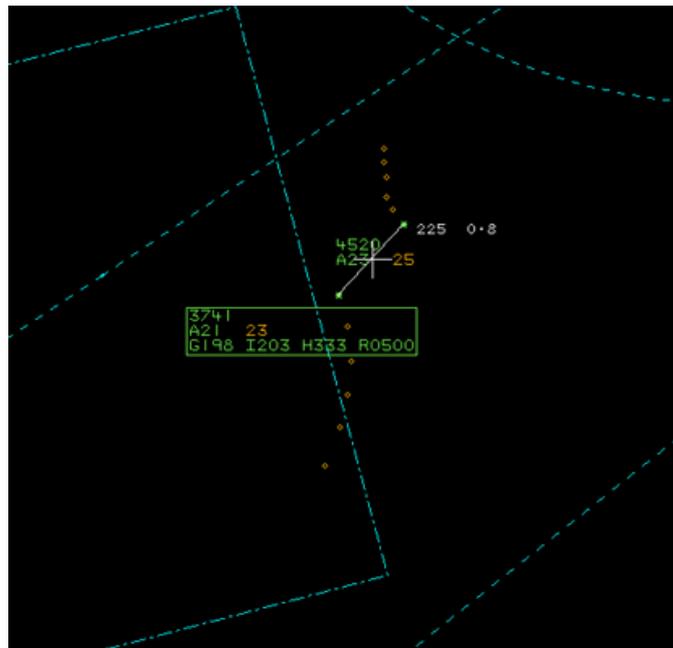
Figure 8: Geometry at 1515:44 (A400 squawking 3741; C182 squawking 4520).

At 1515:44 (Figure 8), the aircraft are at CPA of 0.8nm lateral separation and 200ft vertical separation. The A400 pilot responded to a TCAS RA descent and continued his left turn, whilst the C182 turned left, away from the A400.

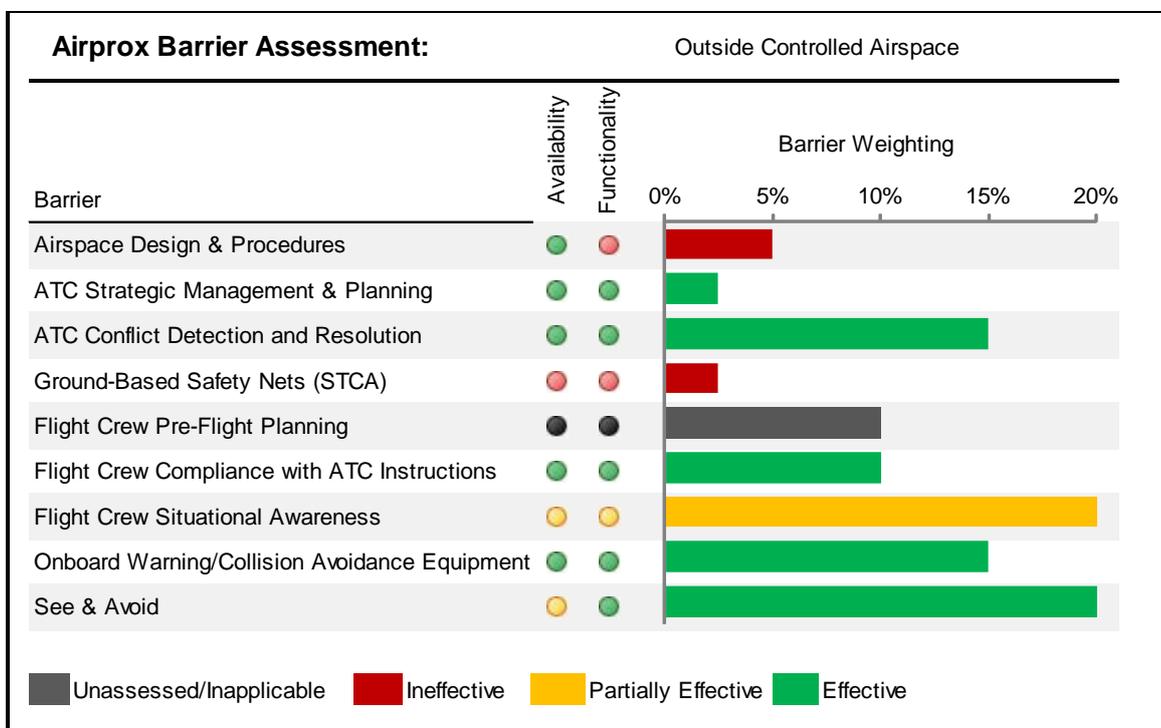
- **Airspace Design and Procedures** were considered ineffective because the Brize CTR did not stop the A400 from spilling out into Class G airspace, and the Brize/Oxford LOA regarding liaison in such circumstances did not apply to the single-engine C182.
- **ATC Strategic management** and **ATC conflict and detection** were effective barriers because both controllers were able to give traffic information and avoiding action. That being said, there was no **STCA** available so Ground-Based Safety Nets were not effective.
- **Flight Crew Compliance with ATC instructions** was thought to be effective.
- **Flight Crew situational awareness** was only partially effective, because the A400 pilot was not aware that he was outside CAS and that he was therefore responsible for collision avoidance rather than ATC.
- **TCAS** and **See and Avoid** were considered effective.

Modern safety management processes employ the concept of safety barriers that prevent contributory factors or human errors from developing into accidents. Based on work by EASA, CAA, MAA and UKAB, the following table depicts the barriers associated with preventing mid-air-collisions. The length of each bar represents the barrier's weighting or importance (out of a total of 100%) for the type of airspace in which the Airprox occurred (i.e. Controlled Airspace or Uncontrolled Airspace).³ The colour of each bar represents the Board's assessment of the effectiveness of the associated barrier in this incident (either Fully Effective, Partially Effective, Ineffective, or Unassessed/Inapplicable). The chart thus illustrates which barriers were effective and how important they were in contributing to collision avoidance in this incident.
