**AIRPROX REPORT No 2016166**

Date: 20 Jul 2016 Time: 1400Z Position: 5242N 00047E Location: NE Marham

**PART A: SUMMARY OF INFORMATION REPORTED TO UKAB**

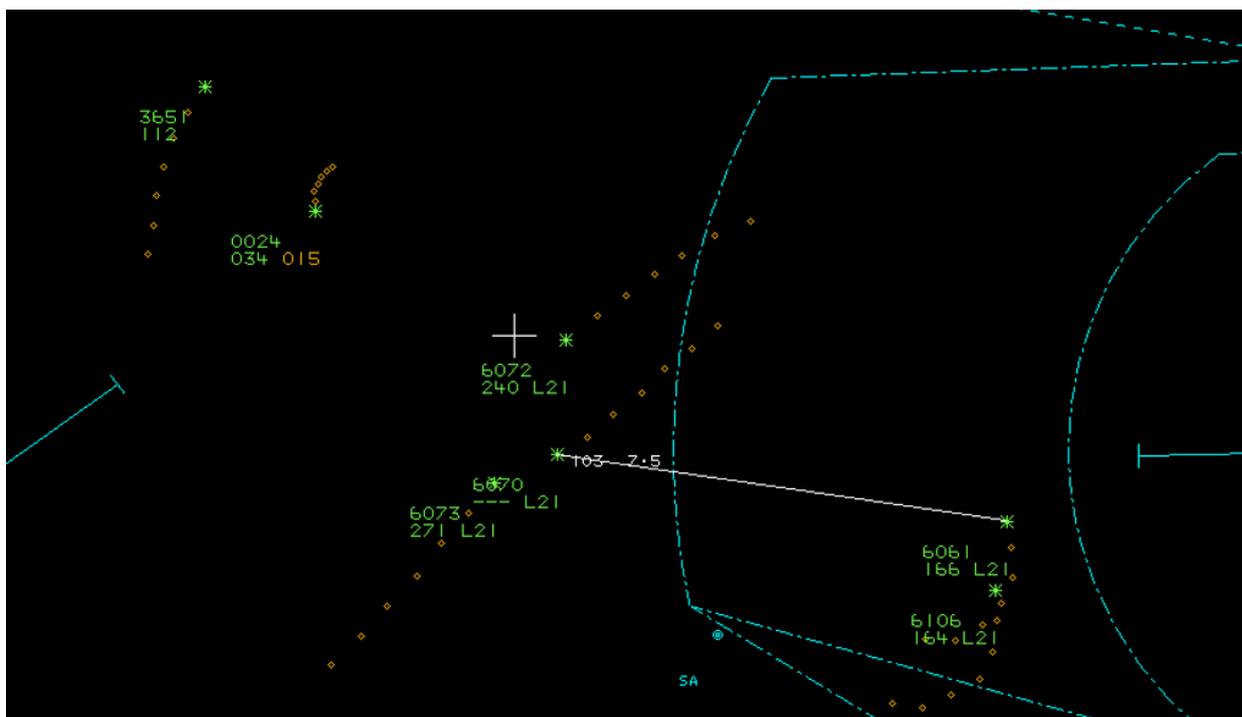
**Figure 1: Geometry at 1359:27  
(Typhoons squawking 6070/6072/6073; F15s squawking 6061/6106).**

At 1359:27 (Figure 1), the Typhoons are engaged in a 2v1 Air Combat Manoeuvres (ACM) and are merging; indicated height block for the fight was reported as 21,000-24,000ft. The F15s are 7.5nm to the east, in a left-hand turn to track west to join up with another F15 for ACM. The Swanwick controller at this point is passing traffic information to the F15s on the Typhoons.

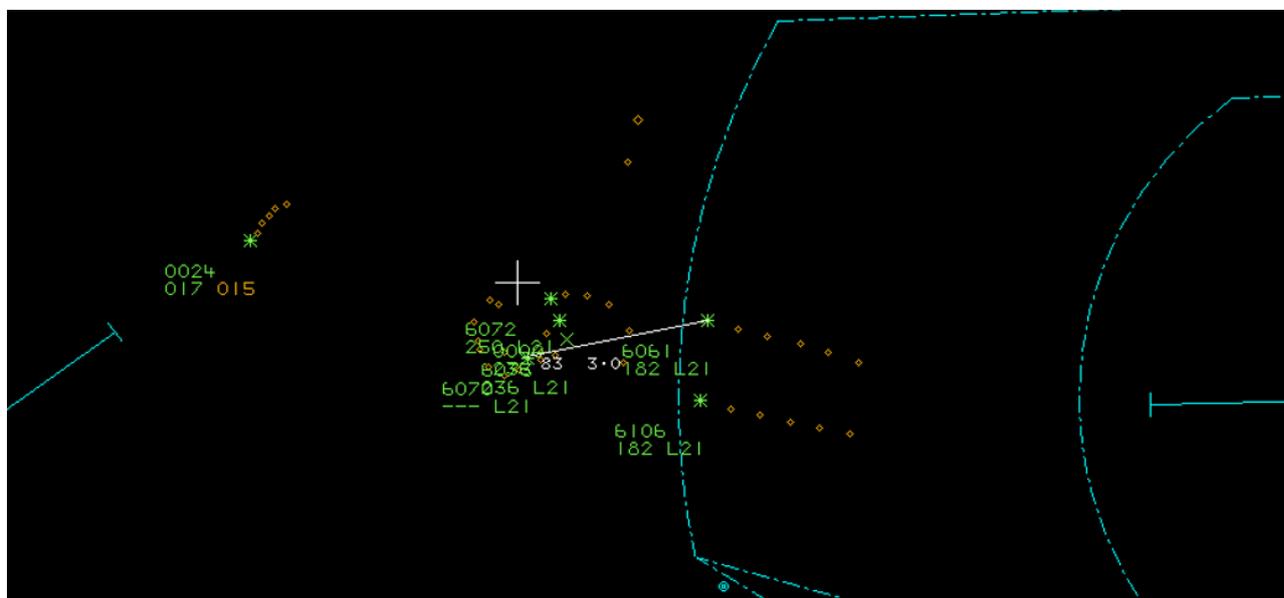
**Figure 2: Geometry at 1400:15  
(Typhoons squawking 6070/6072/6073; F15s squawking 6061/6106).**

At 1400:15 (Figure 2), the Typhoons are merged in a 2v1 fight; the F15s are east by 3nm and reported climbing in a cruise to FL190 to the west to join with a single F15. At this time the controller called the F15s to the Typhoons. Note the cluster of labels and difficulty working out which aircraft is where and the lack of mode/C on one of the Typhoons. The merging of aircraft is often associated with spurious SSR codes or lack of mode/C.

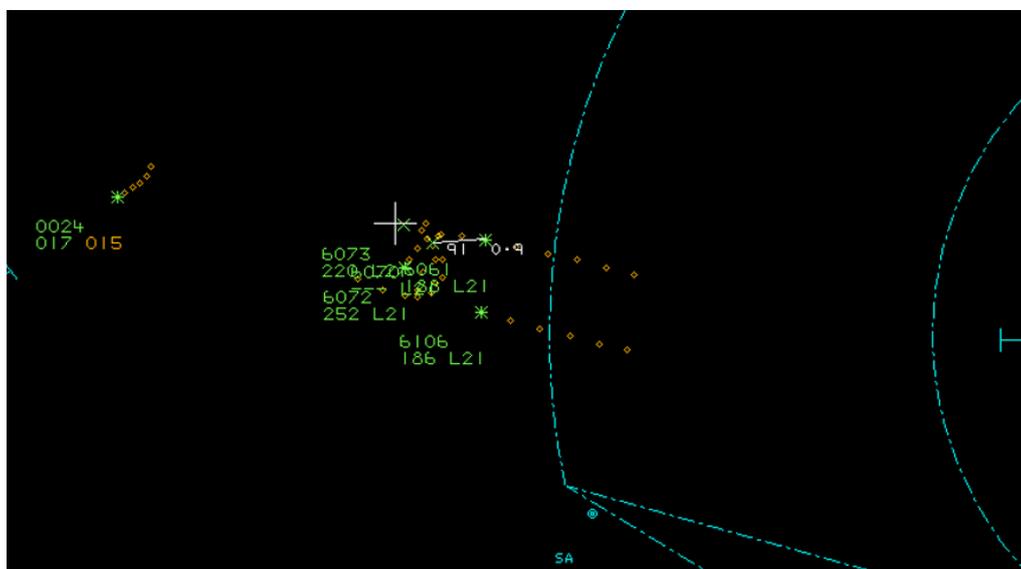
**Figure 3: Geometry at 1400:27**  
(Typhoons squawking 6070/6072/6073; F15s squawking 6061/6106).

At 1400:27 (Figure 3), the controller calls the Typhoons to the F15s '[F15 Flt c/s] previously reported traffic is now overhead indicating flight level 220 to flight level 250'. The F15s call visual on two of the Typhoons and the controller reinforces that it is a 3-ship. The F15s are indicating FL186 and the lowest Typhoon FL220, vertical separation is over 3000ft and lateral separation is within 1nm.

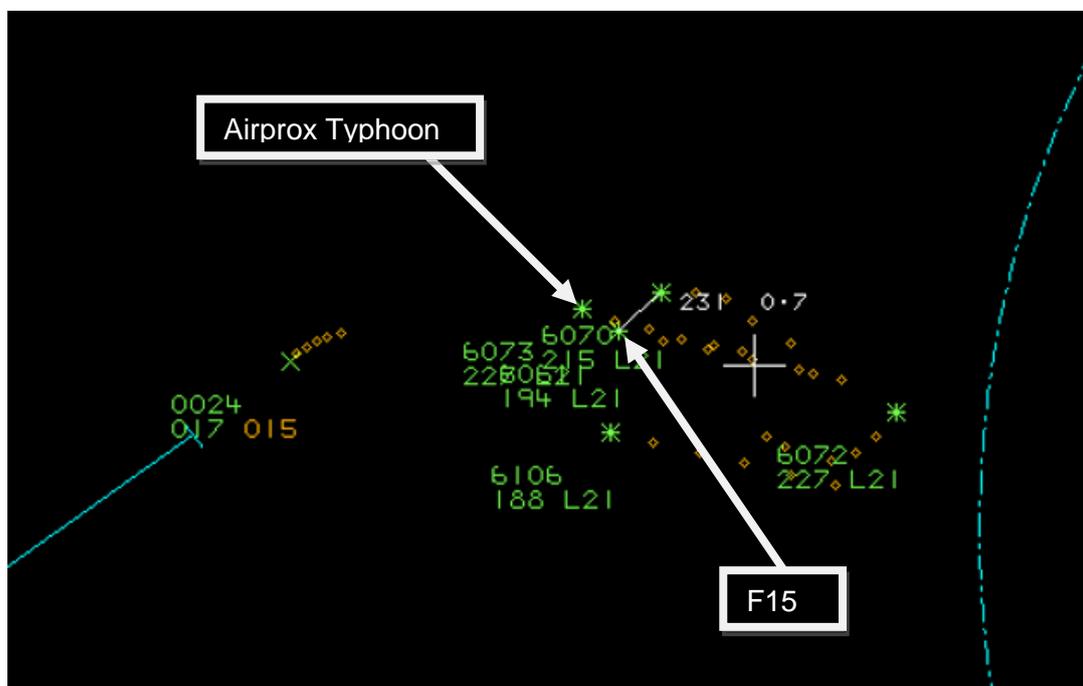
**Figure 4: Geometry at 1400:54**  
(Typhoons squawking 6070/6072/6073; F15s squawking 6061/6106).

At 1400:54 (Figure 4), the controller passes traffic information to the Typhoons with specific reference to the Airprox Typhoon. '[Typhoon Flt c/s] traffic west, 2 miles, tracking west. A pair F15's indicating flight level 188 flight level 195, [Airprox Typhoon c/s] the F15's are in your 6 o'clock 1 mile 1000' below'.

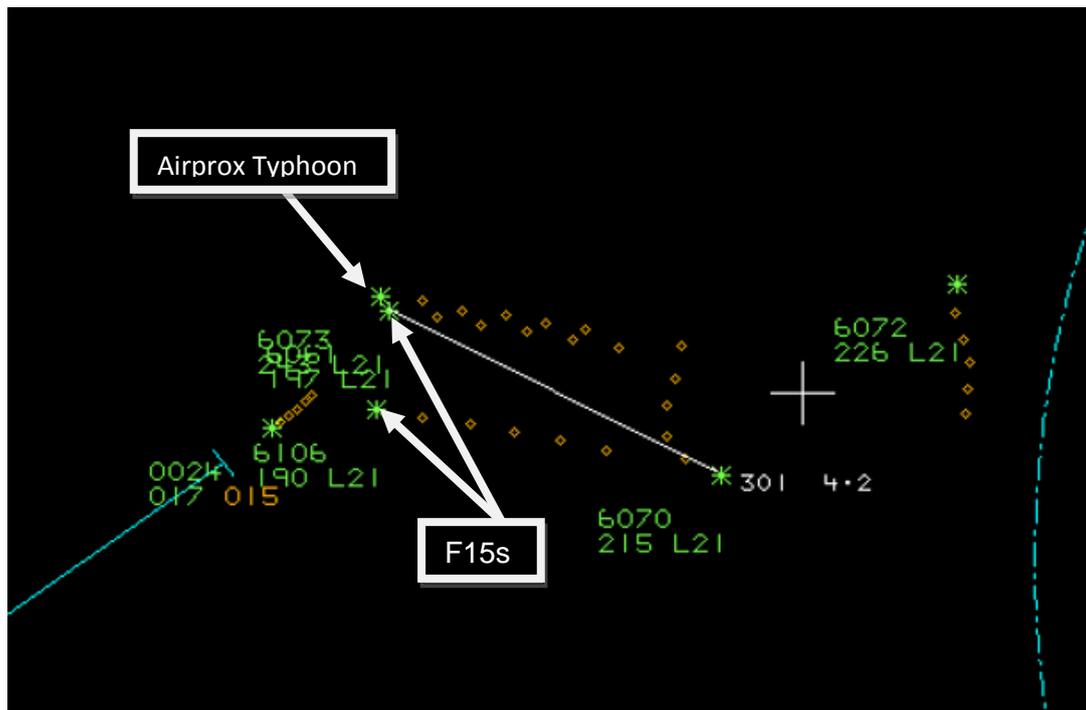
**Figure 5: Geometry at 1401:14  
(Typhoons squawking 6070/6072/6073; F15s squawking 6061/6106).**

At 1401:14 (Figure 5), [Airprox Typhoon c/s] calls visual with one F15 below and so the controller again calls the traffic 'Roger, the other's south by 2 miles 700' below', to which the Typhoon acquires visually.

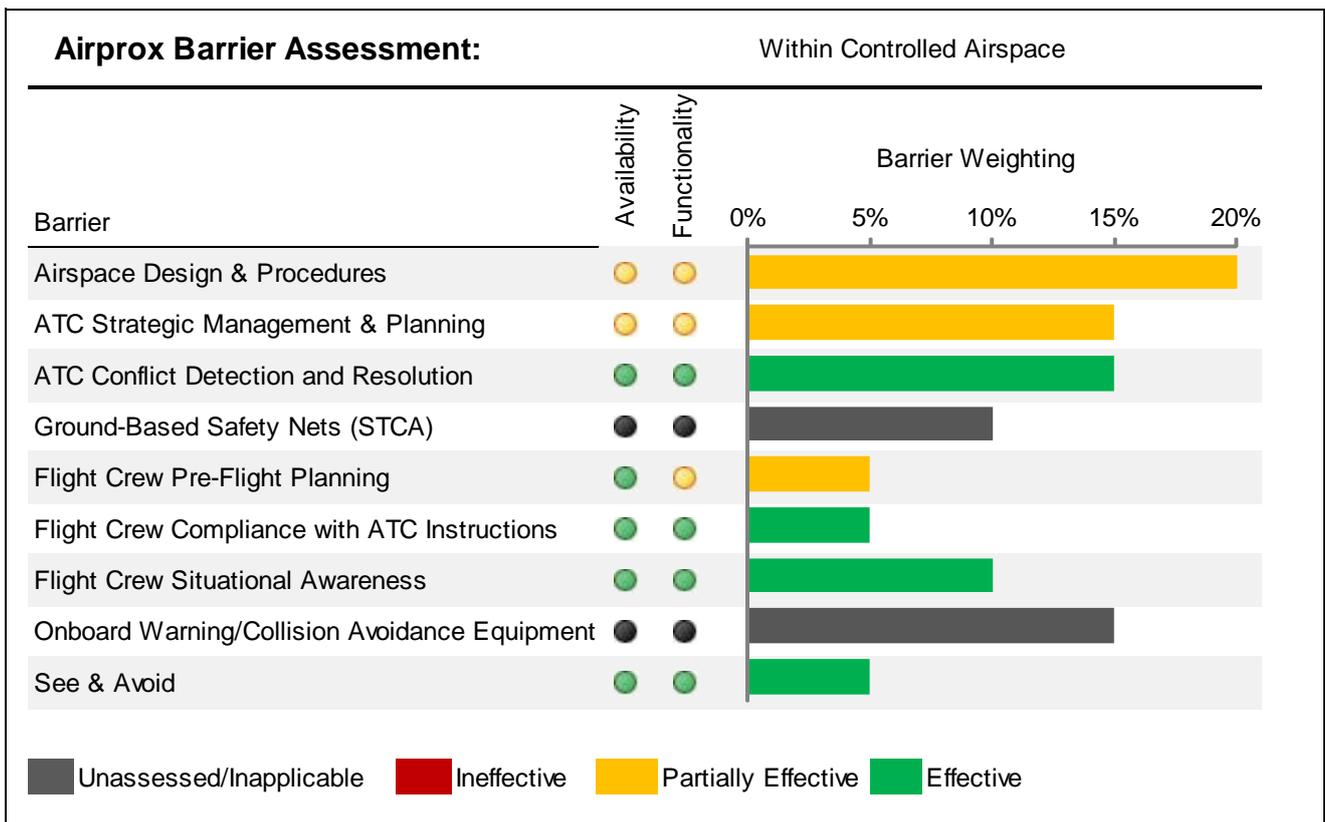
- **Airspace Design and Procedures** was considered only **partially effective** because the local procedures were not robust enough for the situation that had occurred - the unplanned closure of two controlling agencies.
- **ATC Strategic Manning and Planning** was **partially effective** because, notwithstanding that the Swanwick controllers coped well in a difficult situation, Swanwick was not manned to

meet the circumstances of the closure of two controlling agencies and there was no plan for them to do so.

- **Flight Crew Pre-Flight planning** was **partially effective** because the Board believed that the Typhoon crews had not gained a full awareness of the other booked airspace users in their planned operating area, or that their planned operating area (AAR area 8) was active at the time.
- **Onboard Warning/Collision Avoidance Equipment** was **inapplicable** because neither aircraft was fitted with CWS equipment. The Board agreed that, because both aircraft were transponding, if this barrier had been available to at least one of the pilots it could have alerted them to the presence of the other aircraft early enough to carry out any actions to increase separation. Notwithstanding, the Board recognised that the F15 pilots had contact with the Typhoons at all times using their other onboard systems as a substitute for CWS.
