## AIRPROX REPORT No 2016182

Date: 26 Aug 2016 Time: 1307Z Position: 5226N 00102W Location: Husbands Bosworth Glider Site

### PART A: SUMMARY OF INFORMATION REPORTED TO UKAB

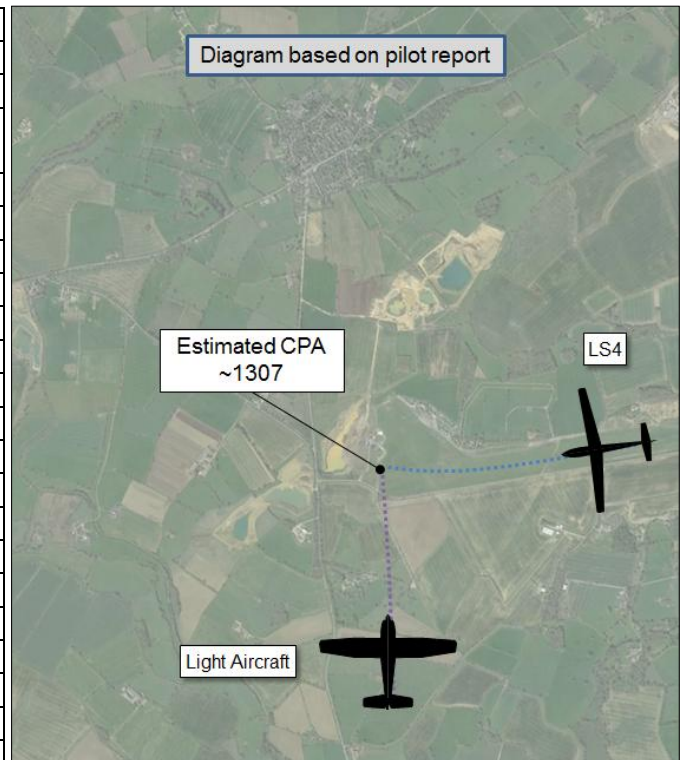
**THE LS4 PILOT** reports that he was winch-launching and the launching area appeared to be clear when the launch commenced. The high-wing light-aircraft was first observed approaching from the south and to the port side within 10secs of collision as he was in the launch at around 800ft. The closing distance was monitored with a view to releasing the winch cable if there was a risk of collision. The winch launch was into wind on runway 27, the winch being stationed at the far west end of the airfield. The other aircraft was carrying FLARM which gave a warning as they got close.

He assessed the risk of collision as 'Medium'.

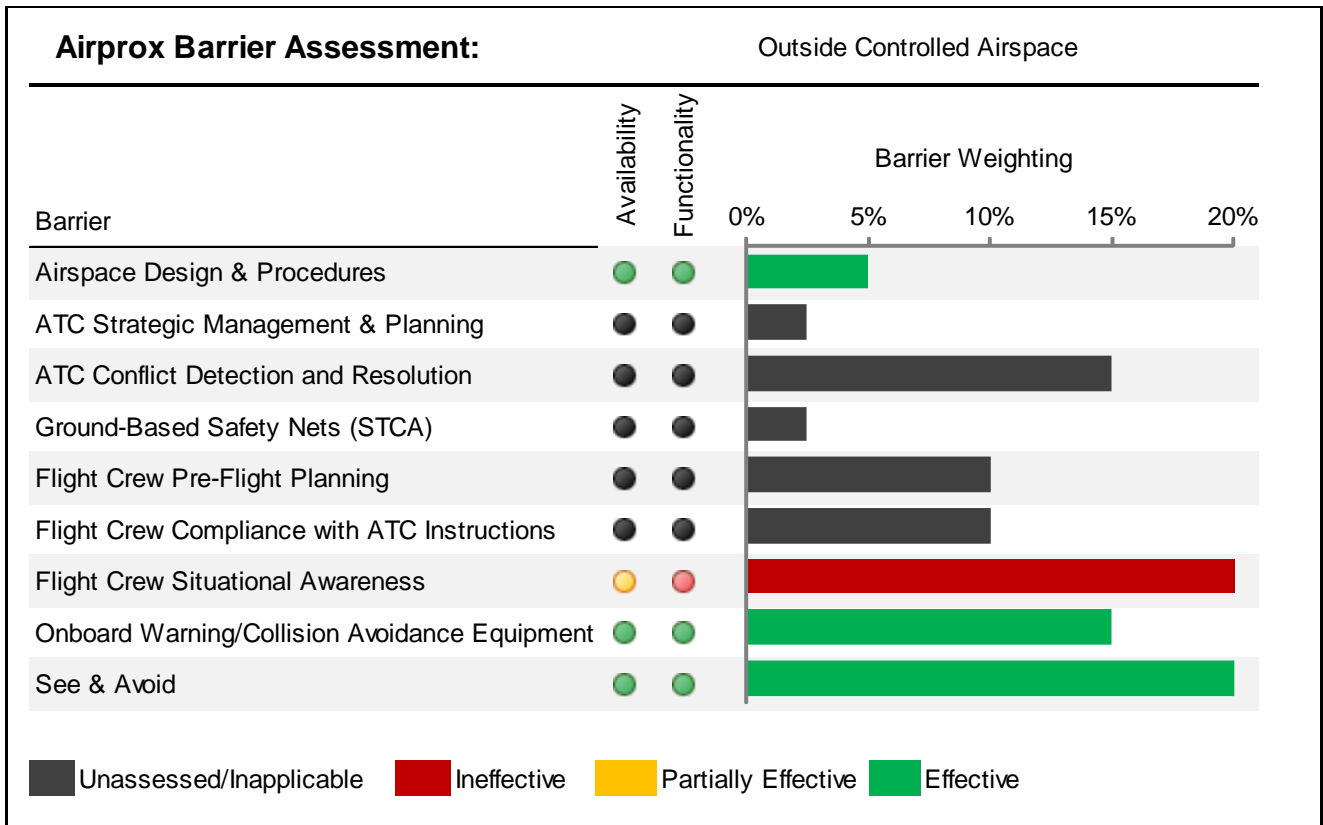
- **Flight Crew Situational Awareness** was considered **ineffective** because the unknown light aircraft pilot had flown through an active and promulgated glider site.
- **See-and-Avoid** was assessed as **fully effective** albeit it was not clear whether the FLARM indications had first alerted the LS4 pilot or whether he had seen the unknown aircraft beforehand.

1. The LS4 pilot continued the winch launch potentially into conflict with the unknown light aircraft.
2. The unknown light aircraft pilot flew close to a promulgated and active glider site below the published maximum winch launch altitude.

Degree of Risk: D.
