AIRPROX REPORT No 2016187

Date: 23 Aug 2016 Time: 1057Z Position: 5624N 00316W Location: 5nm W Dundee airport

PART A: SUMMARY OF INFORMATION REPORTED TO UKAB

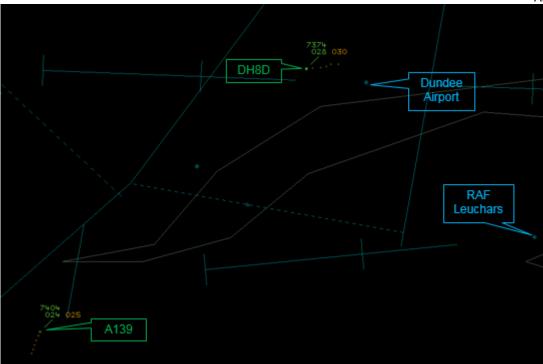
Figure 3 – Prestwick MRT at 1054:50.

At 1054:50 (Figure 3) the DHC8 pilot had made a reversal turn overhead Dundee and reported beacon outbound. The controller asked him to report established inbound on the localiser.

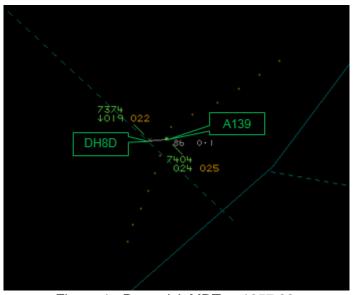
Figure 4 - Prestwick MRT at 1057:08.

CPA occurred at 1057:08 (Figure 4) when the DHC8 was indicating FL019 and the AW139 FL024 (CPA 500ft vertically and 0.1nm horizontally).

The pilot of the DHC8 had observed the presence of the AW139 on TCAS and, being visual with the ground as he stated in his report, had descended below the platform altitude for the approach of 2200ft to 2000ft. This is evidenced by the 'Mode C' height readout of FL019 (descending).

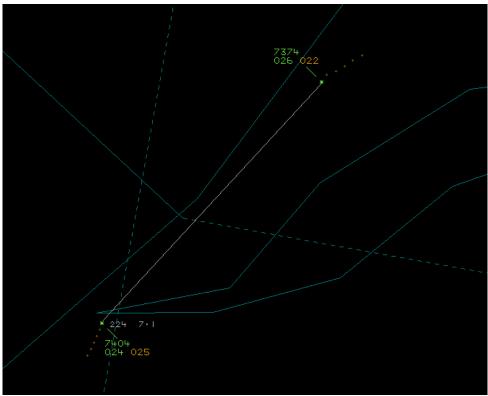
Figure 5: Geometry at 10:55:45 (DHC8 SSR 7374; AW139 SSR 7404).

At 10:55:45 (Figure 5), the DHC8 was tracking south-west under control of Dundee ATC and the AW139 was tracking north-east under control of Leuchars Approach. The Leuchars Approach controller passed Traffic Information to the AW139 pilot on traffic in his right, 2 o'clock, 6nm, similar altitude, in the Dundee hold but shortly inbound to Dundee and stated that he would keep the pilot advised. The pilot responded that he had the traffic on TCAS and would be routing to the west and north. At 10:56:08 the pilot reported visual with the traffic.

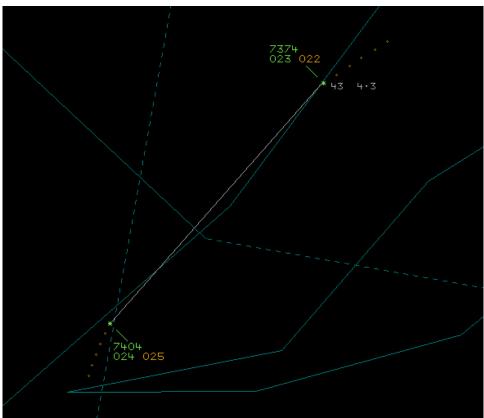
Figure 6: Geometry at 10:56:18 (DHC8 SSR 7374; AW139 SSR 7404).

At 10:56:18 (Figure 6), Leuchars Approach passed Traffic Information by landline to Dundee ATC, stating that the AW139 pilot was visual with the DHC8.

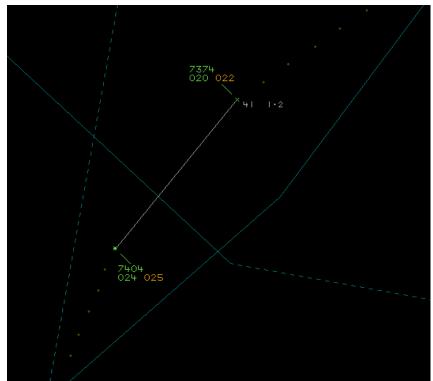
Figure 7: Geometry at 10:56:52 (DHC8 SSR 7374; AW139 SSR 7404)

At 10:56:52 (Figure 7), the Leuchars Approach controller asked the AW139 pilot if he was still visual with the conflicting DHC8. The pilot stated that the traffic was just passing 500ft below.

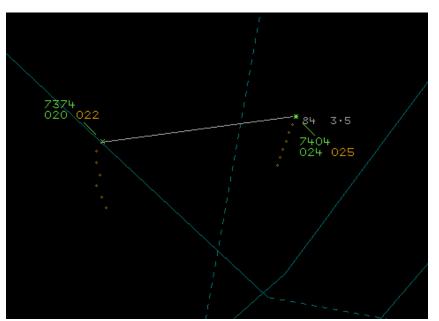
Figure 8: Geometry at 10:58:19 (DHC8 SSR 7374; AW139 SSR 7404).

At 10:58:19 (Figure 8), the AW139 pilot advised the Leuchars Approach controller that the DHC8 appeared to be turning inbound, that they were still visual, and anticipated being clear of the centreline by the time the DHC8 returned to that location.

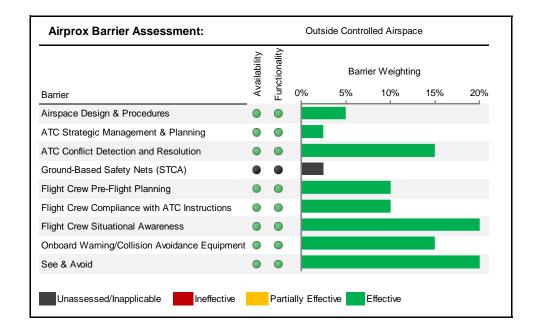
In looking at the safety barriers relevant to this incident, the Board considered that all barriers had functioned fully effectively apart from ATC Ground-Based Safety Nets (such as Short-Term Conflict Alert) which were absent as a result of Dundee not having a radar. As a result, the Dundee controllers were not positively cued by any system about the separation between the 2 aircraft. Somewhat in mitigation, Leuchars was able to provide such information and had positively passed details of their conflict detection to the Dundee controllers.
