AIRPROX REPORT No 2016216

Date: 23 Sep 2016 Time: 1031Z Position: 5243N 00021W Location: 7nm NE RAF Wittering

PART A: SUMMARY OF INFORMATION REPORTED TO UKAB

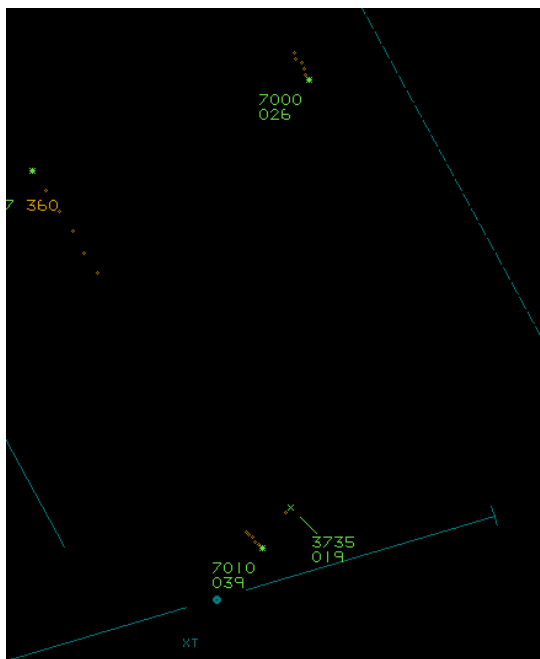
Figure 1: Geometry at 1028:29
(Tutor SSR 3735; light aircraft SSR 7000).

At 1028:29 (Figure 1), the Tutor pilot had just called Wittering Zone on a downwind-leg departure. He was identified and provided with a Traffic Service by the Wittering Zone controller.

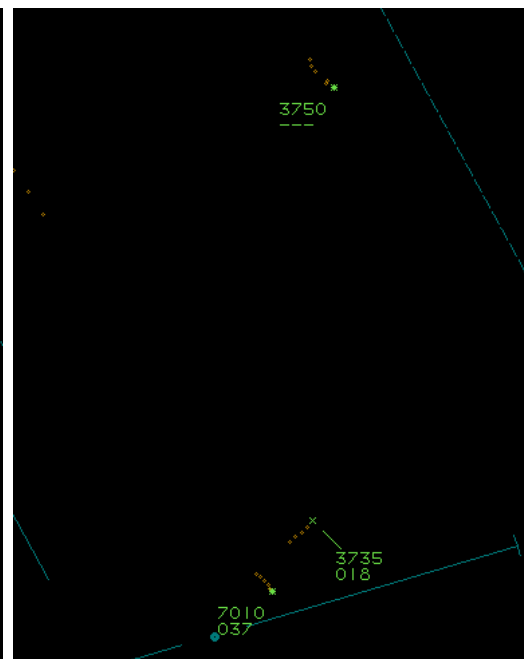
Figure 2: Geometry at 10:28:37
(Tutor SSR 3735; light aircraft SSR 3750).

At 1028:37, the light aircraft, now approximately 15nm NE of Wittering, changed from SSR 7000 to 3750, which indicates that the pilot was receiving a Basic Service from Wittering Zone (conspicuity unverified).

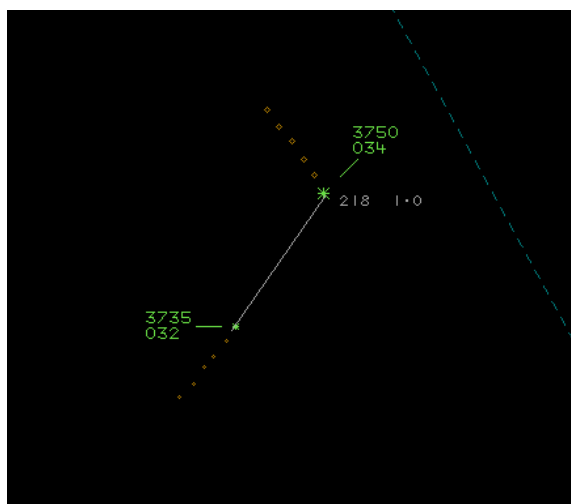
Figure 3: Geometry at 1030:59
(Tutor SSR 3735; light aircraft SSR 3750)

At 1030:59 (Figure 3), the Wittering Zone controller passed Traffic information on “pop up traffic, NE, 2nm, tracking S, indicating 300ft above”. The Tutor pilot subsequently replied that the traffic was in sight. No Traffic Information was passed on VHF at the time.

When Traffic Information was passed to the Tutor pilot on the light aircraft, the Wittering Zone controller described it as 'pop-up' and at a range of 2nm, which is not accurate when compared to the replay data and not timely if the light aircraft was actually displayed on the Wittering Zone controller's radar screen throughout, especially considering that it was receiving a service from them. It would be a reasonable expectation that the controller should have passed more timely Traffic Information, subject to workload. That said, the transcripts indicate that the pilot was able to visually acquire the traffic soon after.

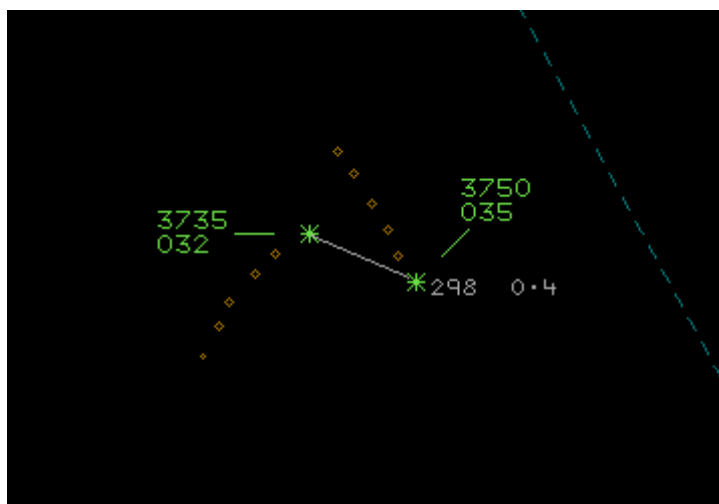
Figure 4: Geometry at 1031:15
(Tutor SSR 3735; light aircraft SSR 3750)

At 1031:15 (Figure 4), the two aircraft passed at their CPA, which was 0.4nm laterally.

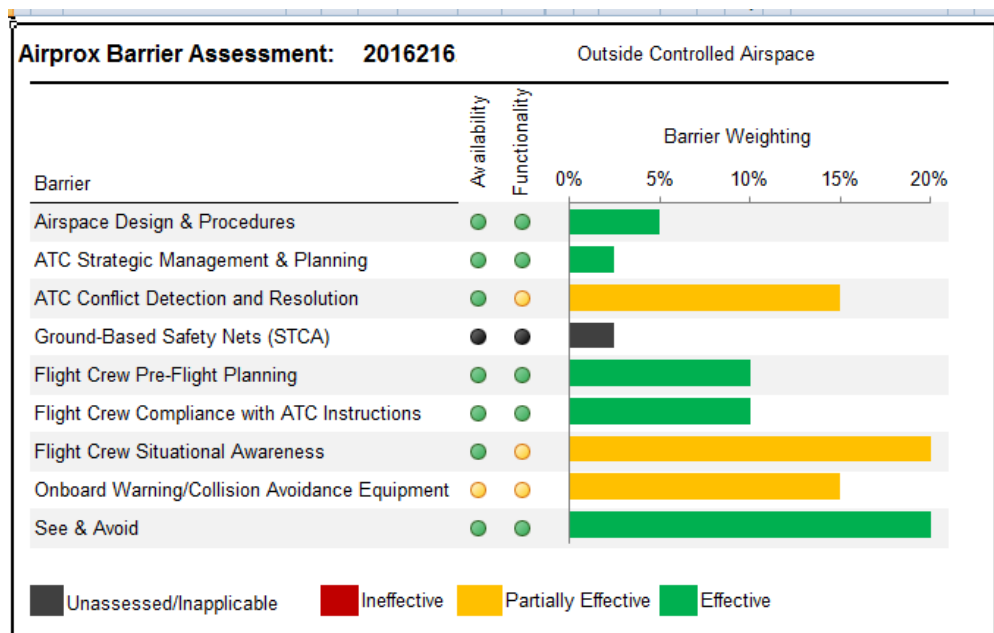
- **ATS Conflict Detection and Resolution** was considered as only **partially effective** because the controller did not detect the conflict sufficiently early to pass timely Traffic Information to the Tutor pilot, and did not provide any Traffic Information to the Europa pilot.
- **Flight Crew Situational Awareness** was also considered to have been **partially effective** because although late, the Tutor pilot was informed about the other aircraft and did receive a TAS alert, albeit also late.
- **Onboard Warning/Collision Avoidance Equipment** was assessed as only **partially effective** because although the Tutor pilot did receive a TAS alert, it was only at 1nm. The Europa pilot's aircraft was not equipped with any collision avoidance equipment but, because his aircraft was transponding, this allowed the Tutor's TAS to warn its pilot of the Europa's presence.

type of airspace in which the Airprox occurred (i.e. Controlled Airspace or Uncontrolled Airspace).³ The colour of each bar represents the Board's assessment of the effectiveness of the associated barrier in this incident (either Fully Effective, Partially Effective, Ineffective, or Unassessed/Inapplicable). The chart thus illustrates which barriers were effective and how important they were in contributing to collision avoidance in this incident.
