**AIRPROX REPORT No 2016221**

Date: 10 Oct 2016 Time: 1244Z Position: 5130N 00043W Location: 8.5nm W Heathrow

**PART A: SUMMARY OF INFORMATION REPORTED TO UKAB**

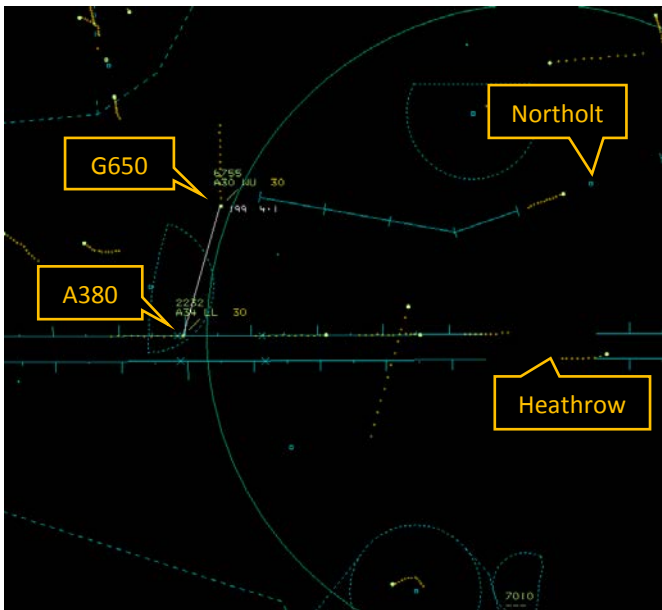
Figure 1 – 1243:55.

There was then a change of controller at Northolt Radar. According to their report, the oncoming controller had been briefed on the traffic situation, including the inbound G650. They stated that they had been distracted by another controller and a subsequent telephone call. They then passed some instructions to another aircraft but, during that pilot's reply, they issued an avoiding action turn to the left to the G650 pilot, which had passed through the Northolt RW07 final approach area and was tracking towards the A380 on the Heathrow RW09L final approach (Figure 1 at 1243:55).

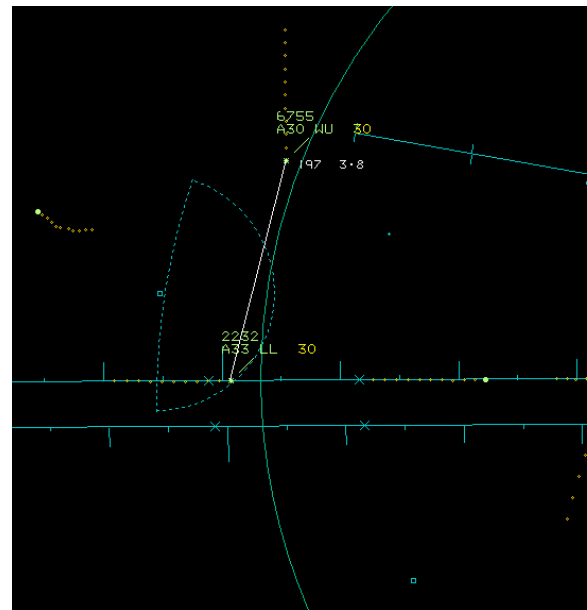
Figure 2 – 1244:00.

At 1244:00 the Heathrow FIN controller issued an avoiding action turn to the right onto a heading of  $180^\circ$  to the A380 pilot (Figure 2).

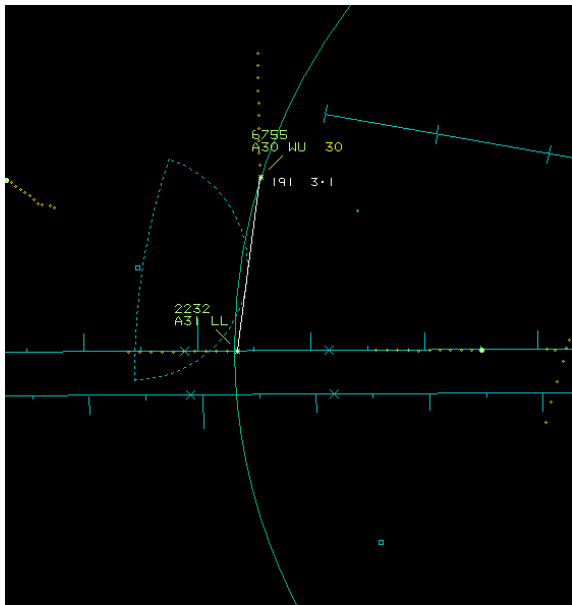
Figure 3 – 1244:13.

At 1244:13 the Northolt controller issued a further avoiding action turn to the left onto a heading of  $360^\circ$  (Figure 3).

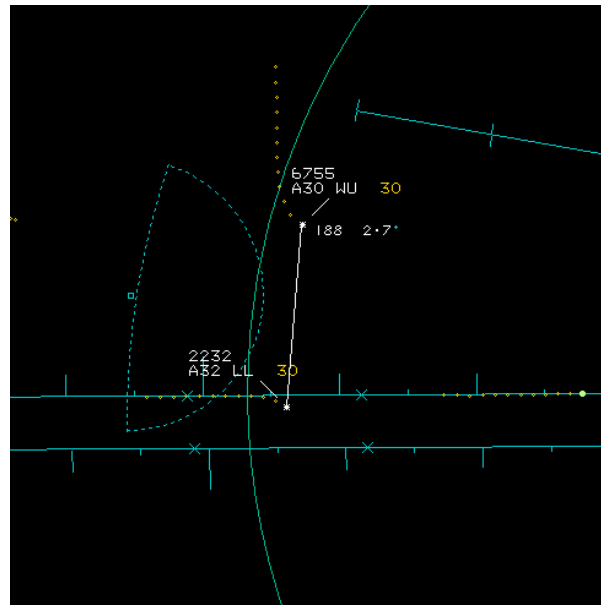
Figure 4 – 1244:23.

The CPA took place at 1244:23 with the aircraft separated by 2.7nm laterally and 200ft vertically (Figure 4). [Required separation was 3nm and/or 1000ft.]

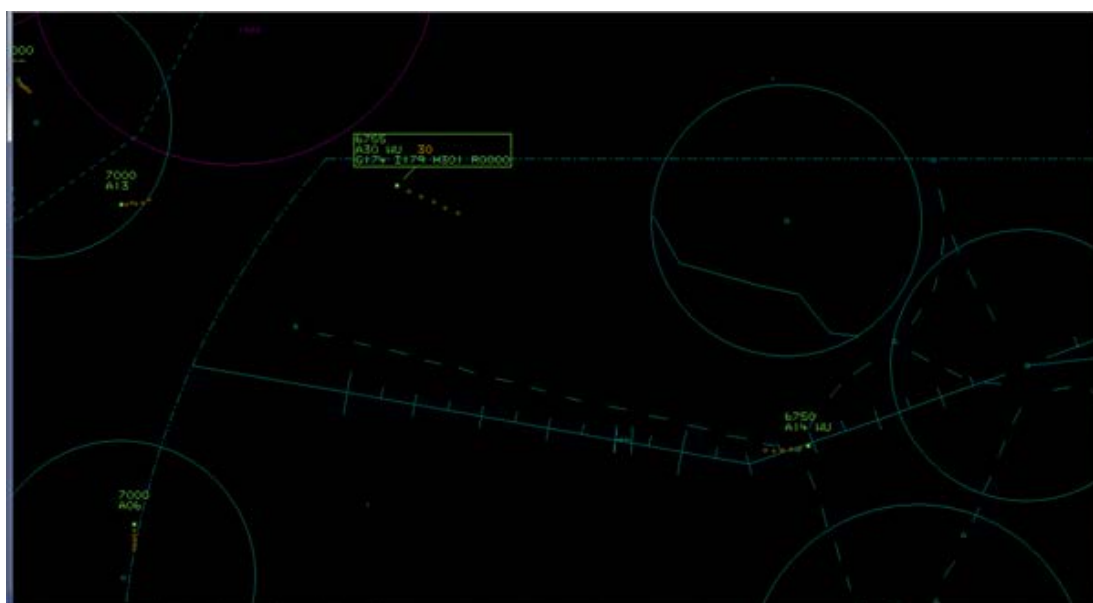
Figure 5: Geometry at 12:42:19 (G650 (6755); A380 (2232)).

At 12:42:19 (Figure 5), the G650 pilot was instructed to turn left onto heading 180° as a standard base leg for RW07. The position was subsequently handed over to an on-coming controller, with the off-going controller remaining in the vicinity to act as a Coordinator.

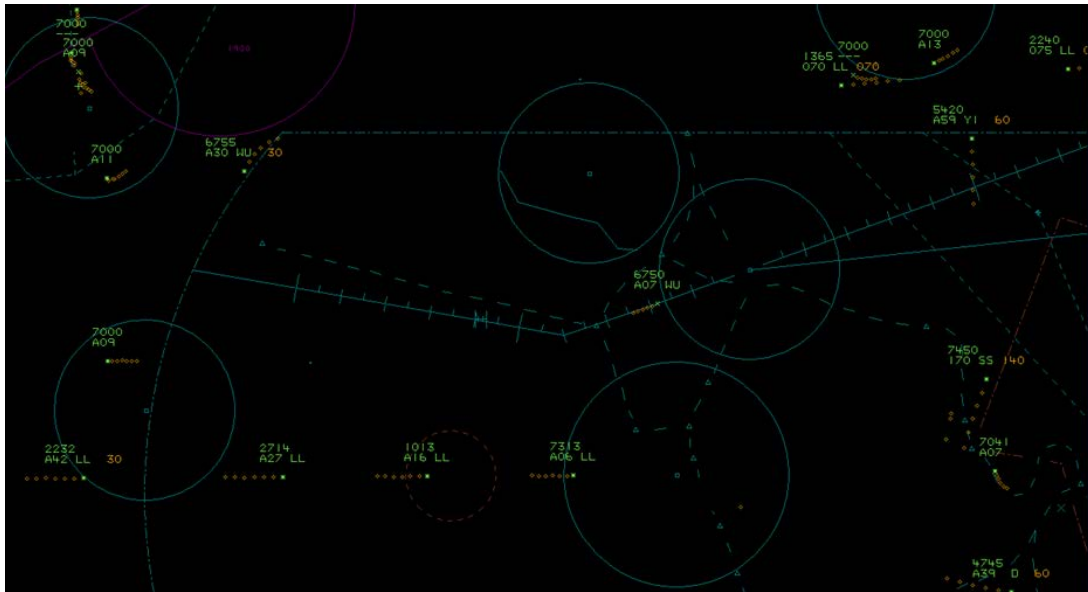
Figure 6: Geometry at 12:43:06 (G650 (6755); A380 (2232); helicopter (7041)).

At 12:43:06 (Figure 6), the Northolt Director answered a landline call from Heathrow Radar (SVFR), who requested a frequency for a helicopter (7041) in transit west towards the Northolt Radar Manoeuvring Area (NRMA) whose pilot would be utilising the heli-lanes.

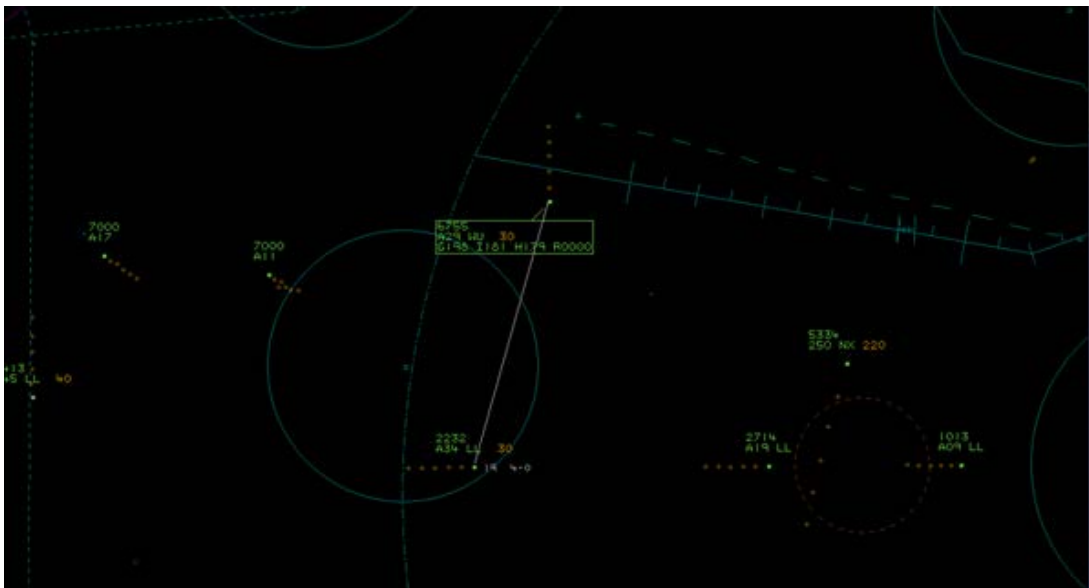
Figure 7: Geometry at 12:43:56 (G650 (6755); A380 (2232)).

At 12:43:56 (Figure 7), the Northolt Director, having had the error pointed out by the Coordinator, instructed the G650 pilot to turn left onto heading 030°, immediately followed by the same instruction as an avoiding action turn.

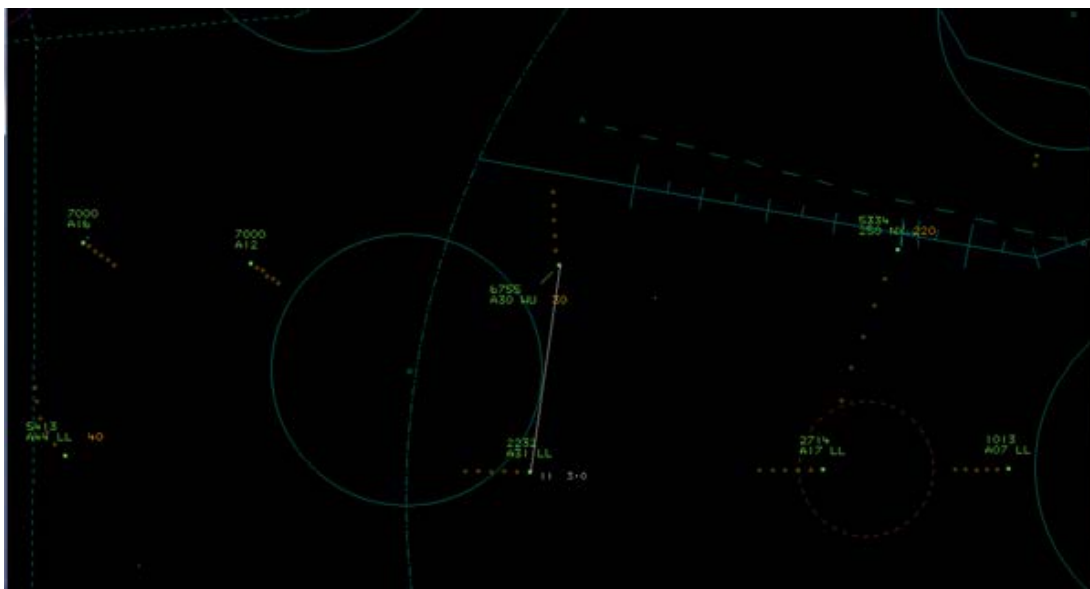
Figure 8: Geometry at 12:44:10 (G650 (6755); A380 (2232)).

At 12:44:10 (Figure 8), the Northolt Director instructed the G650 pilot to turn further left onto heading 360°, with 3nm separation remaining. The rate of turn led to the G650 and the A380 passing with a CPA of 2.8nm horizontally and indicated 100ft vertical separation.

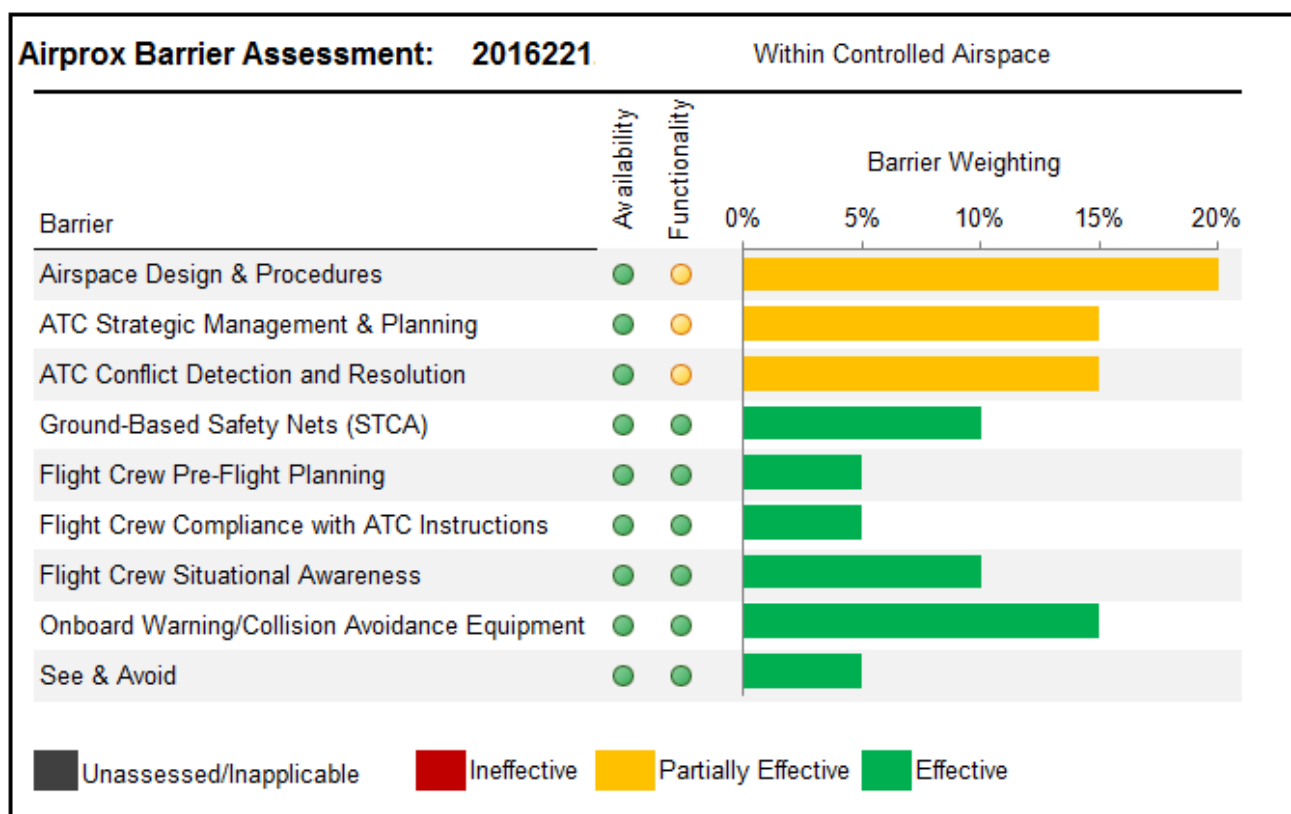
**Airspace Design and Procedures** was considered to be only **partially effective** because they rely on Northolt controllers making a tactical intervention to ensure that Northolt inbound on base leg to RW07 are turned away from the RW09L approach to Heathrow.

**ATC Strategic Management and Planning** was considered to be only **partially effective** because the Northolt Radar sector was not appropriately manned for extended hours operations.

**ATS Conflict Detection and Resolution** was only **partially effective** because the Northolt Radar controller had overlooked the position of the G650 relative to the A380 on approach to Heathrow due to distraction, and the Coordinator had had to remind her.
