AIRPROX REPORT No 2016230

Date: 20 Oct 2016 Time: 1216Z Position: 5051N 00314W Location: Dunkeswell ATZ

PART A: SUMMARY OF INFORMATION REPORTED TO UKAB

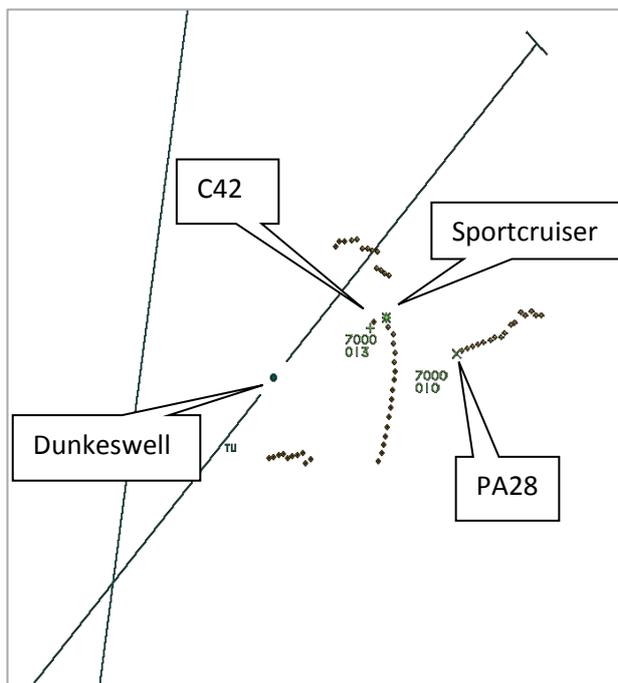
Figure 1: 1216:28

The C42 contacts are intermittent on the radar recordings and, at the time of the Airprox, unfortunately the C42 does not display. For its part, the PA28 does not appear to either head in the opposite direction to the circuit direction or close to the C42, and so the only aircraft that displays on the radar recording whose heading, level and position corresponds with the C42 pilot's report is the Sportcruiser (see Figure 1).

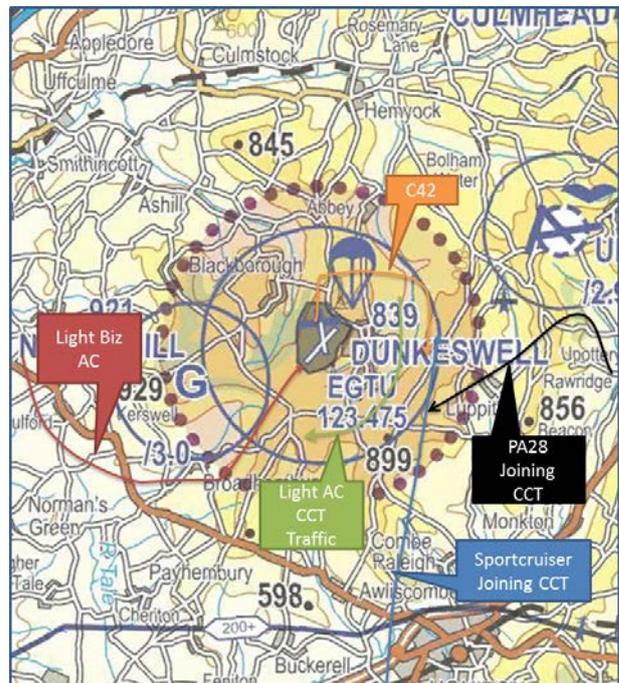
Figure 2: Representative Traffic Situation

Figure 2 provides a representation of the perceived traffic pattern of the various aircraft in and joining the Dunkeswell visual circuit based on radar recordings.

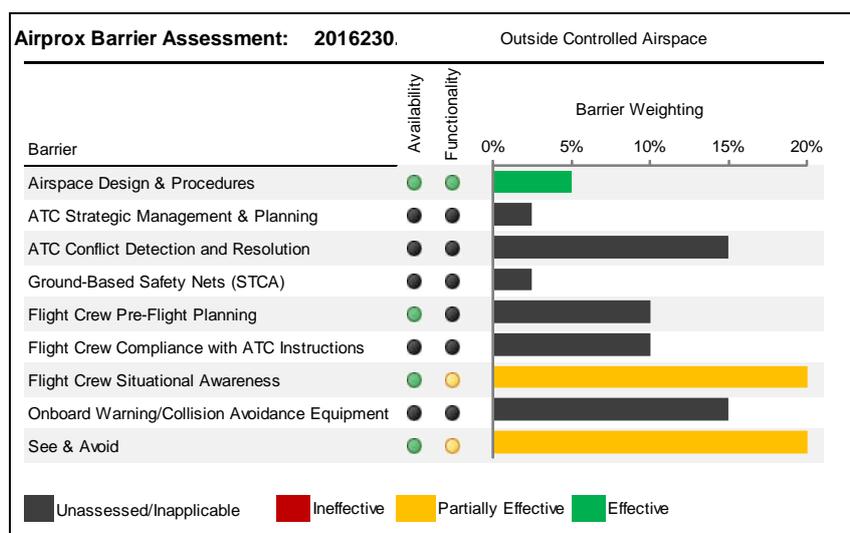
- **Situational Awareness** was assessed as being only **partially effective** because although the aircraft were on the same frequency, both pilots only had a generic awareness of the other aircraft's position.
- **See and Avoid** was also considered only **partially effective** because although the C42 pilot saw the conflicting aircraft it was a late sighting, and the C42 pilot had to carry out emergency avoiding action. The SportCruiser pilot saw a mainly white, high-wing, single-engine aircraft downwind for RWY35 (which was assumed to be the C42) but could not give an estimate of the range he saw it.

Modern safety management processes employ the concept of safety barriers that prevent contributory factors or human errors from developing into accidents. Based on work by EASA, CAA, MAA and UKAB, the following table depicts the barriers associated with preventing mid-air-collisions. The length of each bar represents the barrier's weighting or importance (out of a total of 100%) for the type of airspace in which the Airprox occurred (i.e. Controlled Airspace or Uncontrolled Airspace).⁴ The colour of each bar represents the Board's assessment of the effectiveness of the associated barrier in this incident (either Fully Effective, Partially Effective, Ineffective, or Unassessable/Absent). The chart thus illustrates which barriers were effective and how important they were in contributing to collision avoidance in this incident.
