**AIRPROX REPORT No 2015002**

Date: 16 Jan 2015 Time: 1440Z Position: 5140N 00203W Location: Kemble Airfield

**PART A: SUMMARY OF INFORMATION REPORTED TO UKAB**

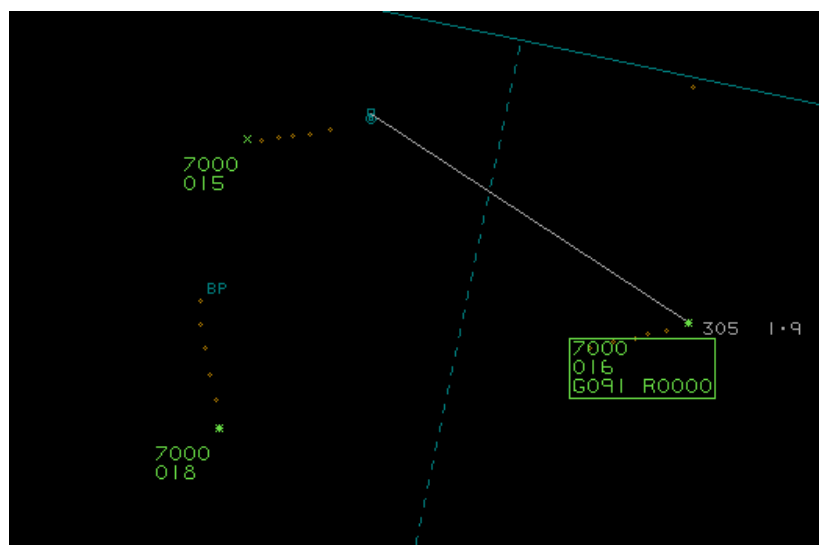
Figure 1 – 1438:11

When the PA28 reported descending deadside, the FISO requested the pilot to report downwind and advised that the circuit was active with four in. The EV97 carried out a touch-and-go and, when the PA28 reported crosswind with contact one ahead downwind, he was requested to report final. The EV97 reported mid/late downwind, was also requested to report final, and was advised that the FISO believed that there was a PA28 ahead. The EV97 reported that they were visual with the one ahead and would report final. Figure 1 shows the position of the PA28 when the EV97 reported visual (the EV97 is not shown on the radar recordings).

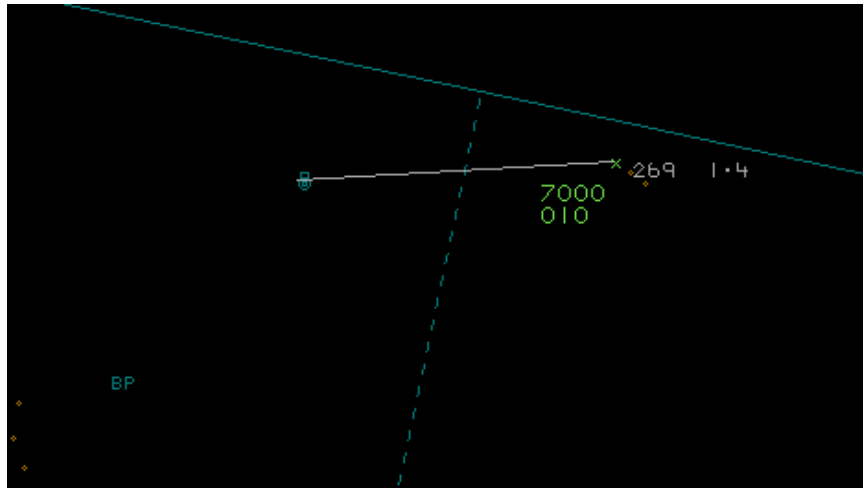
Figure 2 – 1439:24

There were no further transmissions between either the PA28 or the EV97 and the FISO until a crossed transmission that ended "*is contact one ahead*", which could have involved the PA28. The FISO stated that there were two stations transmitting at once, and requested the aircraft turning final to give their callsign. The EV97 replied that they were just turning final to land. Radar did not show the position of the EV97 but did show the PA28 on final at 1.4nm (Figure 2 at 1439:24). At 1439:31 the PA28 faded from radar and a brief contact could be seen which continued for approximately 4 sweeps, which may have been the EV97 (circled in yellow in Figure 3). The FISO transmitted "[callsign] *just to confirm you're visual with none ahead, touch and go at your discretion surface wind northwesterly three knots*". The PA28 reported that they were short final and number one to land. The FISO informed the EV97 that the touch and go was cancelled and gave the PA28 "*runway two six your discretion*".

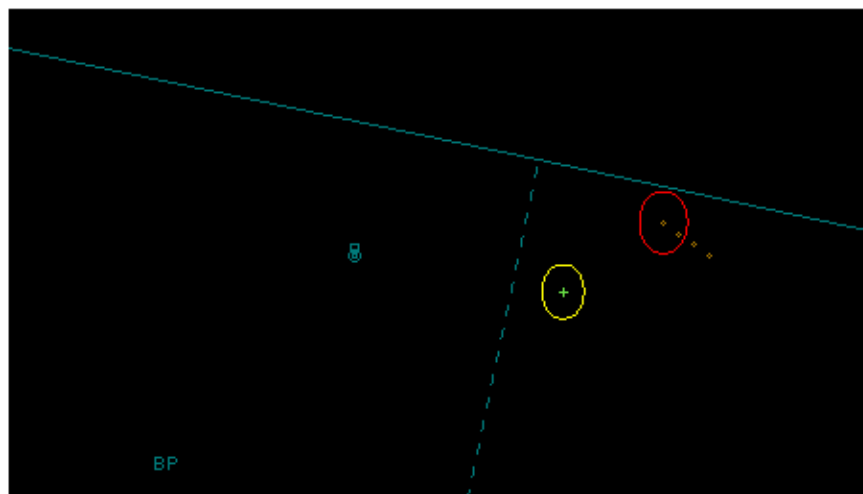
Figure 3 – 1439:31

The FISO saw the Airprox and, at interview, estimated that the aircraft were approximately 20-30ft apart vertically. They transmitted to the EV97 that there was “*an aircraft underneath you I suggest you go-around*”. At interview they reported that if the situation had continued it would have resulted in a collision. The PA28 vacated the runway and reported the Airprox on frequency.
