**AIRPROX REPORT No 2015015**

Date: 23 Feb 2015 Time: 1440Z Position: 5444N 00117W Location: 25nm SSE NATEB

**PART A: SUMMARY OF INFORMATION REPORTED TO UKAB**

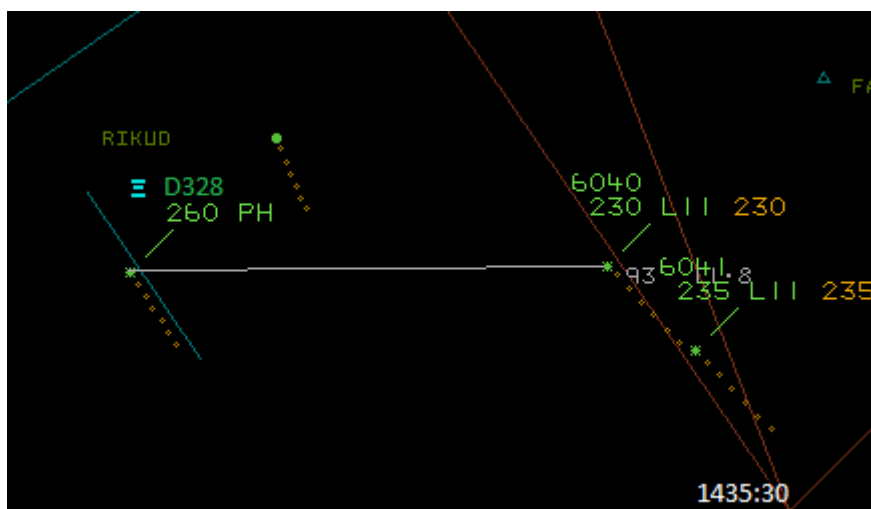
Figure 1.

At 1435:30, the Do328 pilot contacted the Montrose controller maintaining FL260 to RIKUD. Operating to the east of the Do328 were two tankers operating in a racetrack pattern at FL230 and FL235, squawking 6040 and 6041 respectively. (Figure 1).

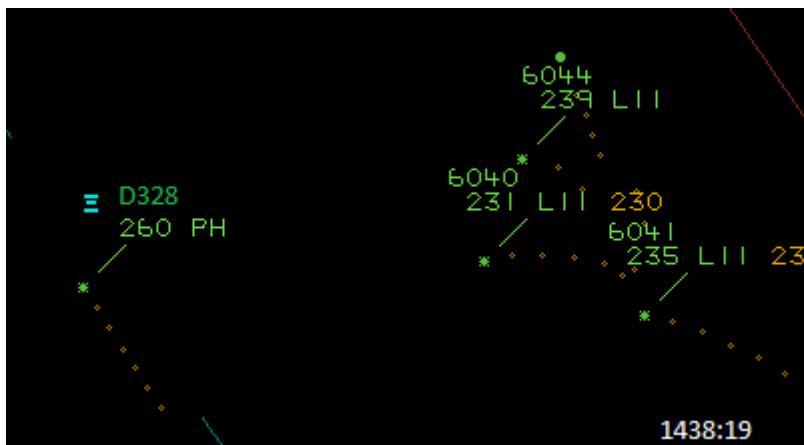
Figure 2.

At 1438:19, one of the F15s appeared on radar squawking 6044 at FL239 as the tankers turned towards the south. (Figure 2.)

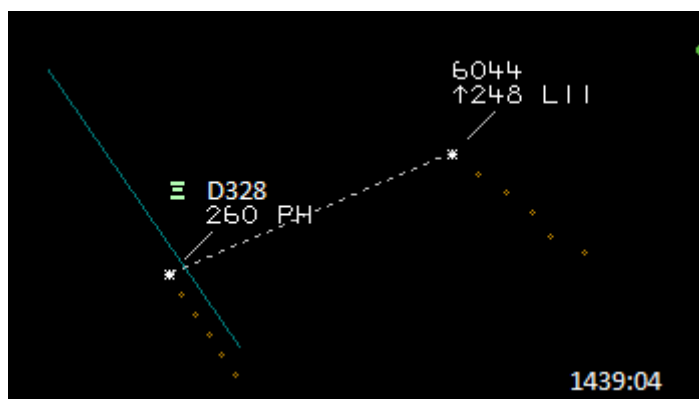
Figure 3.

The F15s started to climb on a converging track with the Do328 and, at 1439:04, low level STCA activated. The F15s were 4.6nm east-northeast of the Do328, climbing through FL248. (Figure 3.) Six seconds later the Montrose controller gave avoiding action to the Do328 pilot as “avoiding action turn left immediately heading 270” which was acknowledged. The Montrose controller then advised the Do328 pilot of “military traffic in your two o’clock range of five miles just coming down your right hand side”. The Do328 pilot reported that they were visual with the traffic.

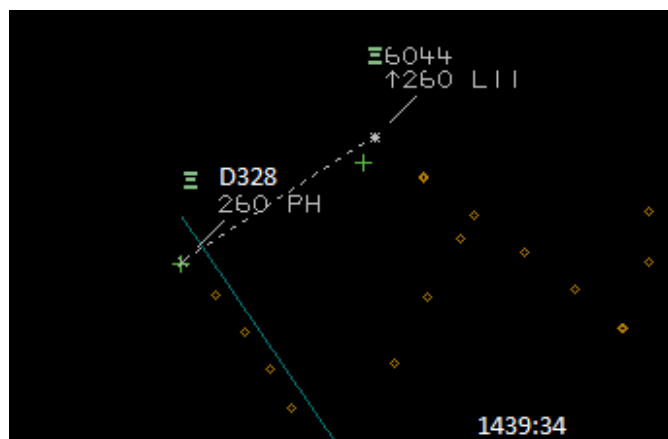
Figure 4.

At 1439:34, a second primary track appeared just to the left of the lead F15. (Figure 4.)

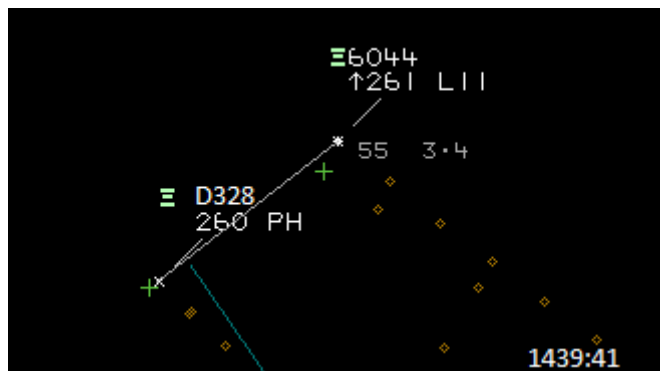
Figure 5.

CPA occurred at 1439:41 (Figure 5) when the Do328 and the transponding F15 were 3.4nm/100ft apart (5nm/5000ft were required). The lateral distance between the Do328 and the primary contact was 3nm.

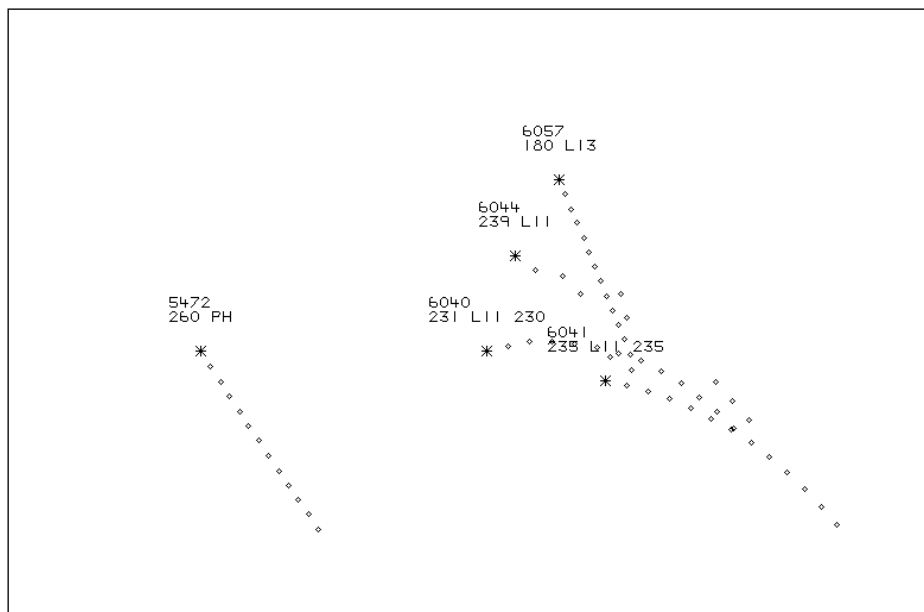
At 1438:24 (Figure 1), the Swanwick controller placed the F15 pilots under a Traffic Service at FL240 and requested if a climb was required. At 1438:29, the F15 pilots requested a climb to FL310.

Figure 1: 1438:24 Traffic Service agreed (F15s 6044, Do328 5472; CAT 6057).

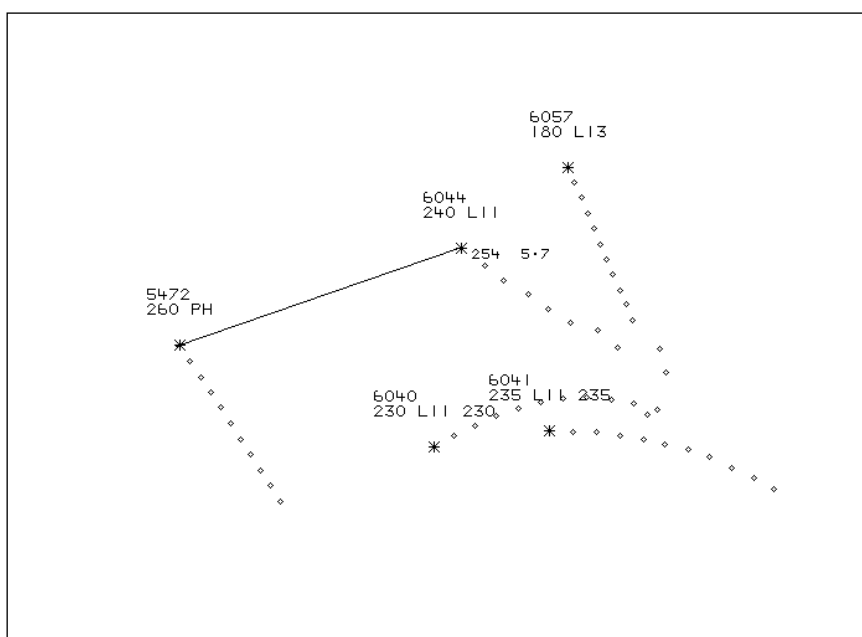
At 1438:38 (Figure 2), the Swanwick controller issued the climb instruction to FL310 to the F15 pilots with 5.7nm horizontal separation on a converging heading.

Figure 2: Climb instruction passed at 1438:38.

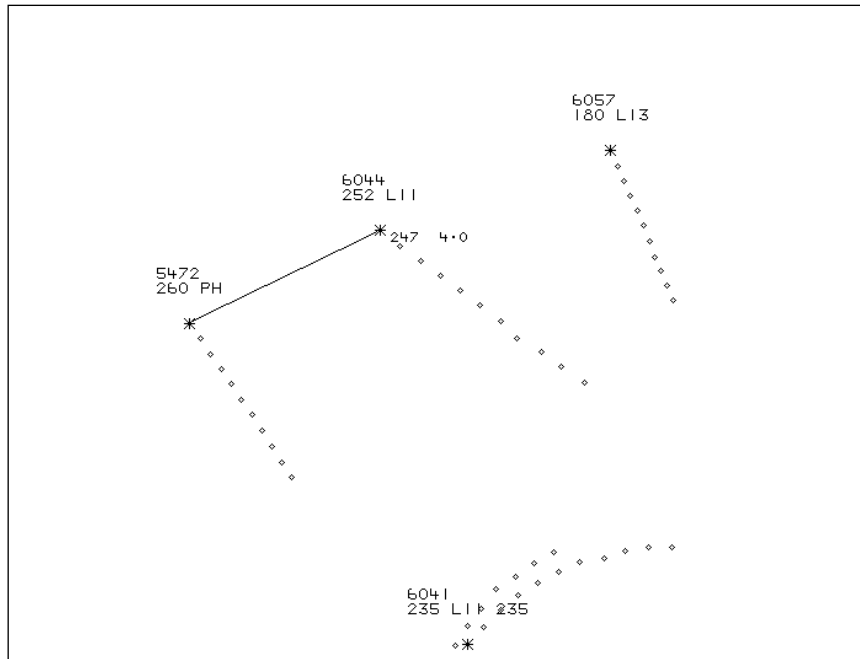
At 1439:14 (Figure 3), the F15s were passing FL252 in the climb with 4nm horizontal separation.

Figure 3: Geometry at 1439:14.

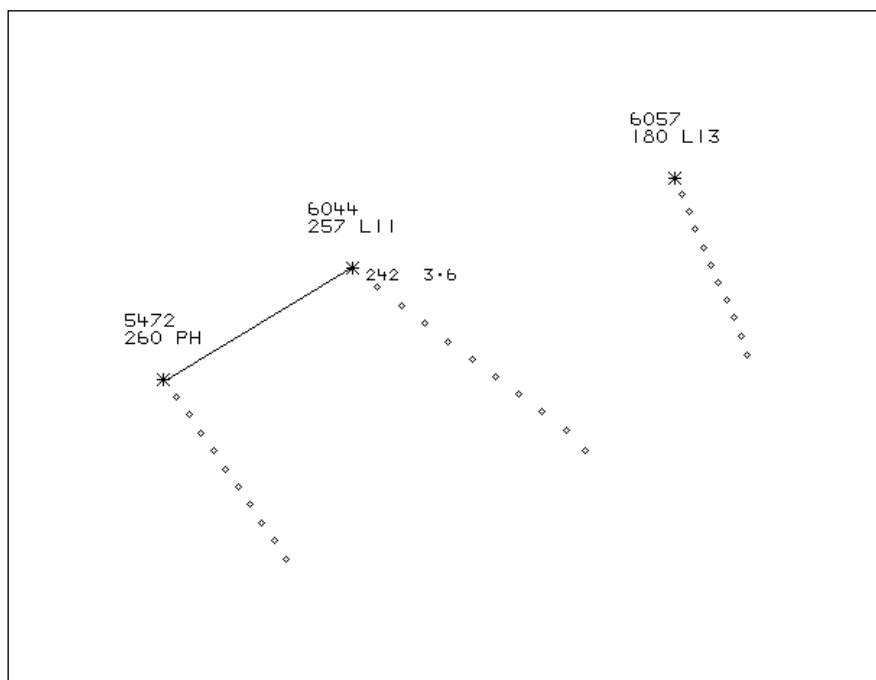
At 1439:27 (Figure 4), Swanwick transmitted to the F15s, "(F15 C/S) avoiding action turn right immediately heading 020 degrees." No information on conflicting traffic was passed at this point.

At 1339:34, the F15 pilot responded with, "er, that'll take us over the water, we're unable."

Figure 4: Avoiding action at 1439:27.

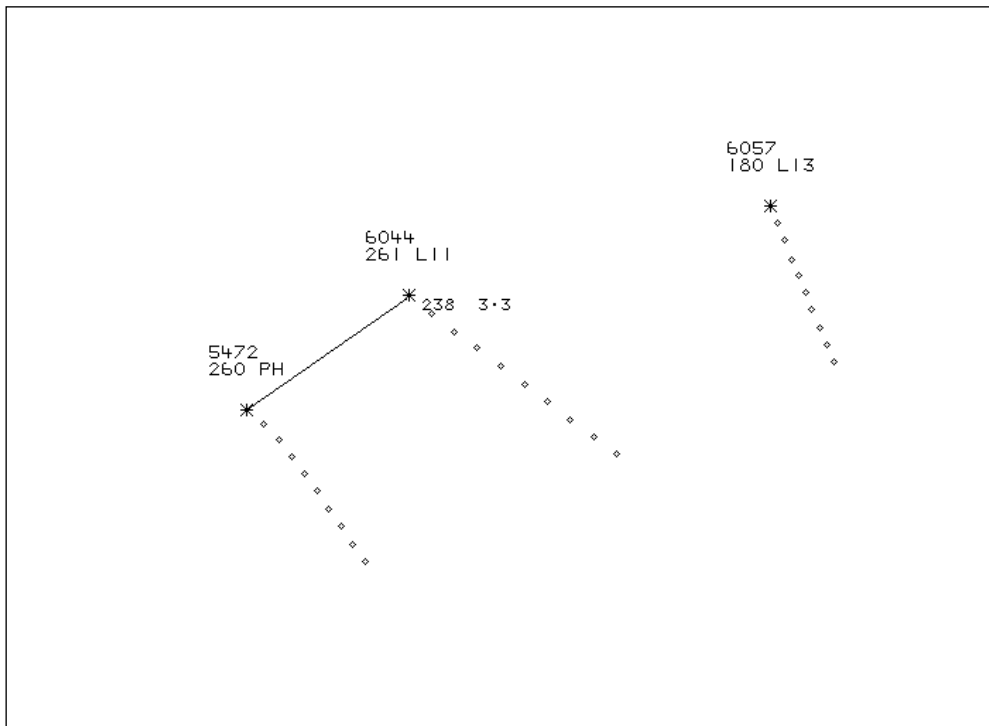
The CPA was estimated at 1439:39 to 1439:43 at 3.3nm horizontally and 100ft vertically. (Figure 5.)

Figure 5: CPA at 1439:41.

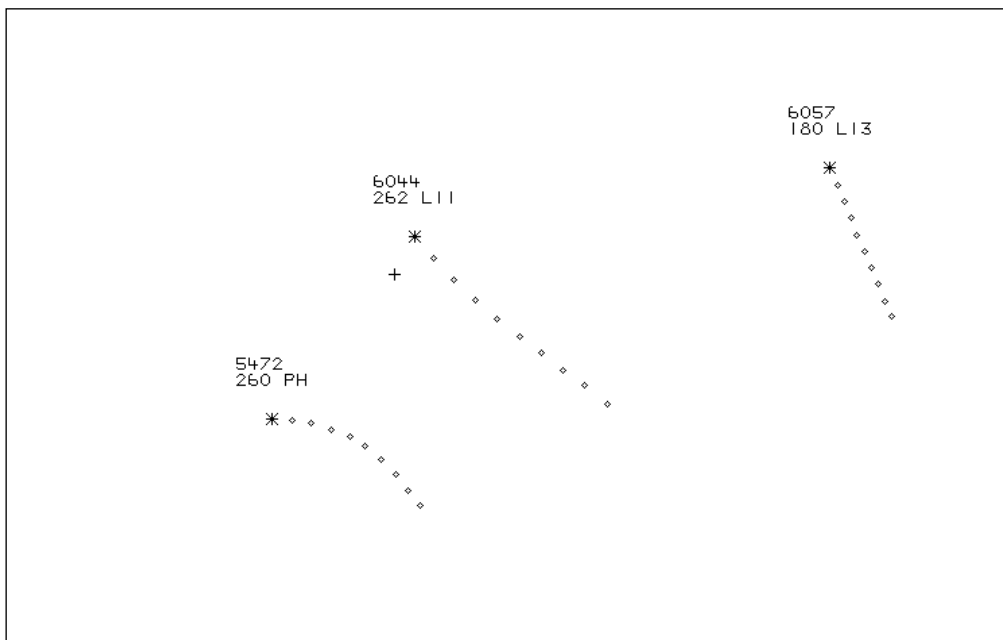
At 1440:00 (Figure 6) the F15 pilots requested heading 350° and the Do328 avoiding action turn is evident.

Figure 6: F15 pilots request for further climb to FL350 at 1440:00.

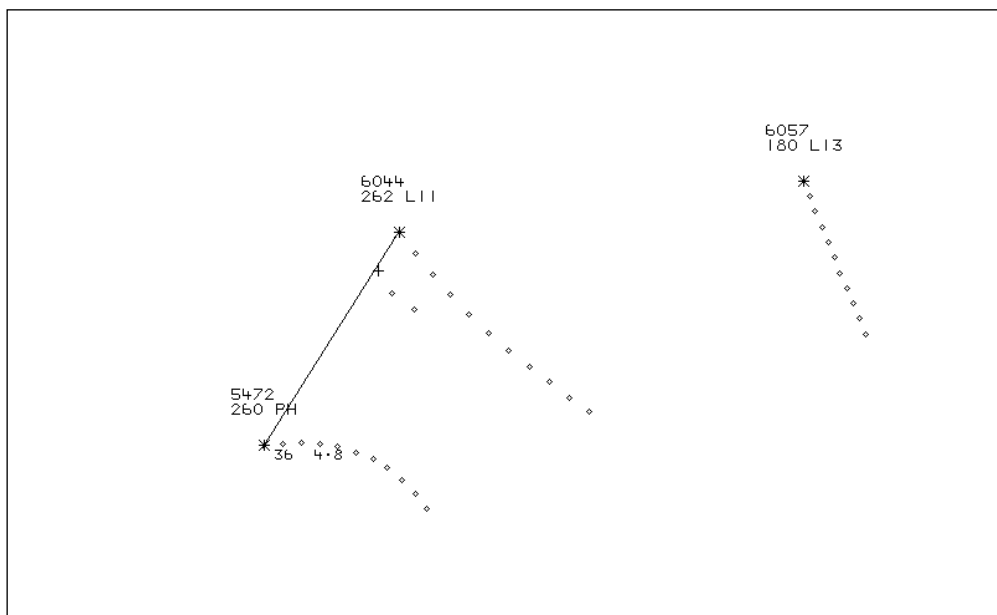
At 1440:06 (Figure 7), Swanwick transmitted, "(F15 C/S) roger, turn right immediately heading 030 degrees."

Figure 7: Further avoiding action turn at 1440:06.

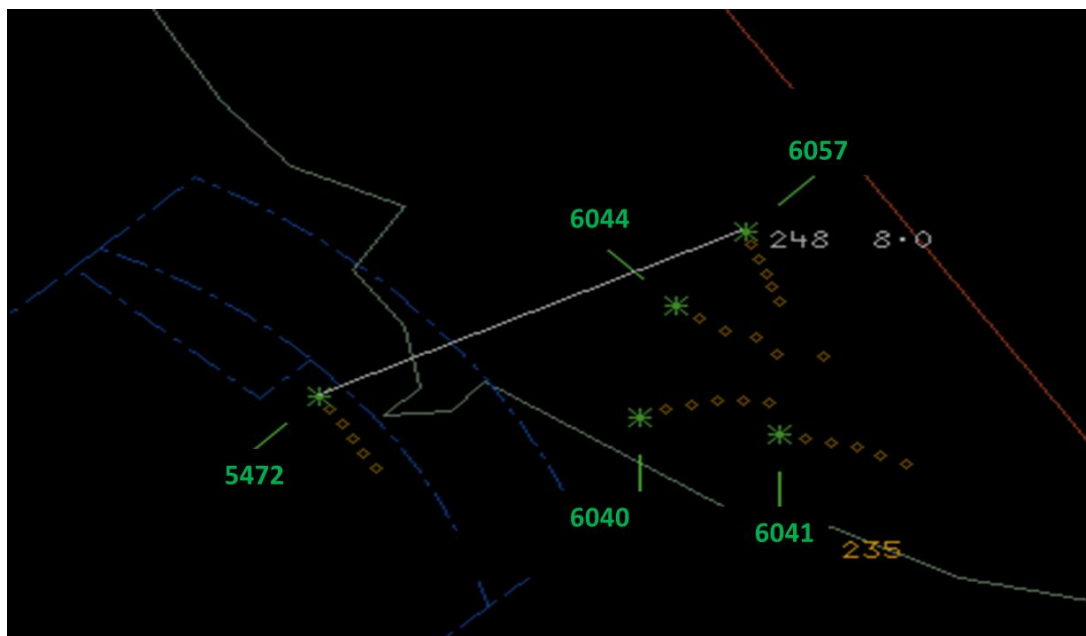
The local investigation reviewed the incident using the radar picture used by the Tac controller. Prior to identifying the F15s, the controller had to manipulate the data blocks, because four were in close proximity, and inadvertently 'hooked' onto the wrong (6057) aircraft. (Figure 8.)

Figure 8 controller 'hooking' the incorrect callsign at 1438:29.

HMI. The controller 'hooked' the wrong aircraft possibly because of the close proximity of four aircraft returns the range of the display and an incorrect procedure. The fact that the F15 callsign had not been paired to the flight strip possibly delayed highlighting issues to the controller. The STCA was a valuable safety barrier that would have assisted ATC and is

The controller fully acknowledged the error in the unit investigation. RAF (U) Swanwick recommended reinforcing HMI skills and reminded controllers to update type of service and provide standard avoiding action phraseology. The unit reviewed ways of adequately briefing controllers of crew restrictions, and a safety survey into the lack of STCA in the sector would be completed.
