### **AIRPROX REPORT No 2015063**

Date: 2 May 2015 Time: 1018Z Position: 5151N 00026E Location: 7.5nm ESE Stansted

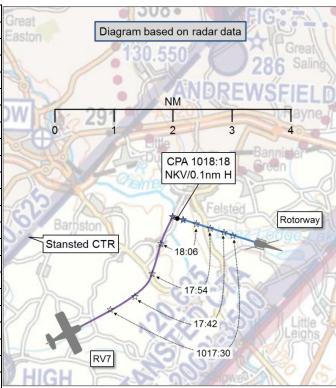
THE ROTORWAY PILOT reports transiting to a private site 2nm southeast of Stansted Airport. He was about to enter the CTR when a yellow, low-wing, single-engine aircraft passed in front of him from left to right, co-altitude and at a distance of about 50ft. The pilot stated that he did not have time to react to the other aircraft's presence.

He assessed the risk of collision as 'High'.
