## AIRPROX REPORT No 2015065

Date: 13 May 2015 Time: 1729Z Position: 5253N 00100W Location: IVO Nottingham

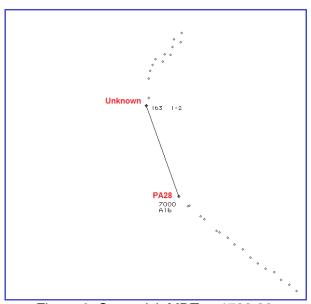
Figure 2: Swanwick MRT at 1728:26

The two aircraft continued to converge and, at 1728:26, the PA28 was shown displaying the general conspicuity code 7000 with the unknown contact in the PA28's 1 o'clock at a range of 1.2nm, see Figure 2.
