AIRPROX REPORT No 2015078

Date: 3 Jun 2015 Time: 1400Z Position: 5206N 00214W Location: Great Malvern

PART A: SUMMARY OF INFORMATION REPORTED TO UKAB

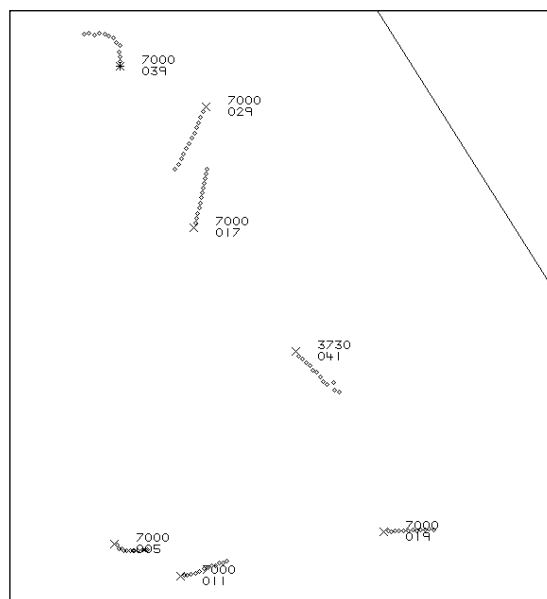
The CPA was estimated at 1350:50 (Figure 1) although no primary return appeared on radar.

Figure 1: CPA estimated at 1350:50 (Squirrel squawk 3730).
