AIRPROX REPORT No 2015089

Date: 28 May 2015 Time: 1350Z Position: 5109N 00259W Location: 1nm N Bridgewater

PART A: SUMMARY OF INFORMATION REPORTED TO UKAB

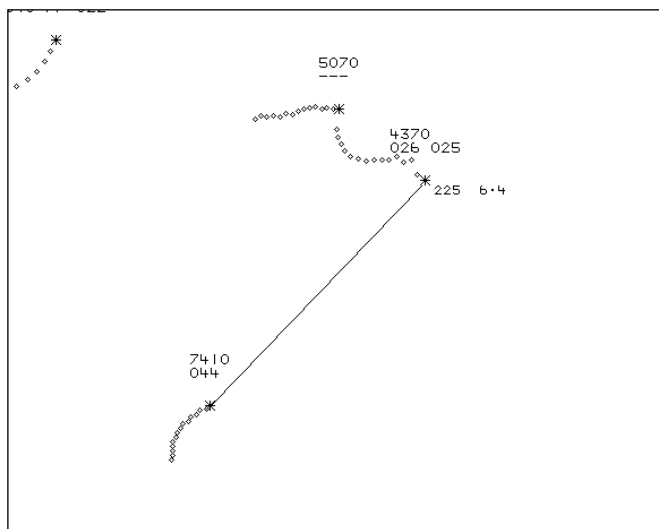
At 1346:47 (Figure 1), Yeovilton Approach called traffic to the Sea King as, "*north east at 5 miles, tracking south-easterly 2000 feet below.*" The crew responded that they were looking for the traffic.

Figure 1: Traffic Information at 1346:47 (Sea King squawk 7410; DA42 squawk 4370)

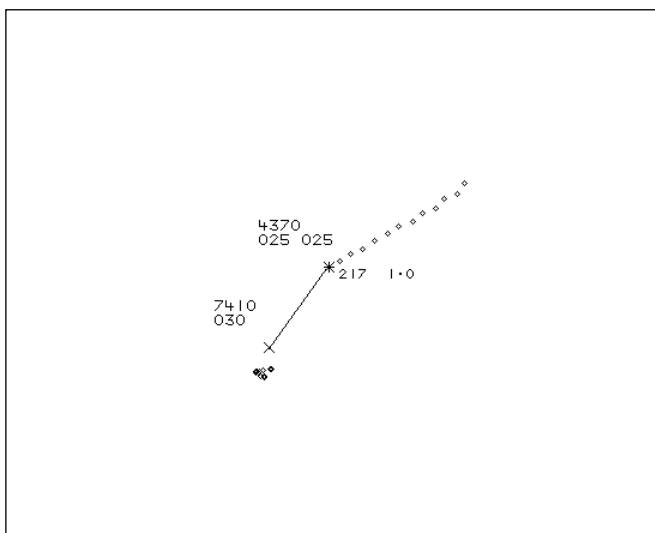
At 1349:31 (Figure 2), Approach transmitted, “*previously called traffic now 1 mile, north, tracking south west 200 feet below.*”

Figure 2: Traffic Information update at 1349:31

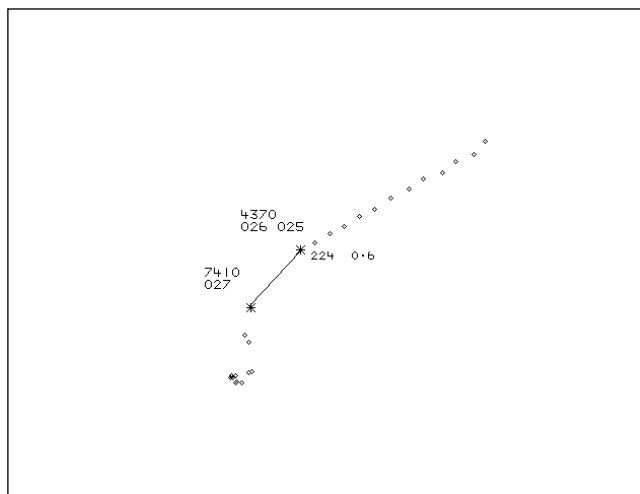
The crew responded at 1349:38 (Figure 3), that they were taking avoiding action.

Figure 3: Avoiding action taken at 1349:38

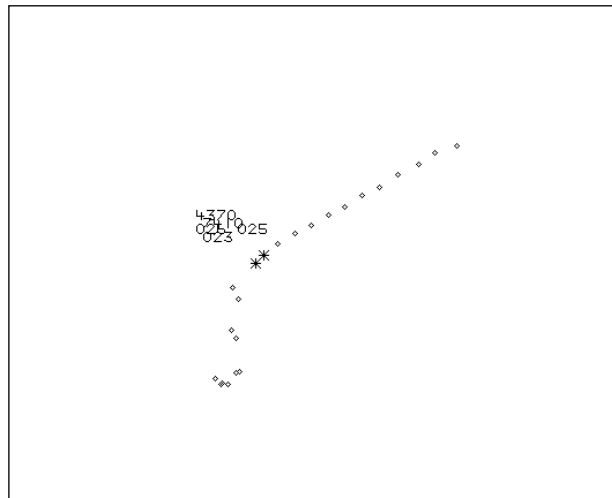
At 1349:42, the aircraft were at the same height with 0.3nm horizontal separation. The CPA was estimated at 1349:50 (Figure 4) with <0.1nm horizontal separation and 200ft height separation and the Airprox was declared at 1349:58.

Figure 4: CPA estimated at 1349:50
