AIRPROX REPORT No 2015115

Date: 20 Jul 2015 Time: 1817Z Position: 5405N 00437W Location: Ronaldsway, Isle of Man

PART A: SUMMARY OF INFORMATION REPORTED TO UKAB

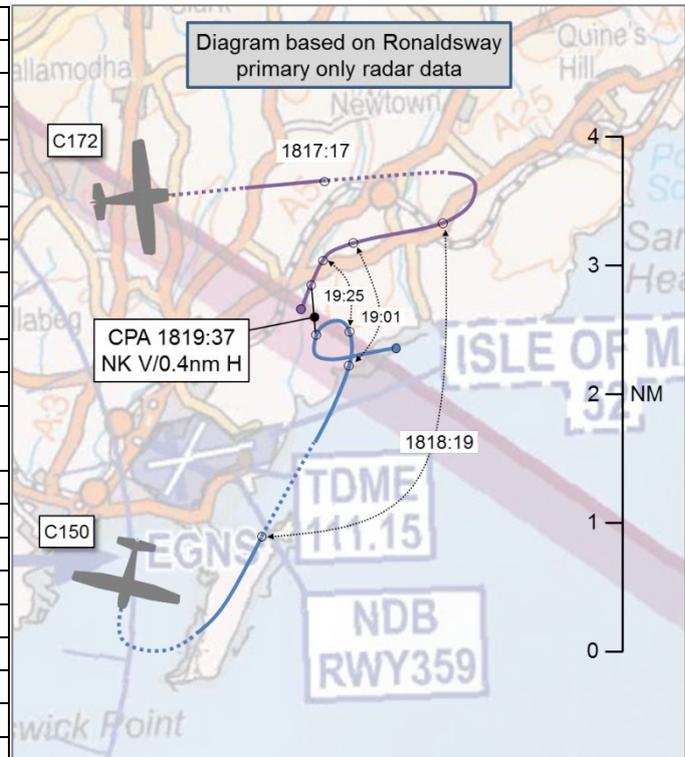
THE RONALDSWAY AERODROME CONTROLLER reports RW26 and RW21, both left-hand, were in use but that the surface wind was favouring RW21 for circuit training. There was low cloud to the north of the aerodrome, affecting the area around the RW21 final approach. The SSR was unserviceable following a failure earlier in the day, so the ATM was displaying watchman PSR-only returns. These were somewhat limited due to the small radar cross-section of the traffic and proximity to the antenna. The C150 and a PA28 [not involved in the Airprox] were left hand in the circuit. Shortly before the incident, the controller had resolved a potential conflict between an IFR inbound, landing from an ILS approach to RW26, and the circuit traffic. This had required the C150 to hold south of the RW26 final approach track. At this time, the Approach controller called to coordinate the VFR arrival of the C172 from the northwest, requesting to land RW21. Considering the traffic situation, and the ILS traffic's potential for go-around, the controller asked the Approach controller to route the C172 initially towards the IOM VOR. On his first call on the frequency, the C172 pilot advised the controller of his routing as passed by Approach. The controller asked him if he would prefer a left- or right-hand circuit, to which he replied that he would accept a right-hand circuit. At this time the C150 was on a 'tight left base' for RW21, and the PA28 was commencing a long LH downwind leg, having been given a long climb out for delaying action against the C150 initially holding ahead. The C172 pilot reported turning toward right base RW21 and, once the C150 was on very short final, the controller asked the C172 pilot whether he was visual with the PA28, left-hand downwind. After initially saying negative. He then replied 'affirm'. The controller instructed him to 'report final number 2' which was read back. The C150 became airborne; the PA28 pilot reported final and the controller cleared him for a touch-and-go. The radar return for the C172 at this time was tracking due east towards about a 2 mile final for RW21, but on a closing heading of around 120° rather than base leg. The controller observed the C172 primary return fly obliquely through final, continuing east. At this point the C150 was airborne, turning left crosswind, and the PA28 was on the

At 1817:45, the controller asked the C172 pilot if he was visual with RW21 which, after a pause, he confirmed was just coming into view. At 1818:30, the controller issued Traffic Information to the C150 pilot, who was now downwind, advising that the C172 appeared to have flown through the final approach and was turning back from the east.

At 1819:02, the controller instructed the C172 pilot to go-around and asked if he was above cloud to which the pilot confirmed he was. The C150 pilot, now late downwind, had begun his left base turn, which he continued as a left turn, the long way round on to the east, away from the circuit and the potential conflict with the C172 (which had been discussed with ATC) and also due to cloud at the end of the downwind leg. The controller also instructed the PA28 pilot, at the beginning of the downwind leg, to route eastbound in an effort to ensure the C172 would not be a confliction. Extensive Traffic Information to all the pilots concerned was passed, the closest of which was passed to the C150 pilot concerning the C172 in his 12 o'clock at half a mile. This range would have been judged from the primary only ATM, and no height information was available. The controller then acquired the C172 visually and was able to return the other aircraft to the circuit whilst routing the C172 pilot towards an approach to RW26.

After considerable discussion, members agreed that the cause of the Airprox was that the C172 pilot had lost sight of the airfield and, having been told to go around by the controller, had then flown close enough to the C150 to cause the controller concern. Members also discussed the risk at length, but eventually concluded that the lack of either altitude information or any assessment from the pilots (who had not seen each other) rendered a meaningful finding impossible.

Cause: The C172 pilot lost sight of the airfield and flew close enough to the C150 to cause ATC concern.
