AIRPROX REPORT No 2015132

Date: 31 Jul 2015 Time: 1620Z Position: 5240N 00019E Location: 9nm W Marham

PART A: SUMMARY OF INFORMATION REPORTED TO UKAB

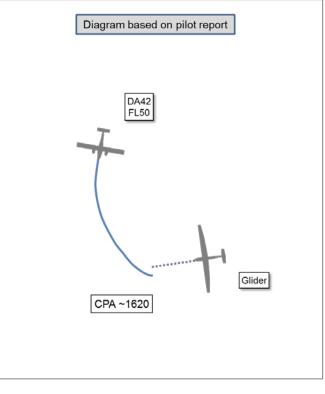
The DA42 pilot's reported time and location of the Airprox did not match with radar recordings. The time and location of CPA is based on the reported heading of 130° and the DA42 being at FL50, shortly before descending on the TACAN approach profile. A sharp turn is also apparent on the radar recording, which is inconsistent with the DA42's previous and subsequent track. The DA42 pilot was not able to provide further clarification of the circumstances of the Airprox.
