AIRPROX REPORT No 2015149

Date: 29 Aug 2015 Time: 1308Z Position: 5113N 00005W Location: Godstone Station VRP

PART A: SUMMARY OF INFORMATION REPORTED TO UKAB

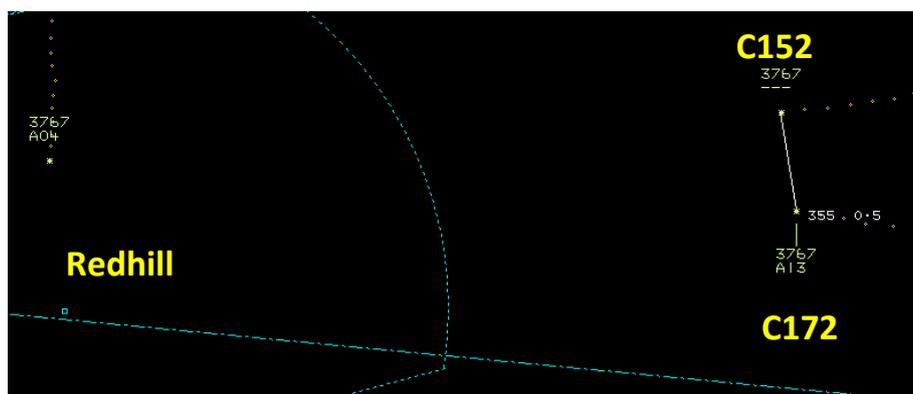
Figure 1 – 1307:01

At 1307:01 the C152 pilot reported at the Godstone Railway Station VRP, adding that they were ahead and to the north of the C172. The controller cleared the C152 to the overhead (Figure 1).

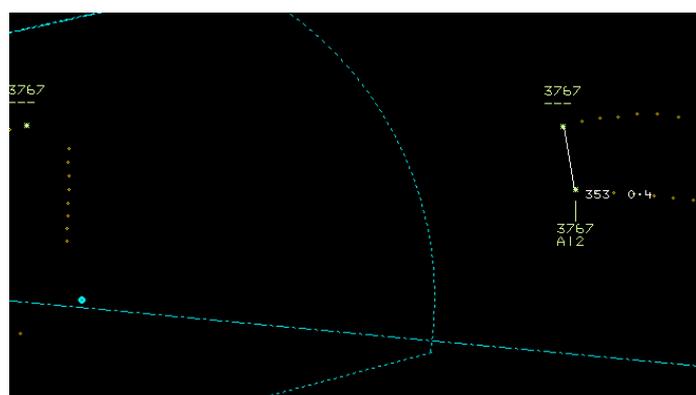
Figure 2 – 1307:37

At 1307:12 the C172 pilot reported directly overhead the VRP and so the controller changed the sequence, instructing the C152 to continue for a straight-in approach for RW26, and the C172 to route to the airfield overhead. The pilot of the C152 also then reported to Redhill ATC that the C172 was above and behind their aircraft. (Figure 2).

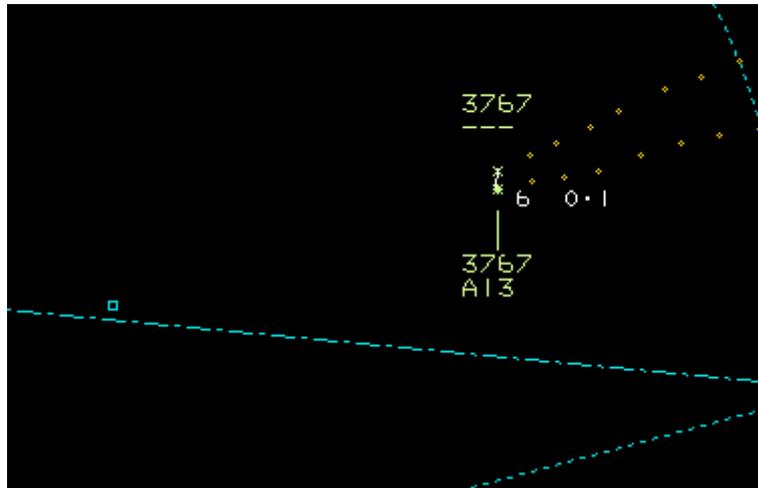
Figure 3 – 1308:34

The Airprox report from the pilot of the C172 suggested that CPA took place following this sequence of instructions from ATC, estimated to be 1307:40. On radar, CPA took place at 1308:34, with only the C172 transponding Mode C altitude. (Figure 3).

The secondary radar return of the C152 in Figure 3 had been lost, and was now primary-only, and the aircraft disappeared fully from radar shortly afterwards, suggesting a descent by the C152.
