AIRPROX REPORT No 2015201

Date: 4 Nov 2015 Time: 0859Z Position: 5145N 00005W Location: Brookmans Park (BPK)

PART A: SUMMARY OF INFORMATION REPORTED TO UKAB

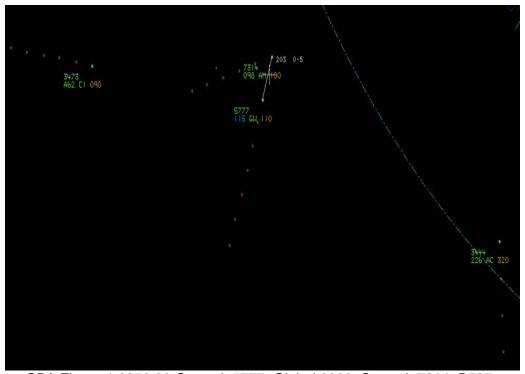
Radar recordings show that the Global 6000 pilot was descending at approximately 1500fpm after passing FL122. However, the B737 pilot was climbing at between 3000-4500fpm on approaching FL93, this then decreased to approximately 1500fpm on approaching his cleared limit of FL100; he levelled at FL98.

CPA Figure 1 0859:28-Squawk 5777=Global 6000. Squawk 7314=B737.
