AIRPROX REPORT No 2014007

Date/Time: 27 Jan 2014 1256z

Position: 5536N 00125W
(55 ne Newcastle)

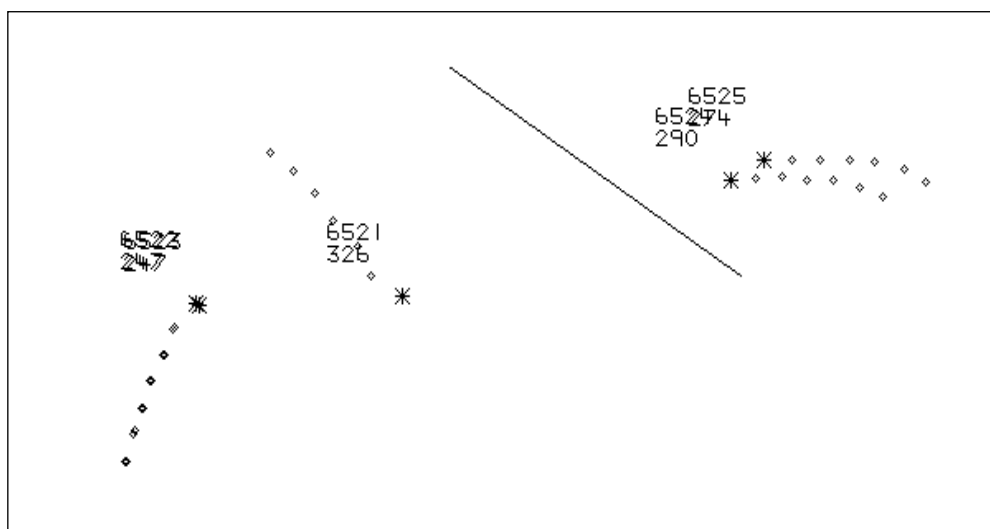
Figure 2: Aircraft geometry at 1255:16. (Typhoon 6521; Hawk 6523, FA20 6524/6525)

At 1255:16, the Hawks declare that they are in a right-hand turn heading onto south descending through FL240, as per Figure 2.

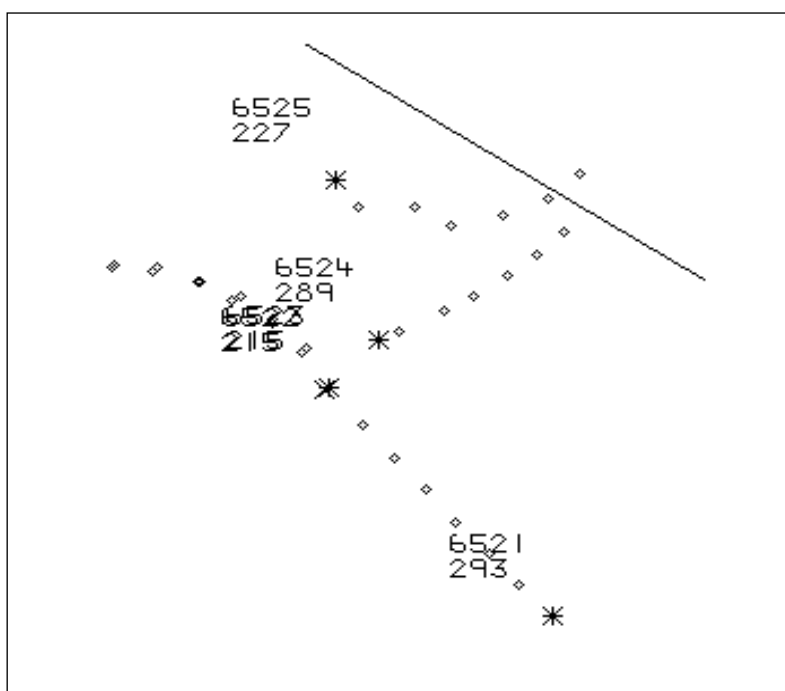
Figure 3: Aircraft geometry at 1255:57.

At 1255:21 the WC informs the Falcons, “for your descent maintain [inaudible] a heading of 270 that will keep you clear of both other players.” The Falcon callsign confirms a heading of 270 degrees at 1255:28 and requests, “maintaining heading of 270 and we’re looking for the block 19...FL190, 180.” At 1255:34, the WC replies with “Roger”, as the Hawks were indicating FL233 and the aircraft were on reciprocal headings with 6.5 nm separation. At this point the Falcon 2 aircraft (squawk 6525) had descended below Falcon 1 (squawk 6524) and the labels are just beginning to separate on the radar replay. As depicted in Figure 3, at 1255:57, the Falcon informs the Hawk, “passing above westbound.”
