AIRPROX REPORT No 2014027

Date/Time: 5 Mar 2014 1050Z

Position: 5049N 00111W
(Lee on Solent)

Type: Defender Mk2 ASK21

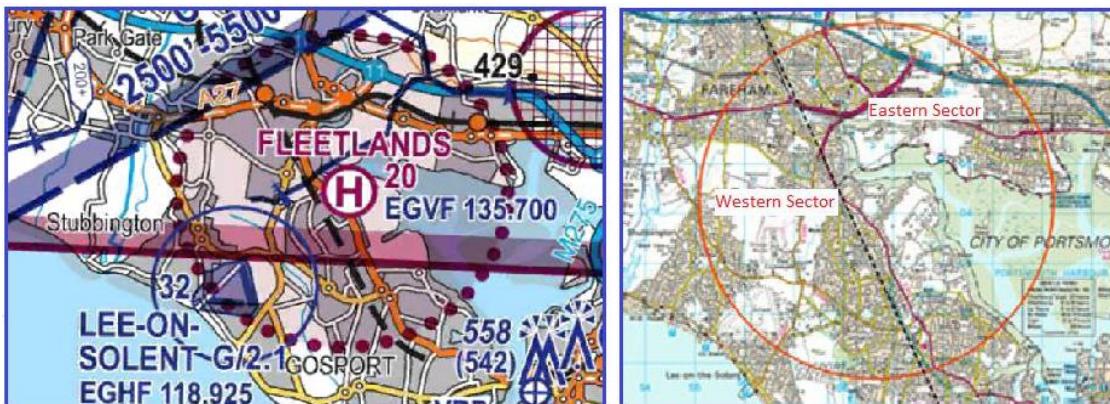
Figure 1:Topographical Chart 1:250,000 Figure 2: Chart extract from Lee on Solent visitors Guide

Lee on Solent is an unlicensed airfield situated 1.9nm southwest of Fleetlands Heliport and lies partly within the Fleetlands ATZ as shown on the Topographical Air Chart of the UK 1:250,000 South (Ed.16), see Figure 1 below. Page 2 of the 'Lee-on-Solent Airfield Visitors Guide' provides a chart together with guidance on joining procedures and states: 'When Fleetlands Information is operating, they may be contacted for information, but, it is not necessary if remaining clear of the Eastern Sector.' The guide provides a chart showing the Eastern Sector, see Figure 2. For RW23, the circuit direction for powered aircraft is right-hand and, for gliders is left-hand.

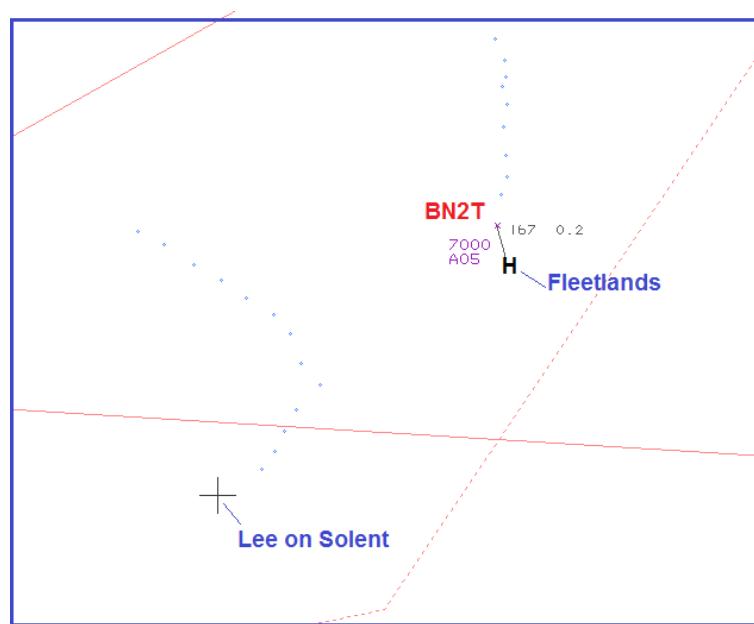
Figure 3: Swanwick MRT at 1050:11

At 1048:17, radar recording showed the Defender, 4.3nm north of Lee on Solent, squawking 7000 and indicating FL012 (Altitude 1416ft QNH 1021hPa). In discussion, the A/G operator reported that the Defender pilot had contacted Lee Radio reporting inbound from the north for a right base join for RW23. He had advised the Defender pilot that gliding was active. Radar recording showed the Defender pilot enter the Fleetlands ATZ from the north and route towards Fleetlands Heliport. The Defender pilot commenced a right turn and, at 1050:11, passed 0.2nm northwest of Fleetlands at an indicated altitude of 500ft, see Figure 3

The A/G operator recalled that the Defender pilot had called on right base but was not seen and he suspected that the Defender pilot had completed a wide circuit and was on long final. This was confirmed when Fleetlands called to advise that the Defender pilot had penetrated their ATZ without calling them. The A/G operator outlined how inbound aircraft normally approach within the western sector keeping clear of Fleetlands.
