PART A: SUMMARY OF INFORMATION REPORTED TO UKAB

An Airprox was reported between a Merlin and a PA28 on 30 April 2014 at 1545. The Merlin received Traffic Information from Benson ATC, although it is unclear whether this was in fact on the PA28, and then switched to Luton for a listening watch. The PA28 was receiving a Basic Service from Farnborough LARS (North).

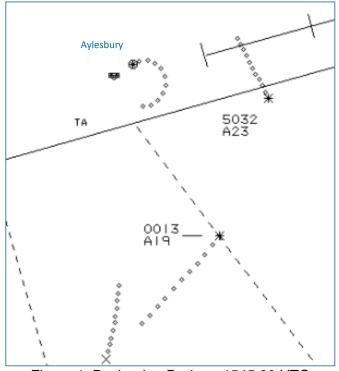
Figure 1: Bovingdon Radar - 1545:00 UTC

The PA28 called Farnborough using the 'student' callsign at 1512:30 UTC and requested a Basic Service. The London QNH 1011hPa was passed, squawk 5032 assigned, and a Basic Service agreed. The PA28 reported leaving the Farnborough frequency at 1526:30 to call Turweston and returned to the Farnborough frequency at 1536:20. No further calls were received from the PA28 until 1552:10 when the pilot requested to leave the frequency for Denham. At 1545:00 the two aircraft were on converging tracks southeast of Aylesbury aerodrome (Figure 1).

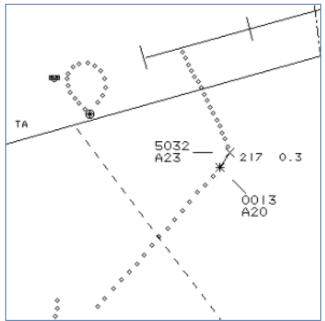
Figure 2: Bovingdon Radar 1545:38 UTC

The aircraft continued on their respective tracks until, at 1545:38, the PA28 appeared to be in the Merlin's 12 o'clock at a range of 0.3nm and 300ft above (Figure 2).

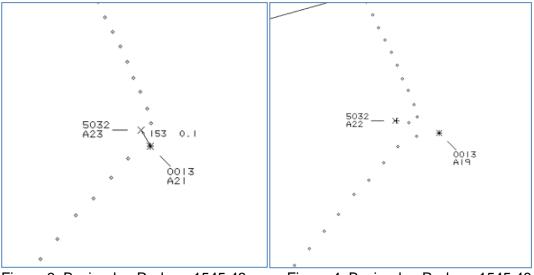
Figure 3: Bovingdon Radar – 1545:43

On the next update of the radar the two aircraft were executing right turns and passing at a distance of 0.1nm and 200ft (Figure 3). They continued to track away from each other in opposite directions and the Merlin had descended 200ft (Figure 4).
