### **AIRPROX REPORT No 2014091**

Date/Time: 8 Jun 2014 1117Z (Sunday)

Position: 5109N 00037E

Airspace: Lashenden ATZ (Class: G)

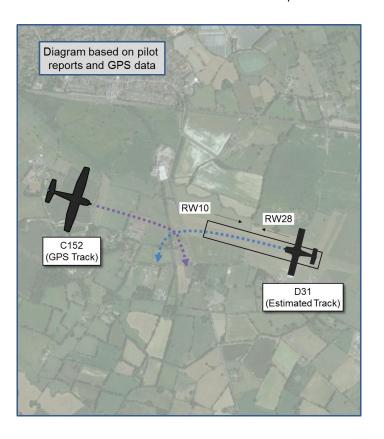
Figure 1. Example Heading Indicator

THE C152 PILOT reports flying a white and blue aircraft, VFR in VMC, heading 100° at 65kt, with no external lighting and squawking transponder Modes 3/A and C. Whilst on final-approach to RW10, at about 300ft agl, he saw the shadow of an aircraft on the grass runway and looked up to see the other aircraft ahead of him. He immediately applied full-power and made a steep turn to the right onto south. In a thorough self-assessment, the pilot reported that he was aware that RW28 was in use, but assessed that he had lined up on RW10 due to a cognitive error; he had developed a mental model of the runway running from west-to-east because he had used the Heading Indicator as a visual aid to line up on the runway and had confused the numbers '30' at the bottom of the Heading Indicator display with the runway '28' markings painted at the threshold.
