## **AIRPROX REPORT No 2014126**

Date/Time: 30 Jul 2014 1418Z

Position: 5211N 00030W  
(3.5nm NW Bedford)

Type: Jetstream 31              Untraced glider

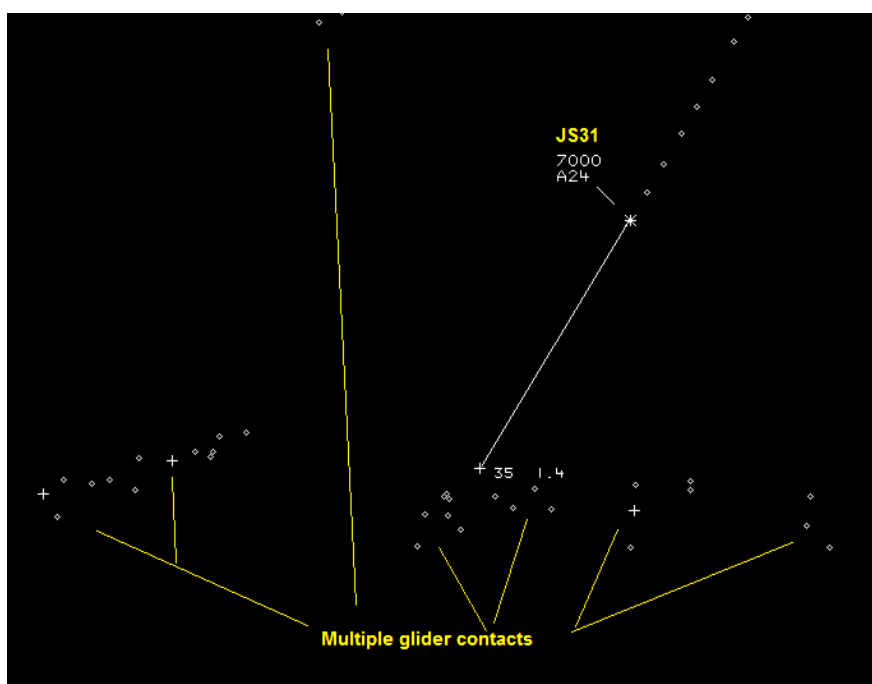
Figure 1: Swanwick MRT at 1417:11

At 1414:17, the controller cleared the Jetstream pilot for a straight-in approach to RW21 with QNH 1015hPa and provided Traffic Information on other instrument traffic at 5nm. This was acknowledged by the Jetstream pilot who advised that he would keep his speed back descending from 2500ft. At 1417:11, radar recording showed the Jetstream 9.5nm from the airfield at 2400ft with 6 intermittent radar contacts ahead. One contact was in the Jetstream pilot's 12 o'clock position at a range of 1.4nm, which subsequently faded from radar, see Figure 1.

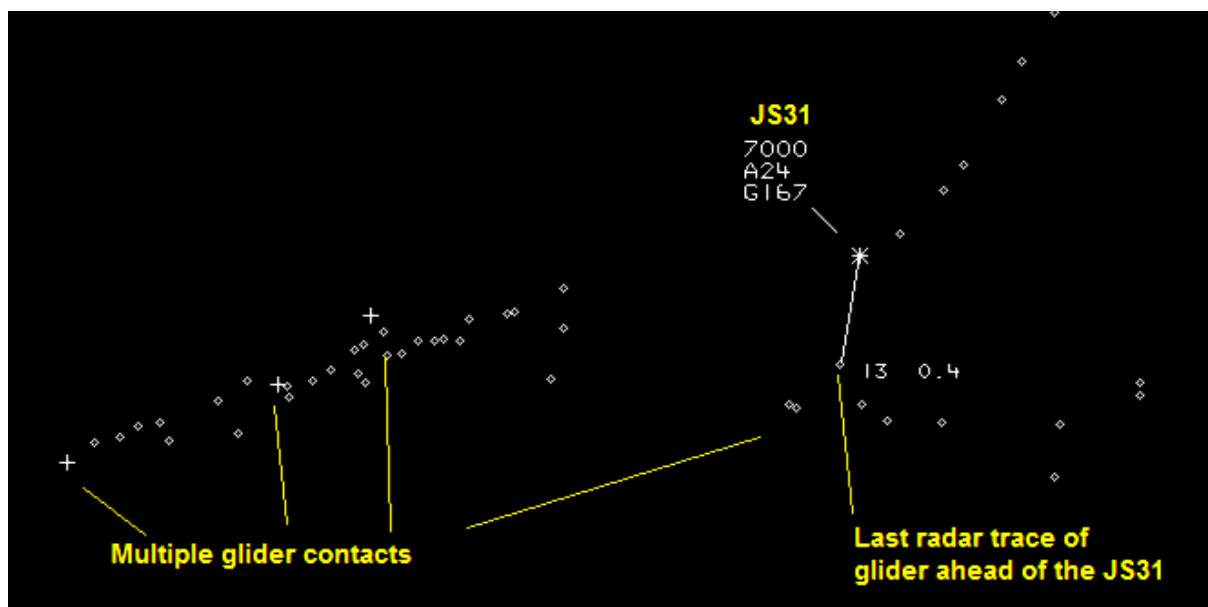
Figure 2: Swanwick MRT at 1417:35

At 1417:35, the Jetstream pilot reported “[JS31 C/S] *we’ve just taken avoiding action against a glider which I make it two thousand five hundred feet and I can count six gliders*”. The controller acknowledged “Roger”, see Figure 2.

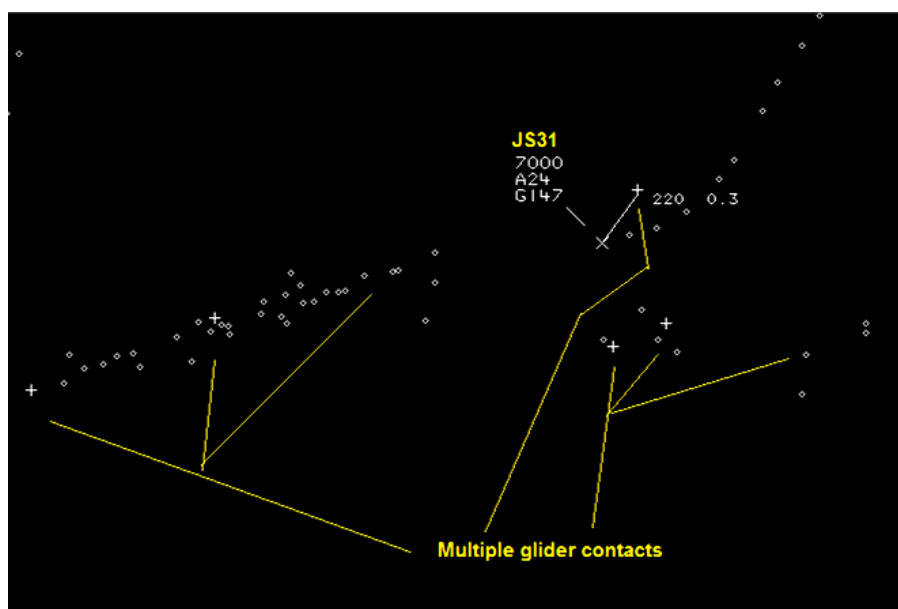
Figure 3: Swanwick MRT at 1417:44

At 1417:44, the Jetstream is shown to have passed a glider contact on the right hand side but it was not possible to determine which glider had been involved in the Airprox, see Figure 3.
