PART A: SUMMARY OF INFORMATION REPORTED TO UKAB

An Airprox was reported on 7 Aug 2014 at 1620 when a Tutor and a S76 flew into proximity at about 2000ft SW of Peterborough. The Tutor pilot was conducting a PFL instructional sortie and was receiving a Traffic Service from Lakenheath but did not receive any Traffic Information. The S76 was flying VFR and VMC; he received a traffic alert from his TCAS.

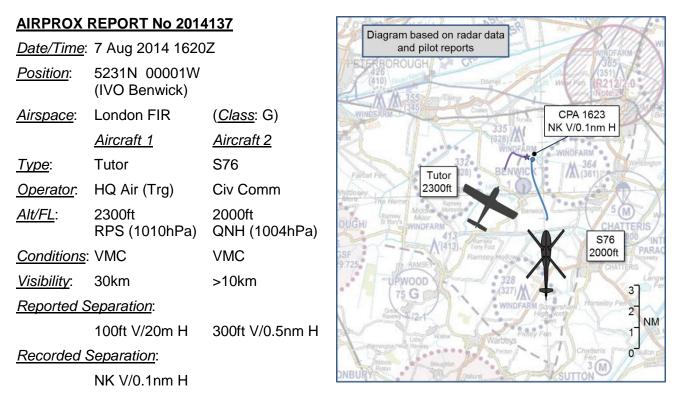
Screenshot 1623:32 with S76 tracking north, Tutor displaying transponder code 0451 (Lakenheath) and tracking east.
