AIRPROX REPORT No 2014149Date/Time: 22 Aug 2014 1410ZPosition: 5106N 00217W
(Bath, Wilts and Dorset Gliding Club)Airspace: Yeovilton AIAA (Class: G)Aircraft 1 Aircraft 2Type: LS4 Glider BE76Operator: Civ Pte Civ TrgAlt/FL: 3600ft 3000ft
QNH (1015hPa)Conditions: VMC VMCVisibility: 30km 5kmReported Separation:

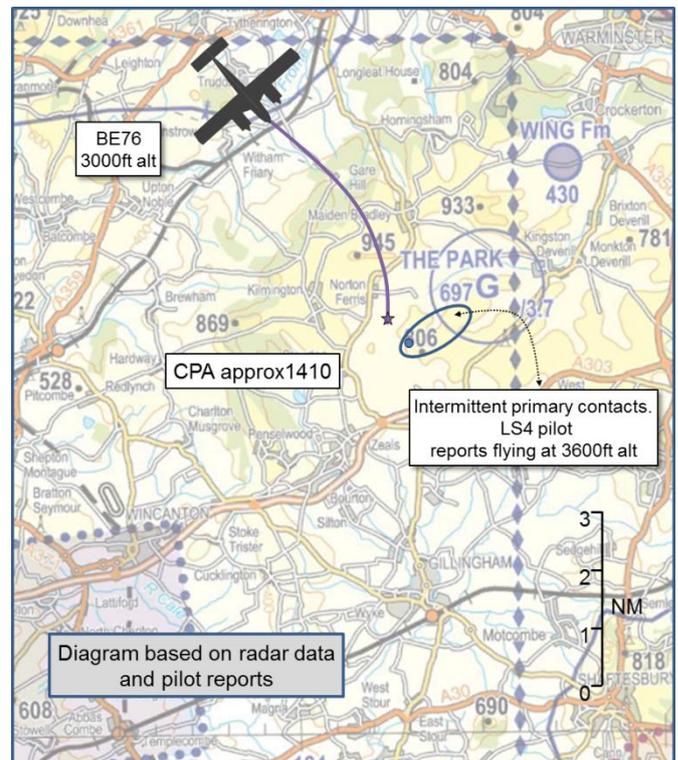
THE LS4 GLIDER PILOT reports flying a white glider with conspicuity markings on the wings and nose. The aircraft was fitted with FLARM. He was thermalling over Zeal airfield whilst listening out on the Bath and Dorset Glider Club frequency. He was keeping a good look-out, ensuring that he checked his 45° arc, when he suddenly saw a two-engine aircraft at a 90° angle off, 400m away heading straight for him. He hoped the thermal would lift him above it, and it didn't seem as if the other pilot took any form of avoiding action as he passed directly underneath him.

THE BE76 PILOT reports flying a white and red aircraft with SSR transponder Modes 3A, C and S selected. The aircraft was not fitted with TCAS or FLARM. He was flying a navigational exercise at 3000ft and he recalled that he was receiving a Basic Service from Yeovil Radar. He had just done a dog-leg to avoid The Park glider site. He first saw a white glider 1nm away, but then it turned left to cross their path. It was slightly higher than him, so he descended to avoid. There were multiple gliders thermalling just below a small patch of cumulus so he couldn't be sure which glider was actually reporting the incident. He opined that the number of gliders around on that day, and the days leading up to it, were hazardous, most don't have transponders, nor are they speaking to anybody. There were three people in his cockpit looking out, yet the gliders were very difficult to spot and he wondered what the solution was to avoid a similar situation in the future.

An Airprox was reported when a LS4 glider and a BE76 flew into proximity at 1410z on 22nd August 2014. Both pilots were operating under VFR in VMC, the LS4 was listening out on the local air-to-ground frequency and the BE76 was receiving as Basic Service from Boscombe Down. The BE76 pilot received Traffic Information from Boscombe Down. The gliders did not show on the NATS radar therefore the exact separation is not known.
