AIRPROX REPORT No 2014151

Date/Time: 14 Aug 2014 0925Z

Position: 5151N 001117W

Airspace: ATZ/London FIR (Class: G)

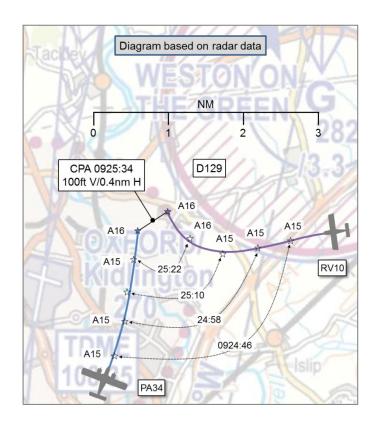
Reported Separation:

50ft V/0.5-1nm H Not seen

Recorded Separation:

100ft V/0.4nm H

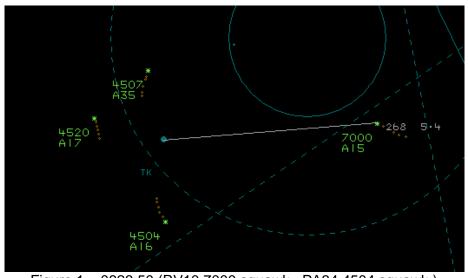
Figure 1 – 0923:50 (RV10 7000 squawk. PA34 4504 squawk.)

At 0923:50, the RV10 pilot contacted OXF Tower when 5.4nm east of OXF (Figure 1.)

The OXF Tower controller advised the RV10 pilot that Weston-on-the-Green and the OXF ATZ were active and requested the pilot's intentions. The RV10 pilot replied that his intentions were to avoid "both the ATZs" and the Aerodrome controller instructed the pilot to remain outside D129 and contact OXF Radar. Traffic Information was passed on the PA34 in the circuit, at 1500ft, just turning downwind.

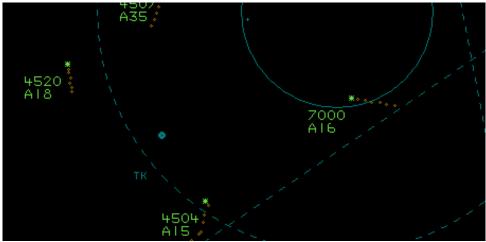
Figure 2 - 0924:30

At 0924:24, the RV10 pilot contacted OXF Radar. The Radar controller advised the RV10 pilot that he believed he was entering a Danger Area active up to FL130 and requested his intentions (Figure 2.)

The RV10 pilot stated that he was just keeping outside the Weston 'Zone' and was routeing "around the edge of your zone en route to Enstone at fifteen hundred feet". The OXF Radar controller advised the RV10 pilot that the Oxford visual circuit was active, left-hand RW19 at 1500ft, and that instrument traffic was also inbound to RW19. Meanwhile the OXF Aerodrome controller passed Traffic Information to the PA34 pilot on the RV10 stating that the RV10 was just on the southern edge of the Weston 'Zone' heading west indicating 1500ft. The OXF Radar controller then informed the RV10 pilot that radar showed that the aircraft was half a mile inside D129. (Figure 3.) At this point area radar recordings show the RV10 just crossing the boundary of D129 having previously entered the danger area by 0.2nm.

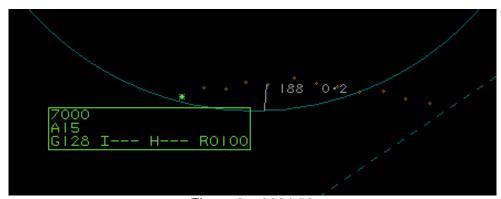
Figure 3 - 0924:50

The pilot apologised and stated that he was routeing clear of D129 and would remain clear of the OXF ATZ. The OXF Radar controller passed Traffic Information on the PA34 stating that the circuit traffic was in conflict with the RV10 in the RV10's eleven o'clock at 1nm. (Figure 4.) The RV10 pilot replied that he was visual with the traffic and would keep to the right of it.

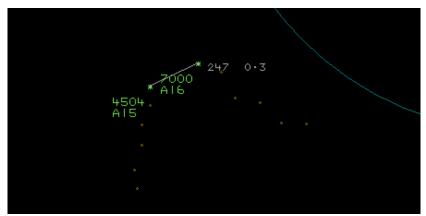
Figure 6 - 0925:34

The two aircraft converged, with CPA occurring at 0925:41, when the two aircraft were 0.3nm horizontally and 100ft vertically apart. (Figure 6 at 0925:34.) The RV10 was 1.9nm from OXF indicating it was inside the ATZ.

The two aircraft subsequently diverged and the RV10 crossed the final approach path en route to Enstone.
