AIRPROX REPORT No 2014230

Date/Time: 14 Dec 2014 1222Z (Sunday)

Position: 5147N 00056W
(Aylesbury/Thame Gliding Site-
elevation 289ft)

Type: EC135 K13 Glider

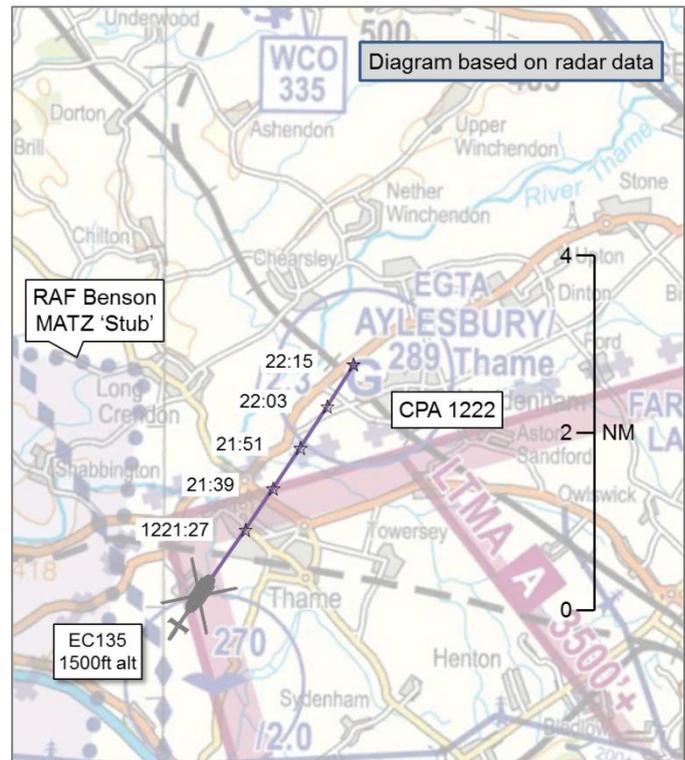
The Airprox occurred in Class G airspace overhead the Aylesbury/Thame Gliding Site. The EC135 pilot, under VFR in VMC, was operating a HEMS Category ‘A’ flight. He realised that his track would take him over the Gliding Site but did not believe that the site was active. However, approaching the overhead he saw a glider being winch-launched. He did not have time to take avoiding action but assessed there was not likely to be a collision although the risk was high. After the glider had been winch-launched the launch controller sighted the opposite direction EC135. An emergency stop signal was broadcast and the winch operator reduced power to stop the ascent. The glider pilot saw the EC135 as the nose of the glider was lowered below the horizon. He reported that it was about 150ft above the glider and 200m in front. The EC135 pilot reported the vertical distance as 300ft.

Turning to the cause, the Board quickly decided that the EC135 pilot had flown through a promulgated and active gliding site and into conflict with the ASK13. With regard to risk, although it was apparent that the 2 aircraft had been very close to each other, the Board concluded that the actions taken by the launch crew had successfully prevented a collision. However, they considered that safety margins had been much reduced below the normal, and the Airprox was consequently assessed as risk Category B.

Cause: The EC135 pilot flew through a promulgated and active gliding site and into conflict with the ASK13.
