AIRPROX REPORT No 2013070

Date/Time: 9 Jul 2013 1845Z

Position: 5501N 00128W
(8nm ESE NATEB)

Airspace: UAR UL602 (Class: C)

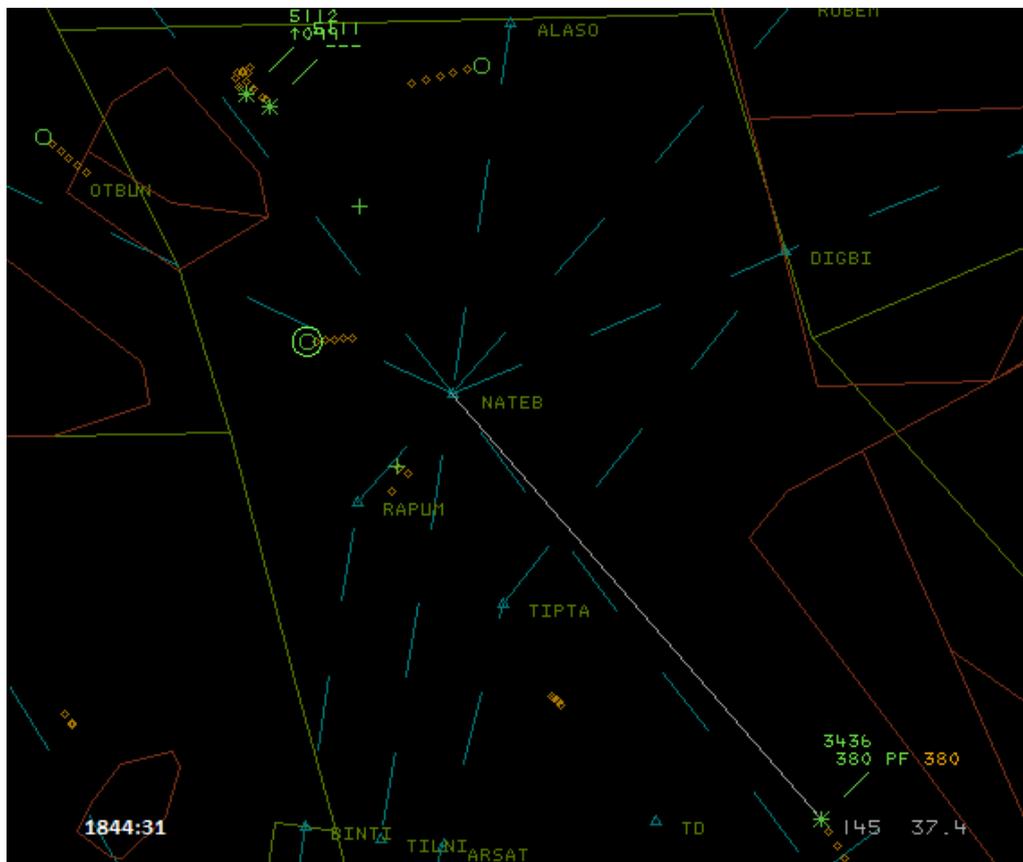
Figure 1

At 1844:31 the B777 was 37.4nm SE of NATEB at FL380 (Figure 1). The Montrose controller instructed the B777 to descend when ready FL260.

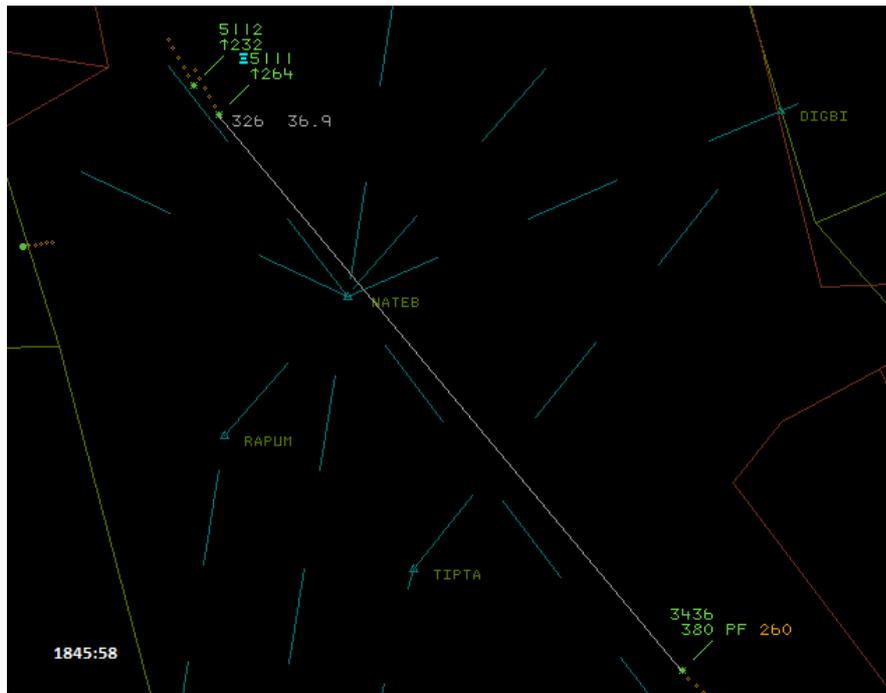
Figure 2.

At 1845:58 the Montrose controller, having observed the 5111 and 5112 squawks climbing, cancelled the B777's descent (Figure 2), and instructed the crew to maintain FL380 (the Montrose controller was planning for 5000ft separation against the Typhoons). The B777 replied that they had just started descent. The Montrose controller instructed the B777 to maintain FL360 due to unidentified military traffic whereupon the B777 replied that they were maintaining FL380.

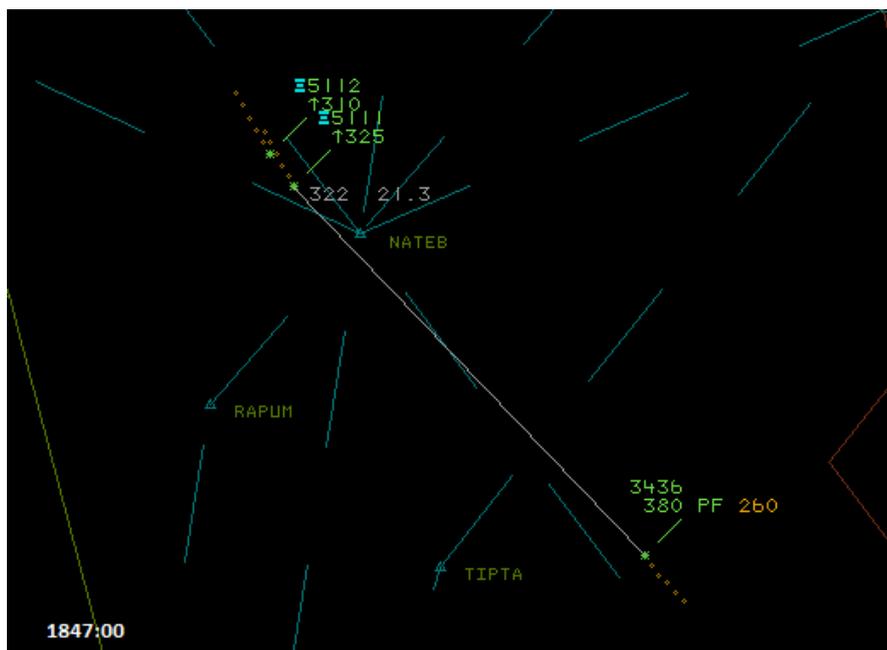
Figure 3.

At 1847:00, as the 5111 squawk was climbing through FL325, the T controller issued avoiding action to the B777, instructing the crew to turn right immediately heading 060° (Figure 3).

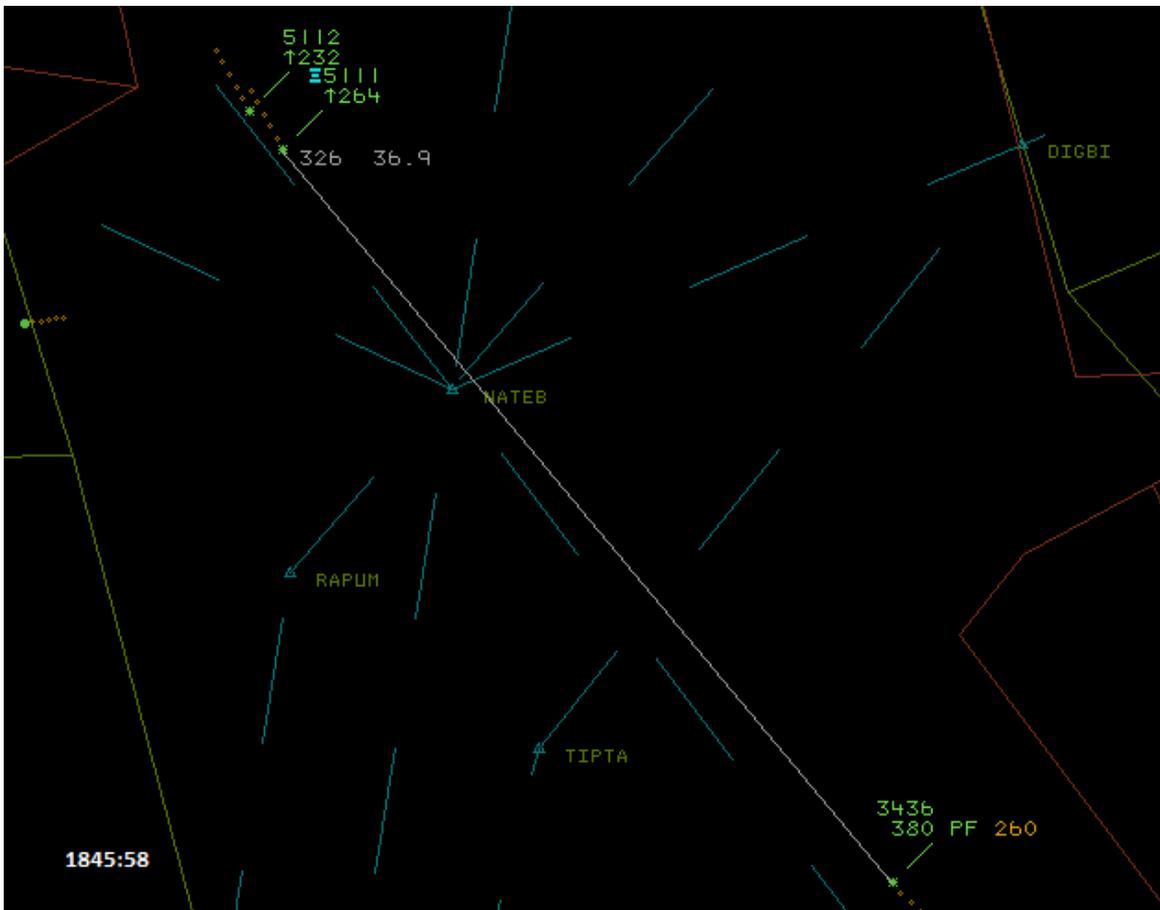
Figure 2.

2.2 At 1845:58 the Montrose controller, having observed the 5111 and 5112 squawks climbing, cancelled the B777's descent (Figure 2), and instructed the crew to maintain FL380 (the Montrose controller was planning for 5000ft separation against the Typhoons). The B777 replied that they had just started descent. The Montrose controller instructed the B777 to maintain FL360 due to unidentified military traffic whereupon the B777 replied that they were maintaining FL380.

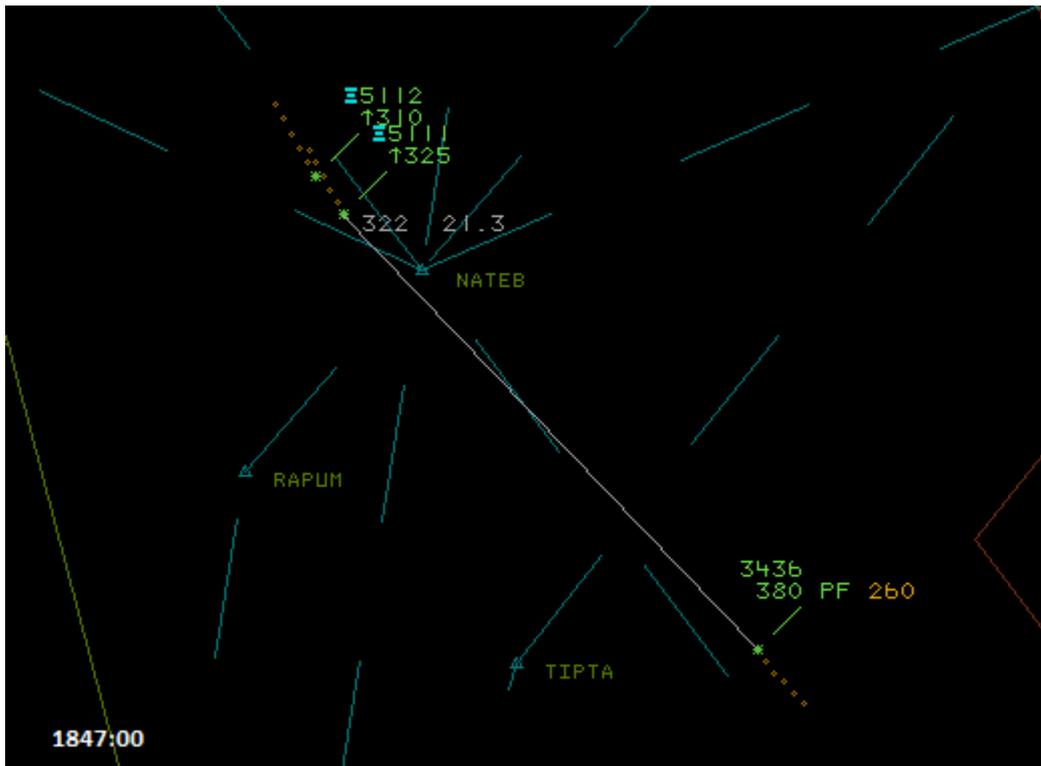
Figure 3.

- 2.6 At 1847:00, as the 5111 squawk was climbing through FL325, the Montrose controller issued avoiding action to the B777, instructing the crew to turn right immediately heading 060 degrees (Figure 3).
