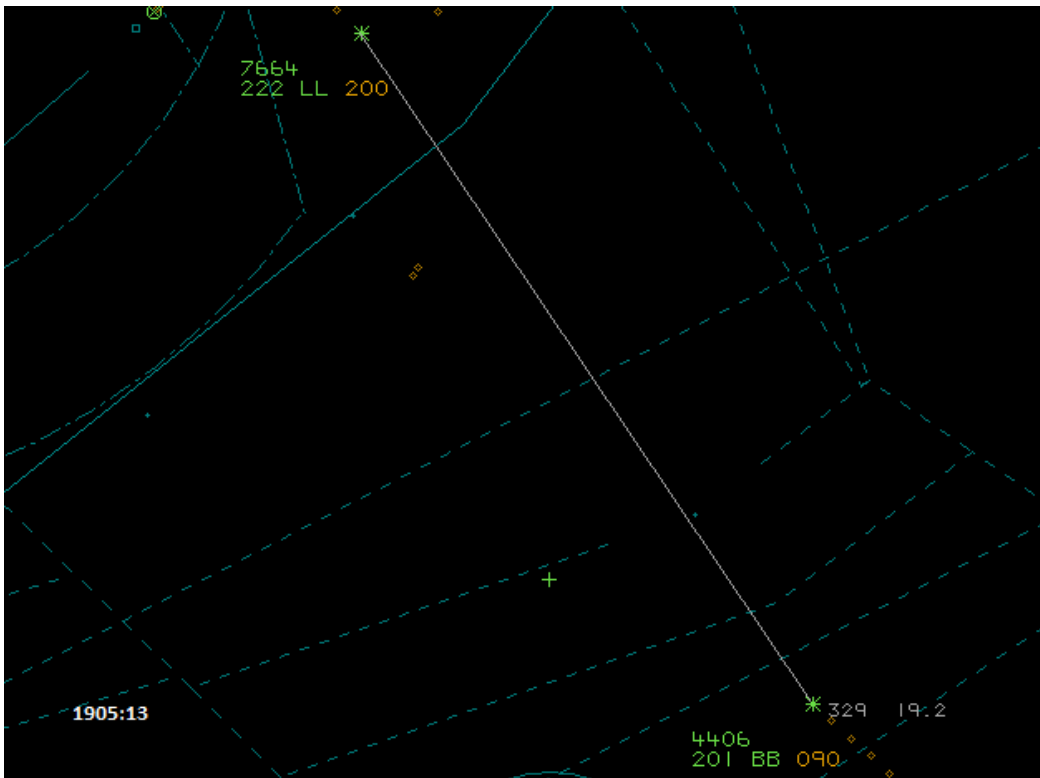
Figure 1

At 1905:13 the DH8D pilot requested a 20° right turn onto heading 335° to avoid weather which was approved by the Welin controller (Figure 1). The two aircraft were 19.2nm apart and the DH8D was 2100ft below the A320, however, the DH8D was only descending at a rate of 500fpm while the A320, descending to FL200, was descending at a rate of 2000fpm.

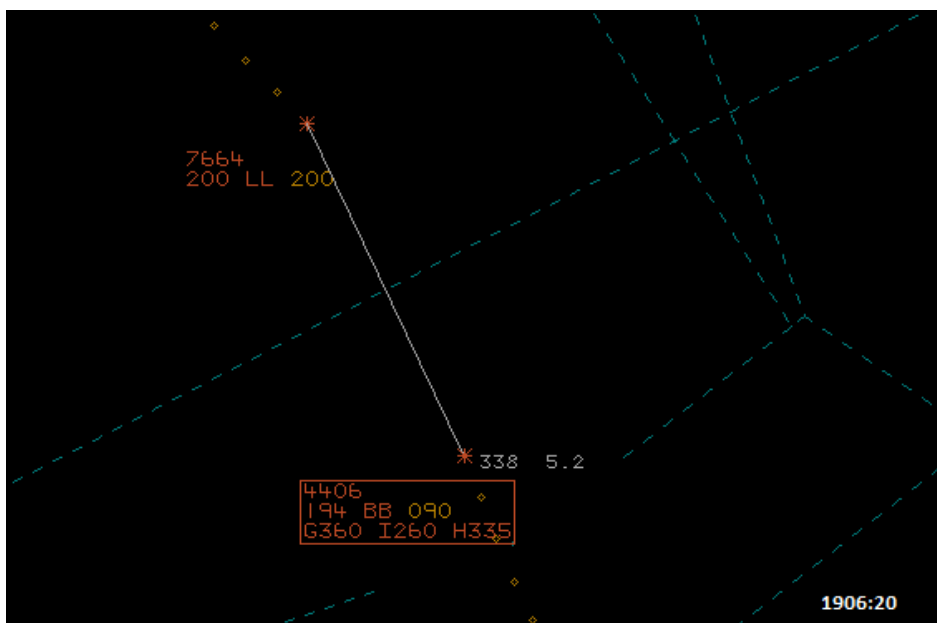
Figure 2

At 1906:05 High level STCA activated. The Cowly controller issued avoiding action to the A320 to turn left heading 095°. The Welin controller issued avoiding action to the DH8D to turn left heading 290°. At 1906:20 the A320 reported receiving a TCAS RA (Figure 2).

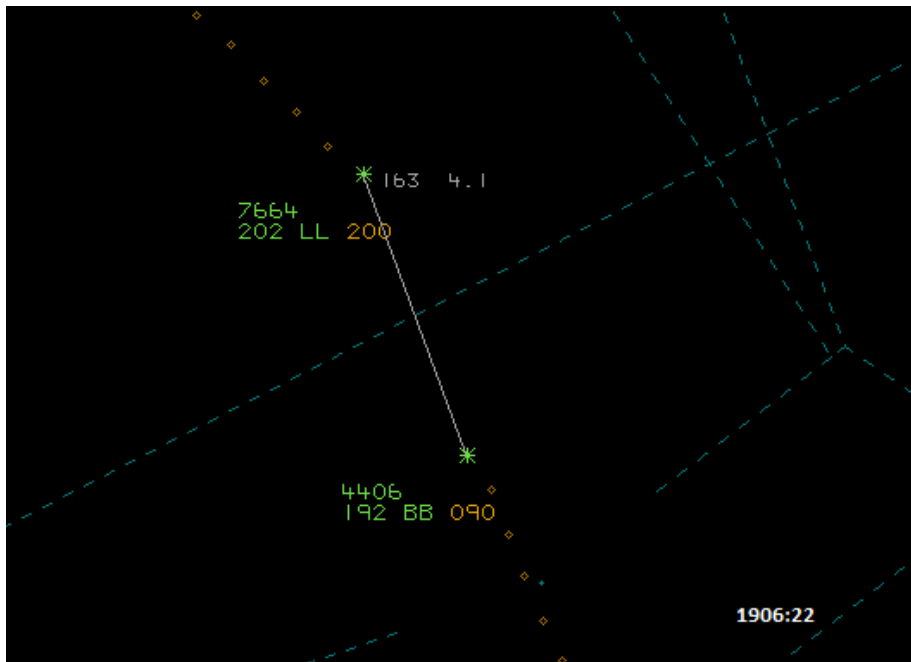
Figure 3

At 1906:22 the two aircraft were 4.1nm and 1000ft apart (Figure 3).
