AIRPROX REPORT No 2013150

Date/Time: 17 Oct 2013 0948Z

Position: 5152N 00153W

Airspace: London FIR (Class: G)

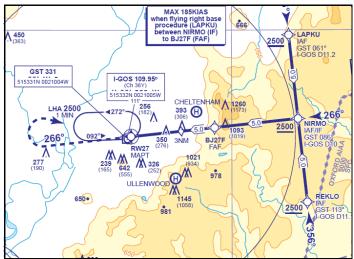
Figure 1 - extract from UK AIP, AD 2-EGBJ-8-7

The C525 pilot was operating IFR inbound to GLO and was in receipt of a Procedural Service from GLO Approach on frequency 128.550MHz. The C525 pilot had been cleared to commence the RNAV approach via REKLO for RW27 and an extract from the GLO instrument approach chart taken from the UK AIP, AD 2-EGBJ-8-7 (30 May 13) is reproduced in Figure 1.

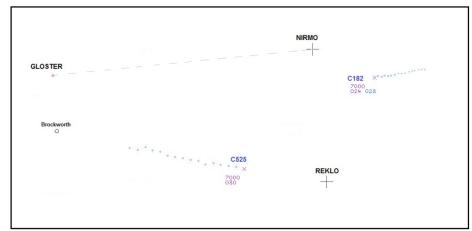
Figure 2 - Swanwick MRT at 0946:29

- C182 "Gloster Radar [C182 C/S] requesting Basic Service"
- ATC "[C182] say again the end of your callsign I've got two similar air-type callsigns on frequency"
- C182 "[C182 C/S]
- ATC "[C182 C/S] pass your message
- C182 "[C182 C/S] is a Cessna one eight two routeing from Oxford to Oxford via Stroud and the M four bridge next point is Brockworth at time nine fifty five er altitude two thousand five hundred feet QNH one zero one three one POB request Basic Service"
- ATC "[C182 C/S] QNH one zero one three and report at Brockworth the instrument pattern active runway two seven with a Citation in a lefthand pattern descending to altitude two thousand three hundred feet"
- C182 "QNH one zero one three and will look out for the instrument traffic [C182 C/S]"
- ATC "[C525 C/S] report your level"
- C525 "Er just at three thousand feet now four miles to REKLO" [0946:29] (see Figure 2).

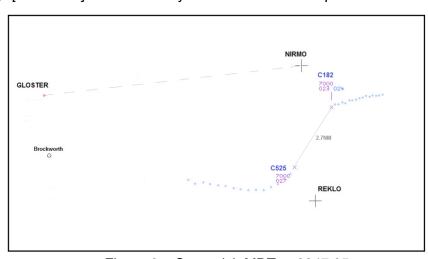
Figure 3 – Swanwick MRT at 0947:05.

thousand five hundred feet east of the field by about ten miles westbound is a Cessna". pilot The C525 replied. "Copied that er what altitude was that at" and the controller responded, "Er reported at three thousand five hundred feet", which acknowledged by the C525 pilot: "copied that thank you very much". The C182 pilot then reported "at two thousand five hundred feet" [0947:05] -See Figure 3.

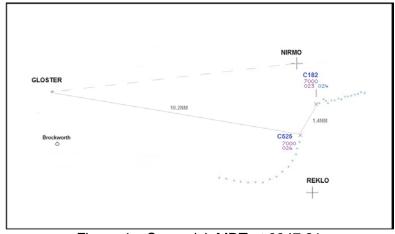
Figure 4 – Swanwick MRT at 0947:21

At 0947:21 the C525 was at FL026 (2600ft) – see Figure 4.

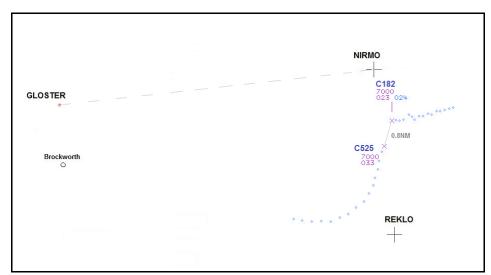
Figure 5 - Swanwick MRT at 0947:29

At 0947:29 the C525 pilot reported, "Copied that sir I'm climbing now to three thousand five hundred feet just had a er a TCAS warning so we're presently just passing through three thousand fi-two hundred feet for three thousand five hundred feet". The controller replied, "[C525 C/S] roger report er when TCAS is complete". The radar recording showed the C525 indicating FL033 (3300ft), 1000ft above the level of the C182 – see Fig 5.
