## AIRPROX REPORT No 2012009

Date/Time: 25 Jan 2012 1814Z (Night)

Type: Tornado GR4 Typhoon FGR4

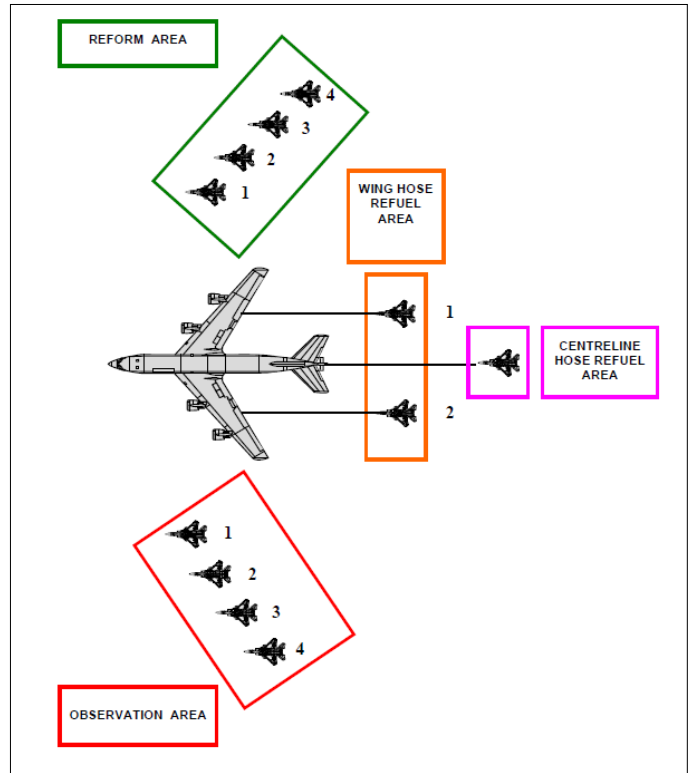
UKAB Note (1): The above is a diagram taken from ATP56 (B), the NATO manual of AAR.
