AIRPROX REPORT No 2012161

Date/Time: 9 Nov 2012 1125Z

Position: 5154N 00210W
(Gloucestershire A/D
- elev 101ft)

Airspace: Gloucester ATZ (*Class: G*)

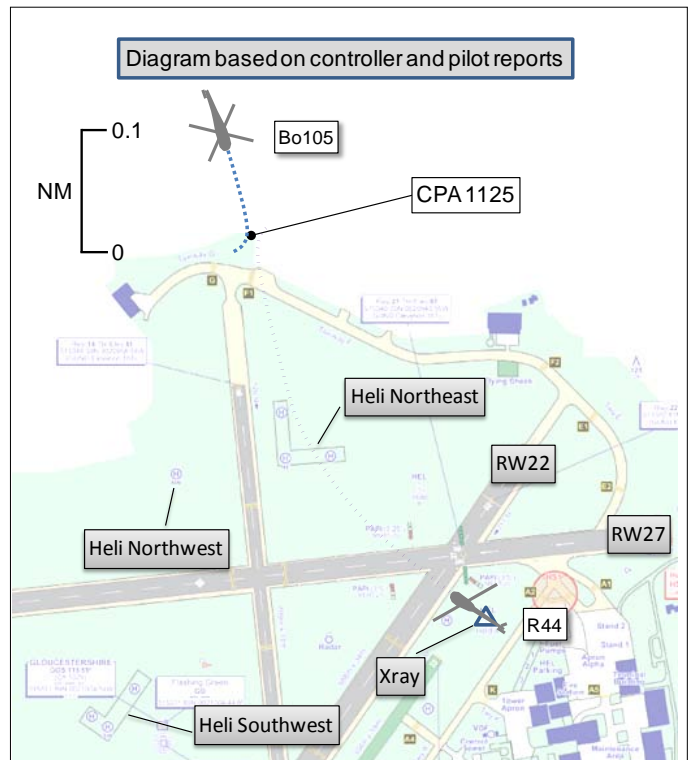
The Airprox occurred when the R44 pilot mistakenly assumed that he had been given take off clearance and immediately transitioned from air-taxiing to depart, crossing RW22 and into conflict with the Bo105 pilot operating in the 'Standard Helicopter Circuit' for RW22.

Cause: The R44 pilot departed without clearance and flew into conflict with the Bo105 on final approach.

Degree of Risk: B.
