AIRPROX REPORT No 2011023

Date/Time: 28 Mar 2011 1410Z

Position: 5136N 00114W
(1nm S Didcot)

Type: Merlin Untraced Glider

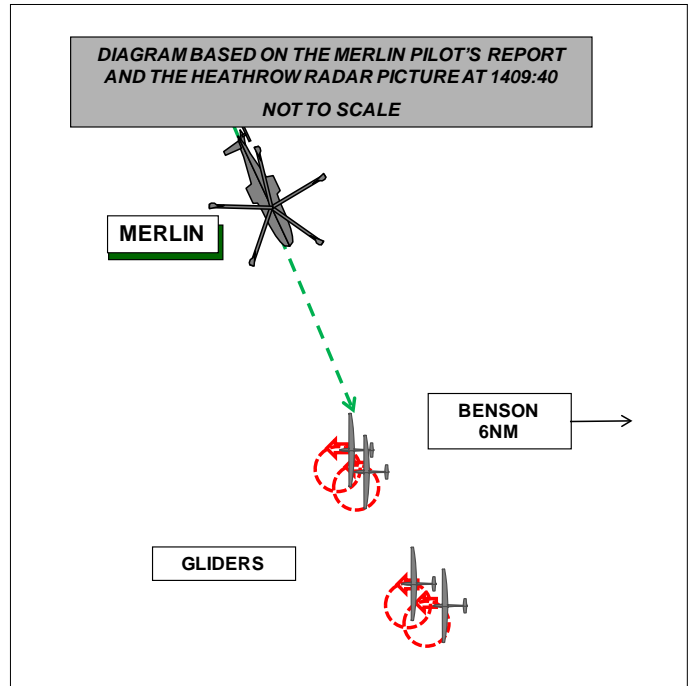
UKAB Note (2): The recording of the Heathrow 10cm radar shows the Merlin throughout tracking 170°, squawking with Modes C and elementary Mode S, initially at an alt of 3000ft. The ac is tracking towards two intermittent primary only contacts manoeuvring in its 12-1230 position. At 1409:40 the helicopter commences a slow descent just as both the primary contact disappear from radar in its 1230 position at about 1.5 and 2nm respectively (there are another 2 gliders at a distance of 4nm in the 12 o'clock). The Merlin passed through the approximate position that the closest glider last painted at 1409:59 at an alt of 2600ft. The primary only contact reappears at 1nm W of the Merlin's track at 1410:37. There are other gliders in the area.
