AIRPROX REPORT No 2010092

Date/Time: 20 Jul 2010 0900Z

Position: 5626N 00252W (3.7nm
N of Leuchars - elev 38ft)

Type: SAAB 340B Harrier T12

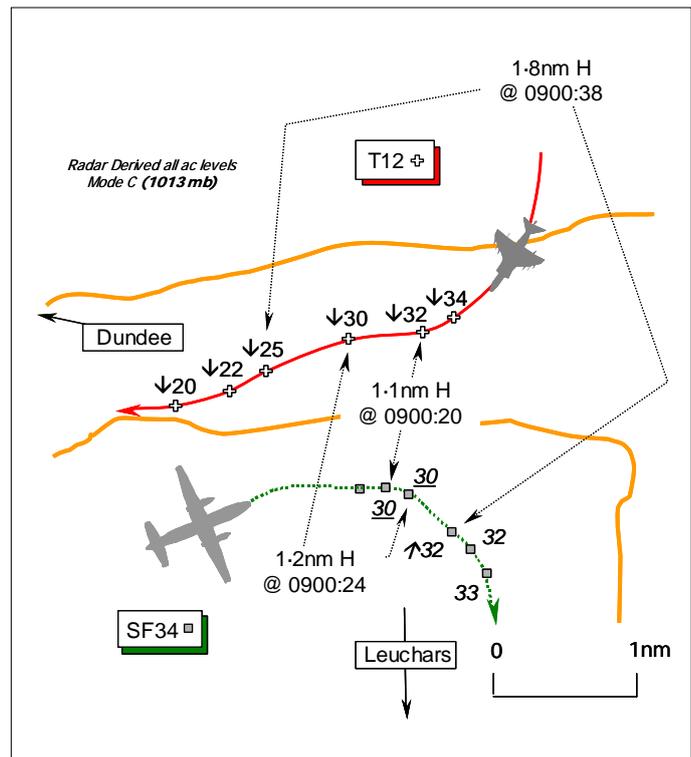
[UKAB Note (1): Minimum horizontal separation occurred at 0900:20, as the Harrier turned R through W descending through 3200ft Mode C (1013mb), with the SF34 1.1nm to the S and 200ft below it. Horizontal separation starts to increase through 1.2nm as the Harrier descends through the SF34’s level on the next sweep, both ac indicating similar levels on Mode C. The climb reported by the SF34 pilot is evident on the recording at 0900:38, as the range increases to 1.8nm with vertical separation of 700ft apparent.]

Cause: The Harrier crew flew close enough to the SAAB 340B to trigger a TCAS RA.
