AIRPROX REPORT No 2010100

Date/Time: 23 Jul 2010 0948Z

Position: 5238N 00050W (1nm
NW Wycombe - elev
520ft)

Airspace: Wycombe ATZ (Class: G)

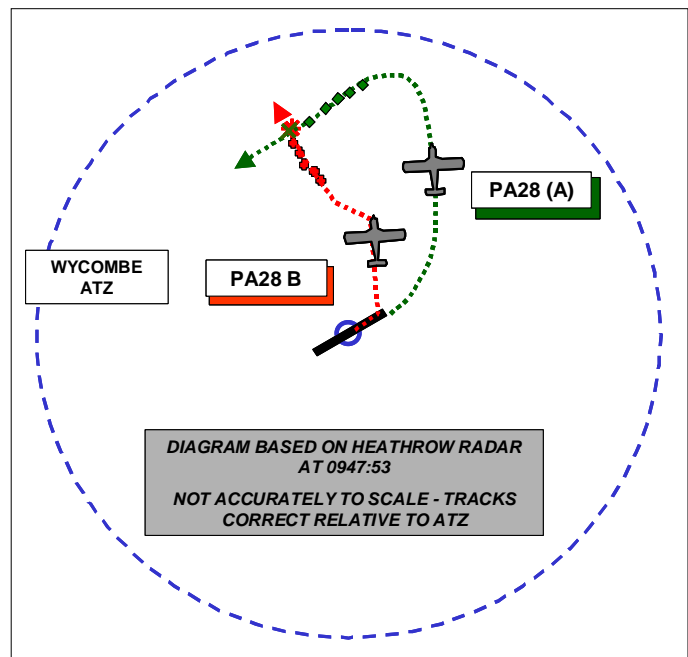
Radar recording shows the PA28 (A) follow the noise abatement procedure for a standard circuit with the PA28 (B) turning left at 480ft aal. PA28 (B) can be seen tracking 330° and climbing to circuit height, crossing the midpoint of the downwind leg in close proximity to PA28 (A).

UKAB Note (2): The incident shows clearly on the recording of the Heathrow 23cm radar (and others). The geometry is as described in the ATSI report above and as depicted in the diagram.

Cause: PA28 (B) turned into conflict with PA28 (A) in the Wycombe ATZ.
