AIRPROX REPORT No 2010102

Date/Time: 29 Jul 2010 1310Z

Position: 5150N 00119W
(Oxford/Kidlington
RW01RHC - elev 270ft)

Airspace: Oxford ATZ (Class: G)
Reporting Ac Reported Ac

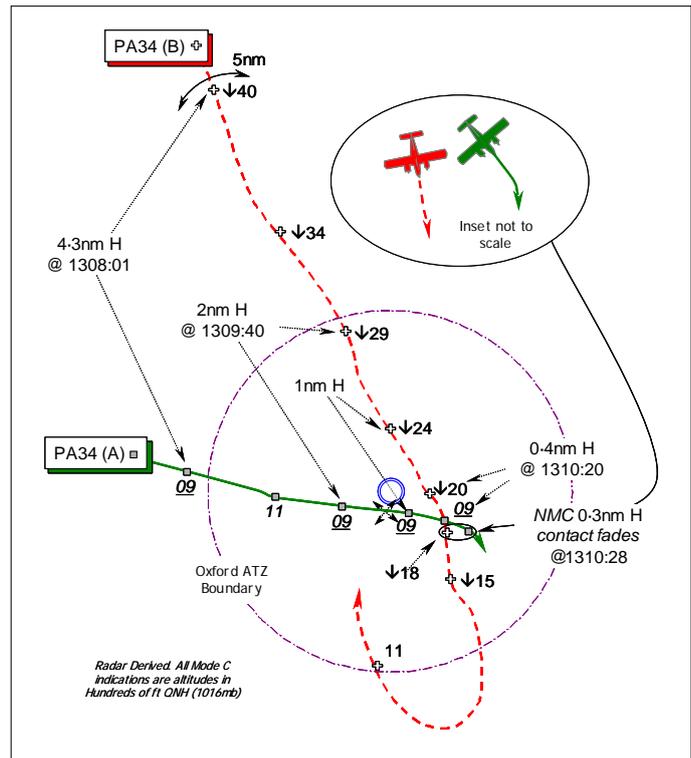
UKAB Note (2): The LACC System recording shows PA34 (A) approaching Oxford Airport from the W, level at an indicated altitude of 900ft QNH (1016mb); on completion of the 100° procedure the ac passes S abeam the Airport at a Radar Ground Speed (RGS) of 108kt. PA34 (B) is shown approaching the Airport in a continuous descent on a generally SSE'ly track. PA34 (B) is shown inside 5d from Oxford at 1308:01, 4.3nm N of PA34 (A). PA34 (B) descends into the ATZ at a RGS of about 190kt after crossing through the climb-out to RW01 ½nm N of the airport and descending through 2300ft QNH. At 1310:20, PA34 (A) is shown crossing through PA34 (B)'s 12 o'clock at a range of 0.4nm indicating 1100ft below the latter, before PA34 (A) commences a R turn downwind. PA34 (B) passes 0.3nm W of and inside PA34 (A) descending through 1800ft before PA34 (A) fades from coverage. Continuing on a southerly course PA34 (B) extends downwind to a range of 2.6nm from the Airport before turning in onto final approach for RW01RHC and fading from coverage
