## AIRPROX REPORT No 2010123

Date/Time: 2 Sep 2010 0615Z

Position: 5503N 00502W (5nm

Airspace: AWY P600 (Class: D)

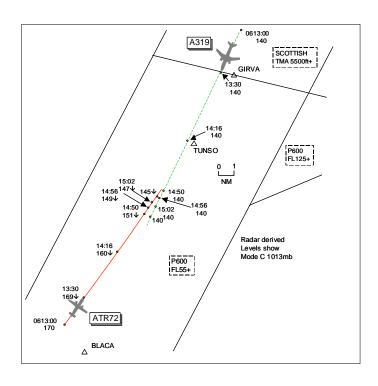
[UKAB Note (1): The CPA occurs between radar sweeps. The radar recording at 0614:56 shows the ATR descending through FL149 in the A319's 1 o'clock range 0.9nm whilst the next sweep 6sec later at 0615:02 shows the ac having passed starboard to starboard separated by 0.4nm, the ATR72 descending through FL147, 700ft above the A319 and in its 4 o'clock. The CPA is estimated to be 0.3nm and at least 700ft vertically.]
