AIRPROX REPORT No 2010136

Date/Time: 19 Sep 2010 1111Z (Sunday)

Position: 5028N 00354W (8.5nm ENE Plymouth)

Airspace: LFIR (Class: G)

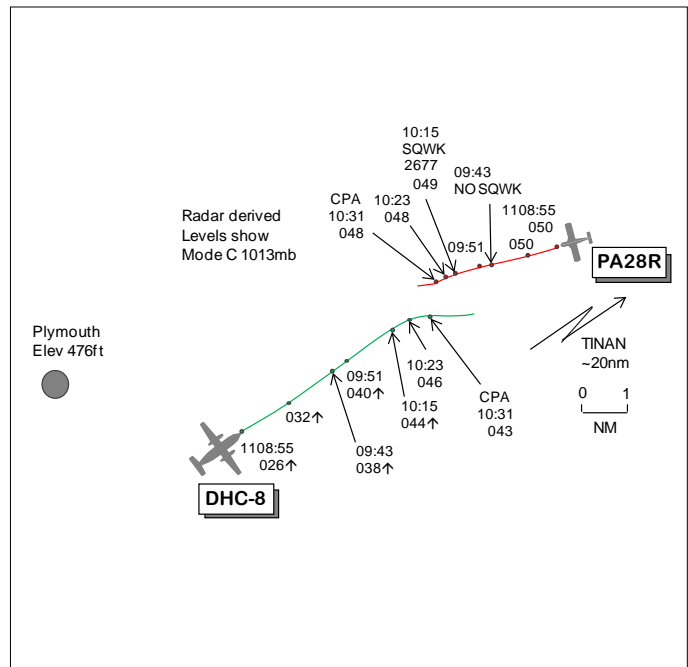
[UKAB Note (2): The CPA occurs at 1110:31, the radar recording shows both ac 8.5nm ENE of Plymouth Airport with the DHC-8 now having descended indicating FL043 and in a R turn passing 0.8nm S of, and 500ft below, the PA28R indicating FL048.]
