AIRPROX REPORT No 2010168

Date/Time: 4 Nov 2010 1226Z

Position: 5052N 00027W (2nm
NNE of Shoreham A/D -
elev 7ft)

Reporter: Shoreham ATC

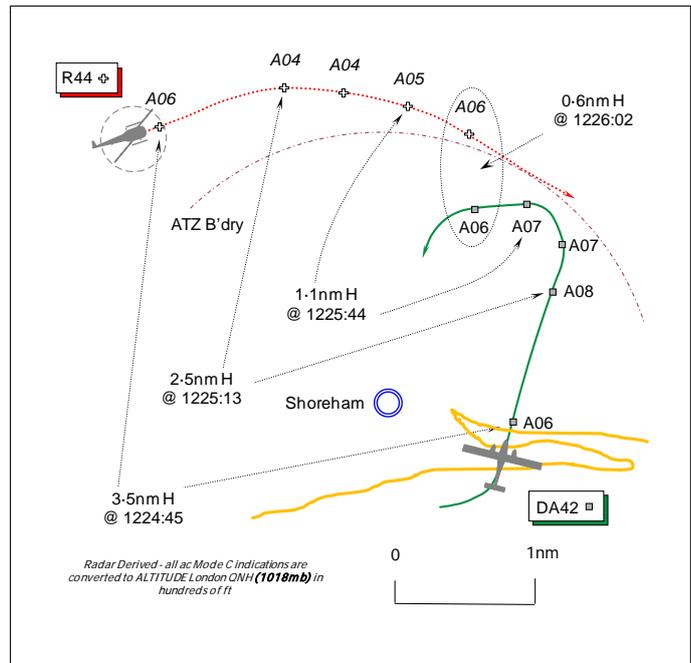
At 1224:45, the DA42 pilot reported Downwind and the controller instructed him to report Final for RW20. The radar recording at 1225:13 shows the DA42 late downwind squawking A0401 indicating an altitude of 800ft London QNH (1018mb) with the R44 helicopter, squawking A7000 at an altitude of 400ft London QNH, 2.5nm NNW of the airport tracking E around the Shoreham ATZ. At 1225:44, the radar recording shows the DA42 inside the Shoreham ATZ, on Base-leg for RW20, indicating 700ft ALT, with the R44, indicating 400ft ALT, in the DA42's R 2 o'clock at a range of 1.1nm. The R44 continued to track E remaining just outside the Shoreham ATZ. It was at 1226:04, that the

Shoreham controller first advised the DA42 pilot of the presence of the R44, “..caution a helicopter below you not on my frequency clear now.” At this point the radar recording shows the DA42 turning onto final at 1.6nm from the Airport with the R44 passing 0.6nm behind and just outside the ATZ; both ac are indicating 600ft ALT.

The controller’s written report indicates that the helicopter passed ahead of the DA42 on Final approach and at the point the controller sighted the helicopter, it may have been perceived to have been crossing ahead and below the DA42. The radar recording, however, shows the R44 passing 0.5nm clear astern of the DA42, the latter descending through 500ft ALT on Final, with the helicopter just outside the ATZ boundary.
