AIRPROX REPORT No 2010172

Date/Time: 24 Oct 2010 0930Z (Sunday)

Position: 5140N 00001W (10nm NNW London/City)

Type: C404 M20J

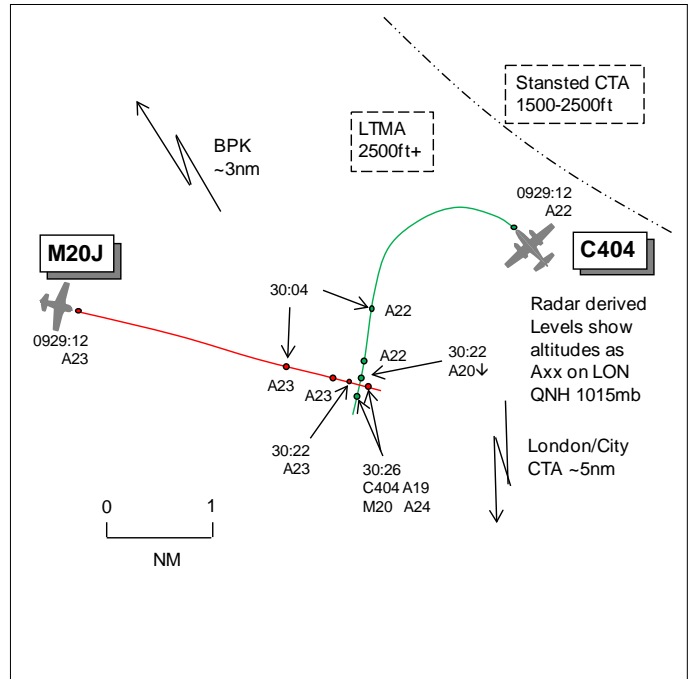
[UKAB Note (1): At 0930:22, the radar recording shows the C404 tracking S'ly descending through altitude 2000ft with the M20J in its 2 o'clock range 0.1nm at 2300ft, 300ft above. The CPA occurs before the next sweep 4sec later at 0930:26 when radar recording shows the 2 ac having passed and now diverging at range of 0.1nm, the C404 now level at 1900ft and the M20J at 2400ft. At the CPA, 0930:24, it is estimated the ac passed with no lateral separation and 400ft vertical separation.]
